# Department of Transportation

*Monroe County, New York*

## **THOMAS AVENUE IMPROVEMENTS PROJECT**

### *TREE SURVEY REPORT*

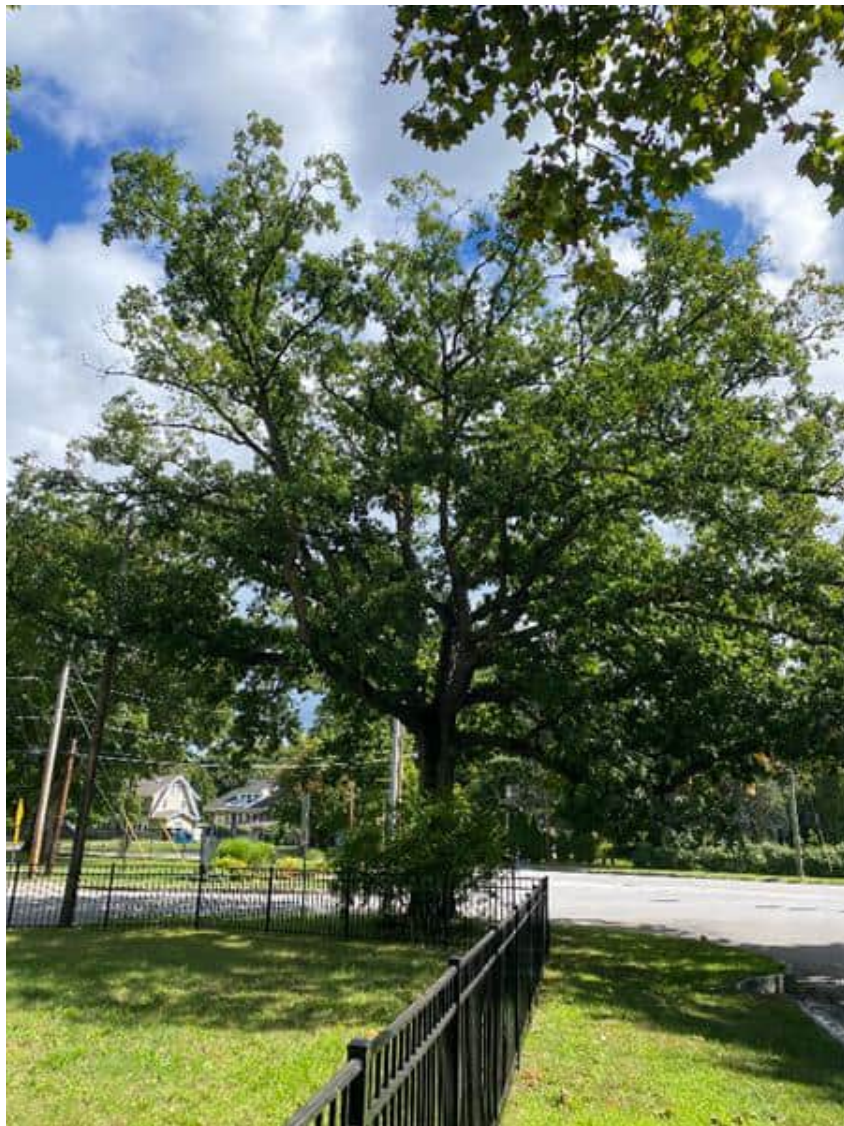
Photo 1: Tree ID No. 1, white oak (36" DBH). View facing east.

| Tree ID # <sup>1</sup> | Approx. Address | Scientific Name | Common Name | DBH (in) | Approx. Height (ft) | Live Crown Ratios (LCR) | Overall Risk Rating | Overall Residual Risk | Tree Defects | Recommended Mitigation | Latitude <sup>2</sup> | Longitude <sup>2</sup> |
|---|---|---|---|---|---|---|---|---|---|---|---|---|
| 1 | 21 Thomas Ave | <i>Quercus alba</i> | white oak | 36 | 50 | 75% | MODERATE | LOW | Low hanging, overextended branches at poor attachment angles; minor decay in canopy; co-dominant canopy stems; buried root collar | Prune low hanging, over-extended branches; expose buried tree collar | 43.230544 | -77.599690 |

Tree ID No. 1 is a white oak tree and poses a risk to Thomas Avenue, Sagamore Dr., one (1) private property, a utility pole, and power lines located immediately adjacent to and within the area of the tree. Many branches are over-extended over Thomas Avenue and Sagamore Dr. and are at poor angles of attachment to the trunk. The trunk has a poor taper, with multiple codominant leaders, and the root collar is buried. CED's recommendation is to expose the buried root collar and prune the overextended branches of the tree to reduce the overall load on the tree. At least one of the codominant leaders should either be pruned or removed. Tree removal is also a possible option for this tree. However, if the appropriate mitigation is performed the tree will eventually pose an overall low residual risk.

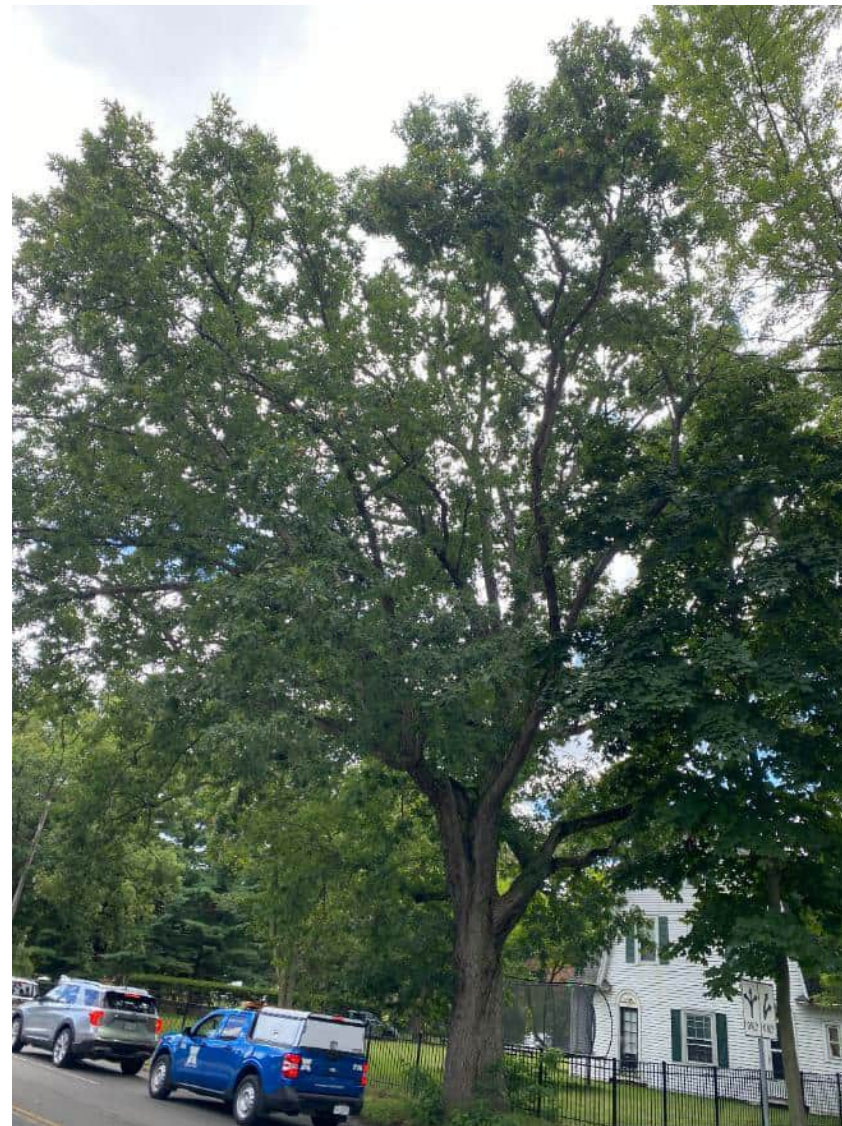
Photo 2: Tree ID No. 2, white oak (42" DBH). View facing south.

Tree ID No. 2 is a white oak tree and poses a risk to Thomas Avenue and two (2) private properties. Many branches are over-extended over Thomas Avenue at poor angles of attachment to the trunk. The trunk has a poor taper, with multiple codominant leaders, and the root collar is buried. CED's recommendation is to expose the buried root collar and prune the overextended branches of the tree to reduce the overall load on the tree. At least one of the codominant leaders should also be either pruned or removed. Tree removal is also a possible option for this tree. However, if the appropriate mitigation is performed the tree will eventually pose an overall low residual risk.

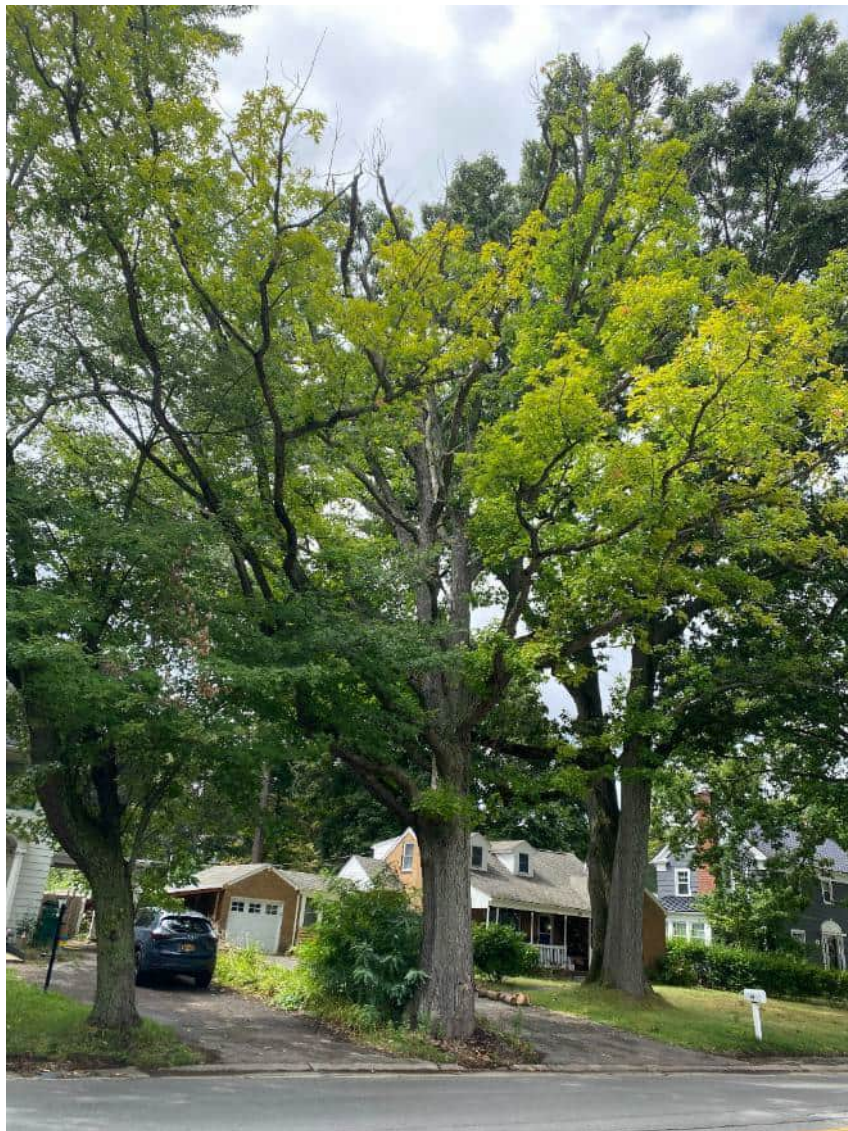
Photo 3: Tree ID No. 3, white oak (40" DBH). View facing west.

Tree ID No. 3 is a white oak tree and poses a risk to Thomas Avenue, two (2) private properties, and adjacent trees. At least 25% of the crown showed dieback, and 80% of the leaves present within the crown displayed chlorosis, which suggests poor tree health. This can be the result of various factors, including nutrient deficiencies, imbalances in the soil pH, or environmental stressors. CED recommends the tree should be pruned to remove the dead branches from the canopy. However, this mitigation option still poses a moderate level of residual risk. If no mitigation is performed on the tree within the next four years, and no significant increase in tree vigor is visible within four years, removing the tree may be the most viable option.

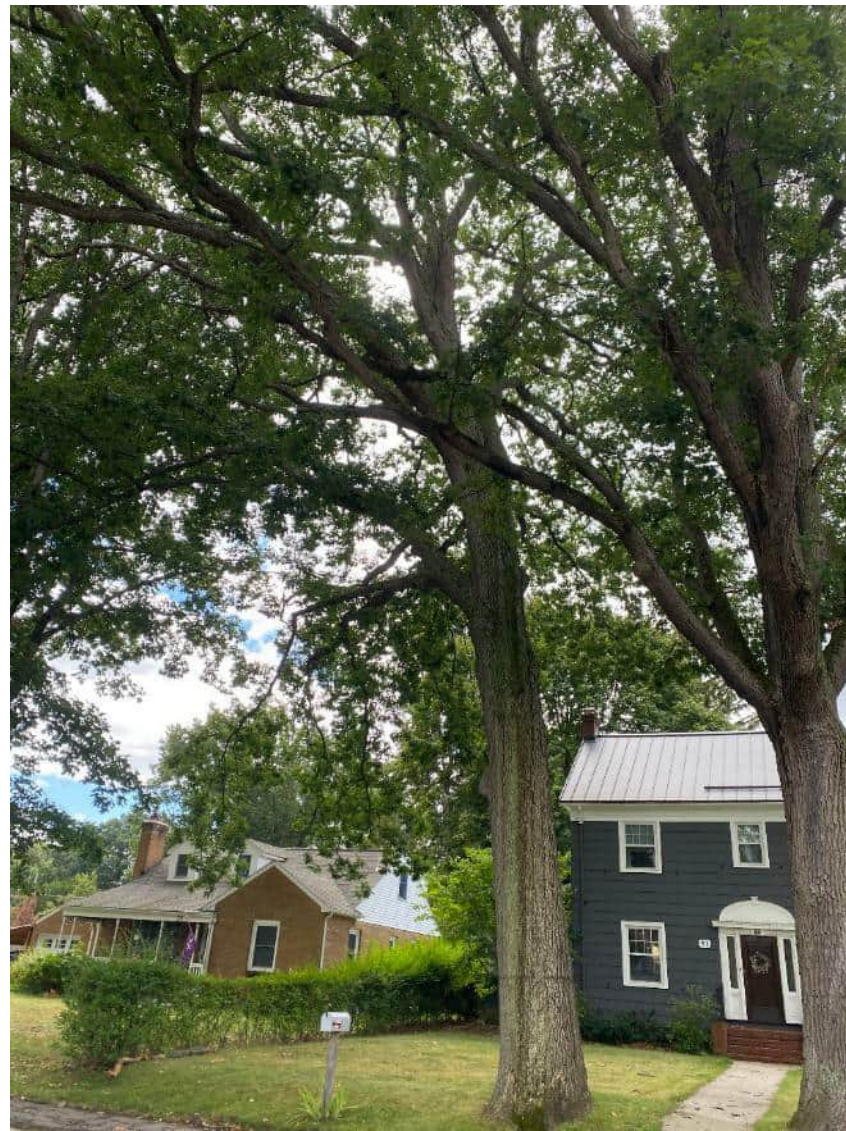
Photo 4: Tree ID No. 4, white oak (37" DBH). View facing southwest.

Tree ID No. 4 is a white oak tree and poses a risk to Thomas Avenue and (2) private properties. The crown of the tree is unbalanced, and many branches are over-extended over Thomas Avenue at poor angles of attachment to the trunk. Most of the branching is on only the southwestern side of the tree. The trunk has a poor taper and is leaning towards both private properties. CED's recommendation is to prune the branches of the tree to reduce the overall load on the tree. Tree removal is also a possible option for this tree. However, if the appropriate mitigation is performed the tree will eventually pose an overall low residual risk.

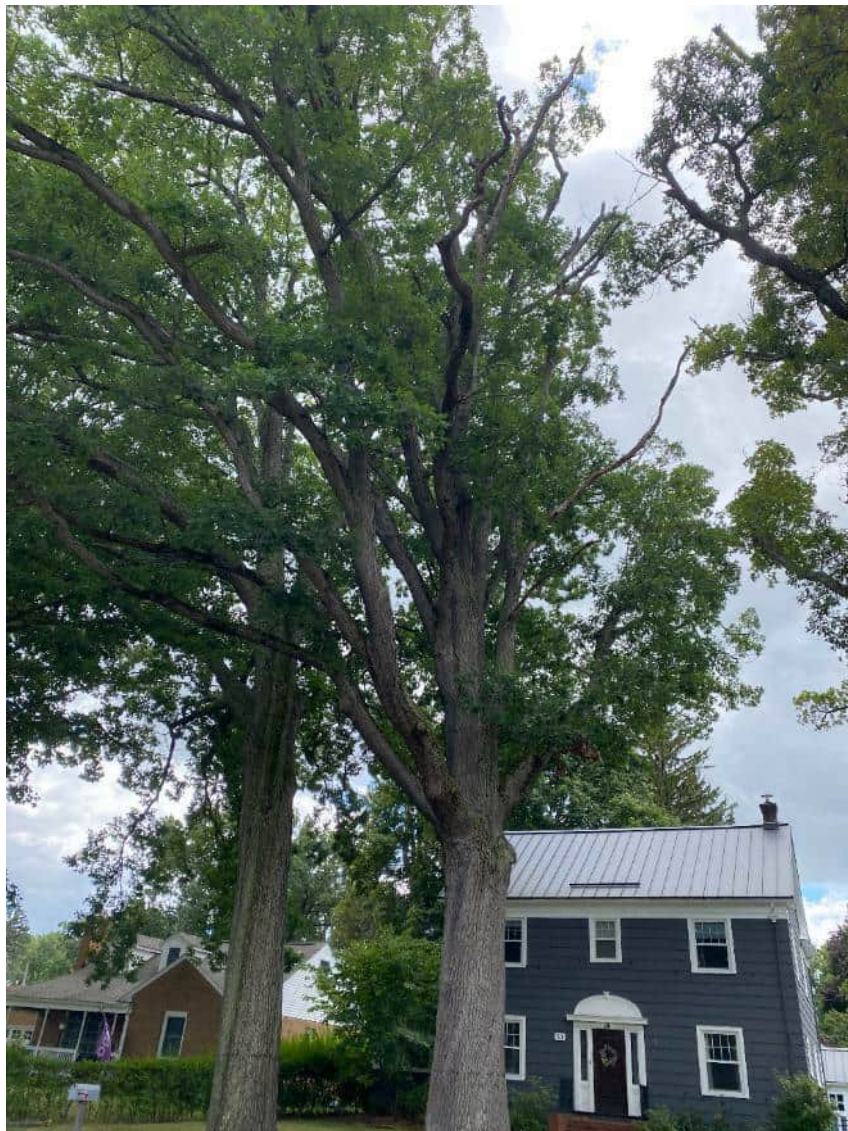
Photo 5: Tree ID No. 5, white oak (42" DBH). View facing southwest.

Tree ID No. 5 is a white oak tree and poses a risk to Thomas Avenue and two (2) private properties. The crown of the tree is unbalanced, and many branches are over-extended over Thomas Avenue at poor angles of attachment to the trunk. Most of the branches are on only the southern side of the tree and many are almost overlapping with Tree ID No. 4. The trunk has a poor taper and is leaning towards both private properties. CED's recommendation is to prune the branches of the tree to reduce the overall load on the tree. At least one of the codominant leaders should also be either pruned or removed. Tree removal is also a possible option for this tree. However, if the appropriate mitigation is performed the tree will eventually pose an overall low residual risk.

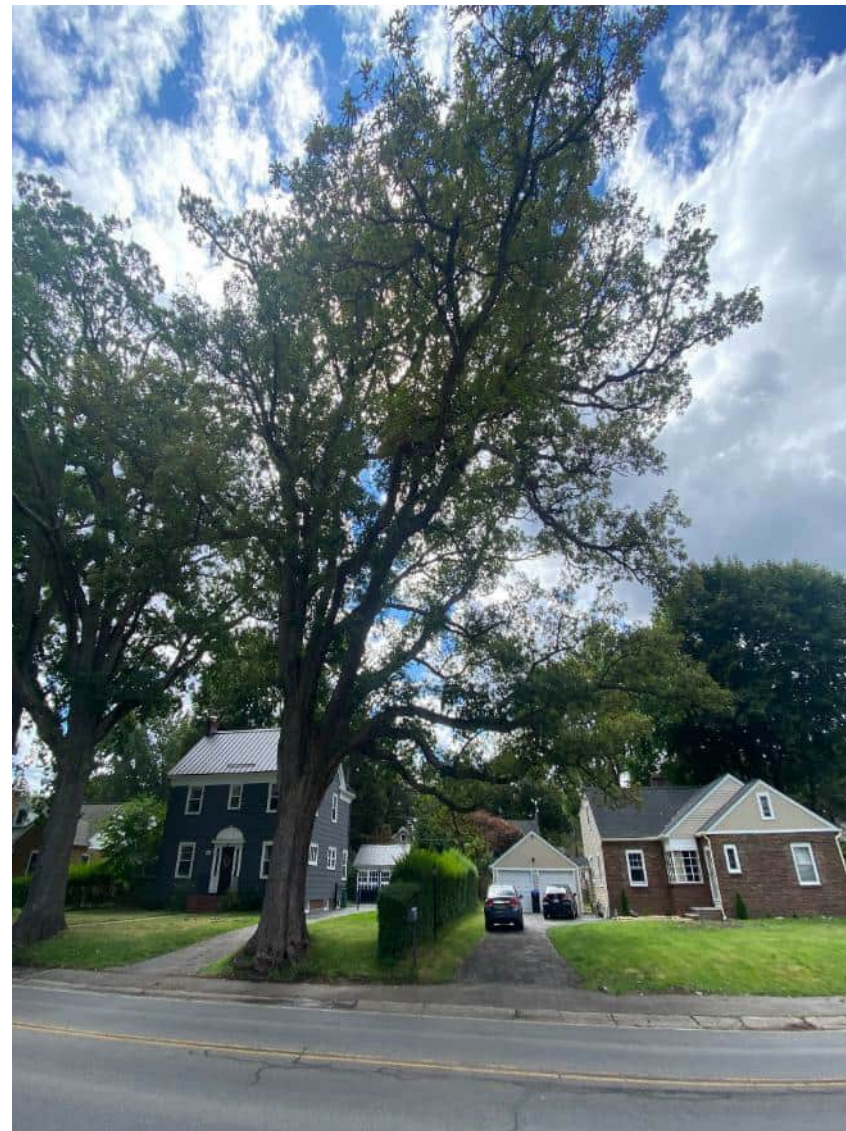
Photo 6: Tree ID No. 6, white oak (48" DBH). View facing southwest.

| Tree ID # <sup>1</sup> | Approx. Address | Scientific Name | Common Name | DBH (in) | Approx. Height (ft) | LCR | Overall Risk Rating | Overall Residual Risk | Tree Defects | Recommended Mitigation | Latitude <sup>2</sup> | Longitude <sup>2</sup> |
|---|---|---|---|---|---|---|---|---|---|---|---|---|
| 6 | 51 Thomas Ave | <i>Quercus alba</i> | white oak | 48 | 100 | 60% | HIGH | MODERATE | Low hanging, overextended, and curling branches; some branches over street and private properties; co-dominant stems on trunk & in canopy; large mushrooms on trunk base indicate decay | Prune overextended and low hanging branches | 43.231204 | -77.600673 |

Tree ID No. 6 is a white oak tree and poses a risk to Thomas Avenue and two (2) private properties. The crown of the tree is unbalanced with overextended branches over Thomas Avenue, some low-hanging branches are curling, and there is a low hanging branch directly above the driveway of one of the private properties. Many branches in the canopy show poor attachment angles. The trunk has inclusion bark and a poor taper. There are large mushrooms and multiple cavities at the tree base and tree roots, which indicate decay is present. There is possible stem girdling present on the side of the tree based adjacent to the sidewalk. Even if pruning is performed within the next year to reduce the load on the tree, the tree will still pose a moderate residual risk. Due to this, CED's

recommendation is to remove the tree. If no corrective action is taken, the entire tree is expected to fail in four years.

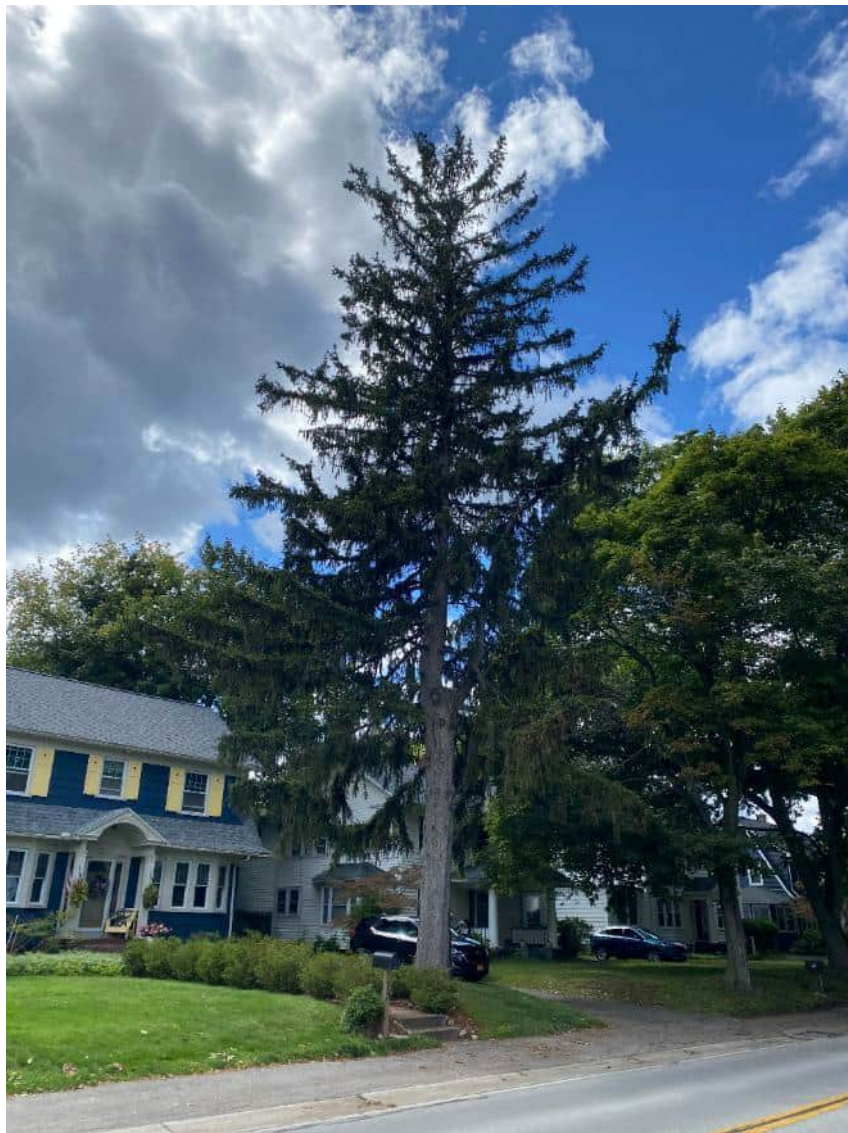
Photo 7: Tree ID No. 7, Norway spruce (28" DBH). View facing west.

| Tree ID # <sup>1</sup> | Approx. Address | Scientific Name | Common Name | DBH (in) | Approx. Height (ft) | LCR | Overall Risk Rating | Overall Residual Risk | Tree Defects | Recommended Mitigation | Latitude <sup>2</sup> | Longitude <sup>2</sup> |
|---|---|---|---|---|---|---|---|---|---|---|---|---|
| 7 | 75 Thomas Ave | <i>Picea abies</i> | Norway spruce | 28 | 80 | 38% | LOW | LOW | 1 co-dominant canopy stem, excessive number of lower branches missing | Remove or prune co-dominant stem from canopy | 43.231489 | -77.601103 |

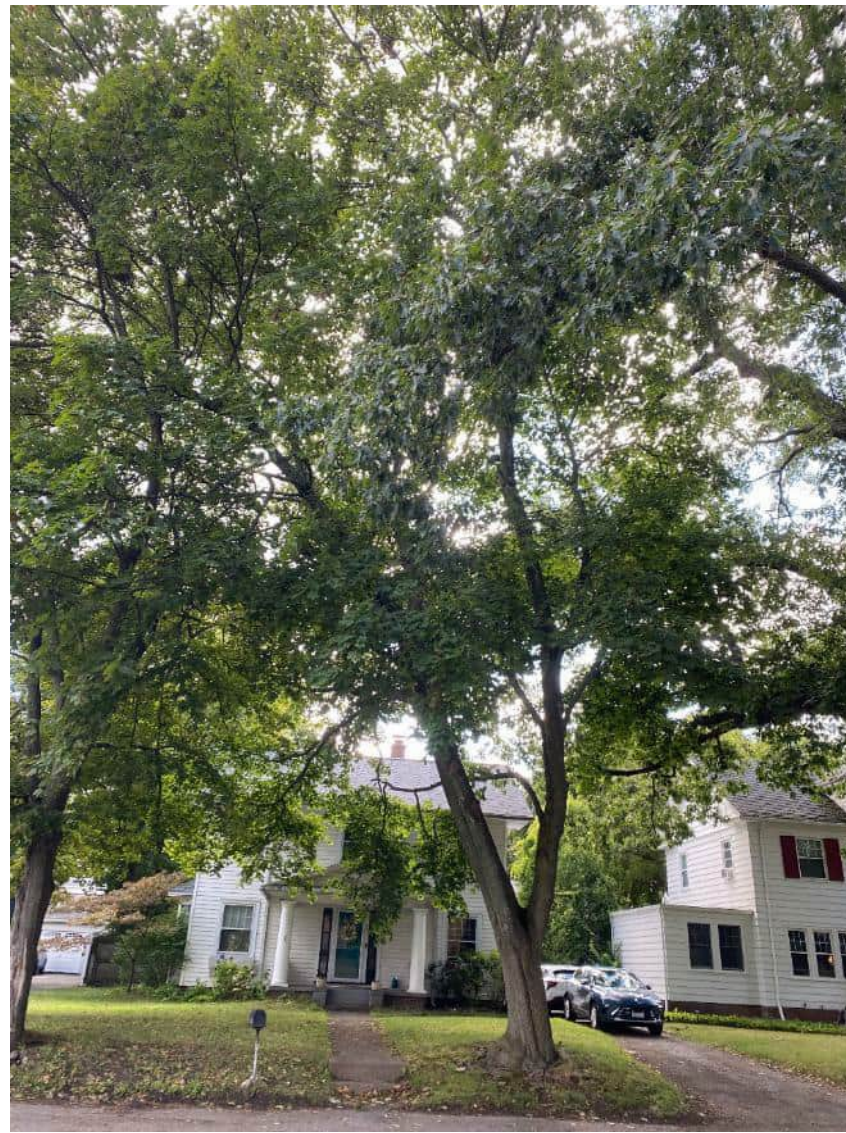
Photo 8: Tree ID No. 8, Norway maple (28" DBH). View facing southwest.

Tree ID No. 8 is a Norway maple and poses a risk to Thomas Avenue and two (2) private properties. The crown of the tree is unbalanced and has low-hanging, overextended branches growing towards Thomas Avenue and one of the private properties. The tree trunk has two codominant leaders and inclusion bark. The codominant stems have poor attachment angles and exhibit potential signs of decay, with discoloration present along the stems. CED's recommendation is to remove the smallest codominant leading stem to reduce the load on the tree. The low-hanging, overextended tree branches should also be pruned to reduce the overall load on the tree. This tree should be regularly monitored for signs of increased decay. If the appropriate mitigation is not completed in the next two to three years, tree decay may increase, as will the likelihood of failure. If no mitigation is performed on the tree, removing the tree may be the most viable option.

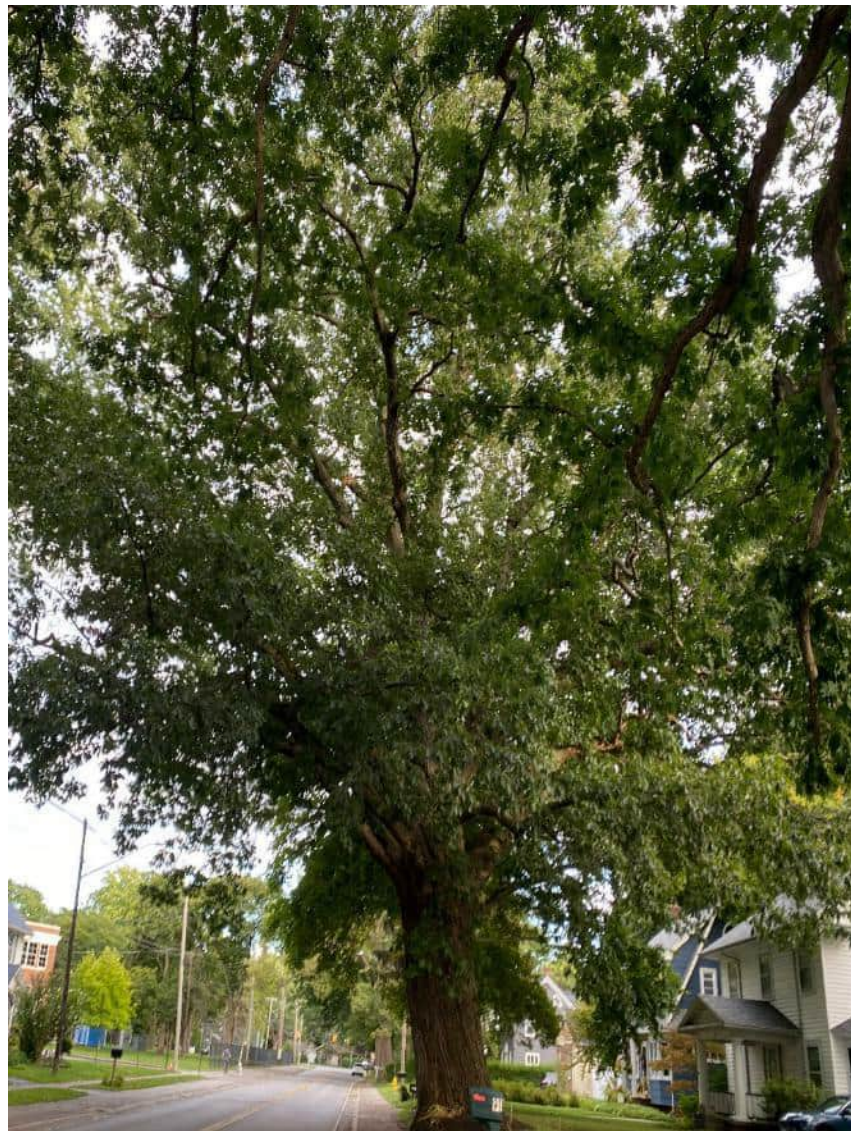
Photo 9: Tree ID No. 9, northern red oak (74" DBH). View facing southeast.

Tree ID No. 9 is a northern red oak tree and poses a risk to Thomas Avenue and three (3) private properties. Many branches are over-extended over Thomas Avenue at poor angles of attachment to the trunk. The canopy has multiple codominant leaders, and there is a cavity near the base of the tree. CED's recommendation is to prune the dead, overextended, and low-hanging branches of the tree to reduce the overall load on the tree. At least one of the codominant leaders should also be either pruned or removed. The tree's base should be monitored regularly for signs of increased decay. Tree removal is also a possible option for this tree. However, if the appropriate mitigation is performed the tree will eventually pose an overall low residual risk.

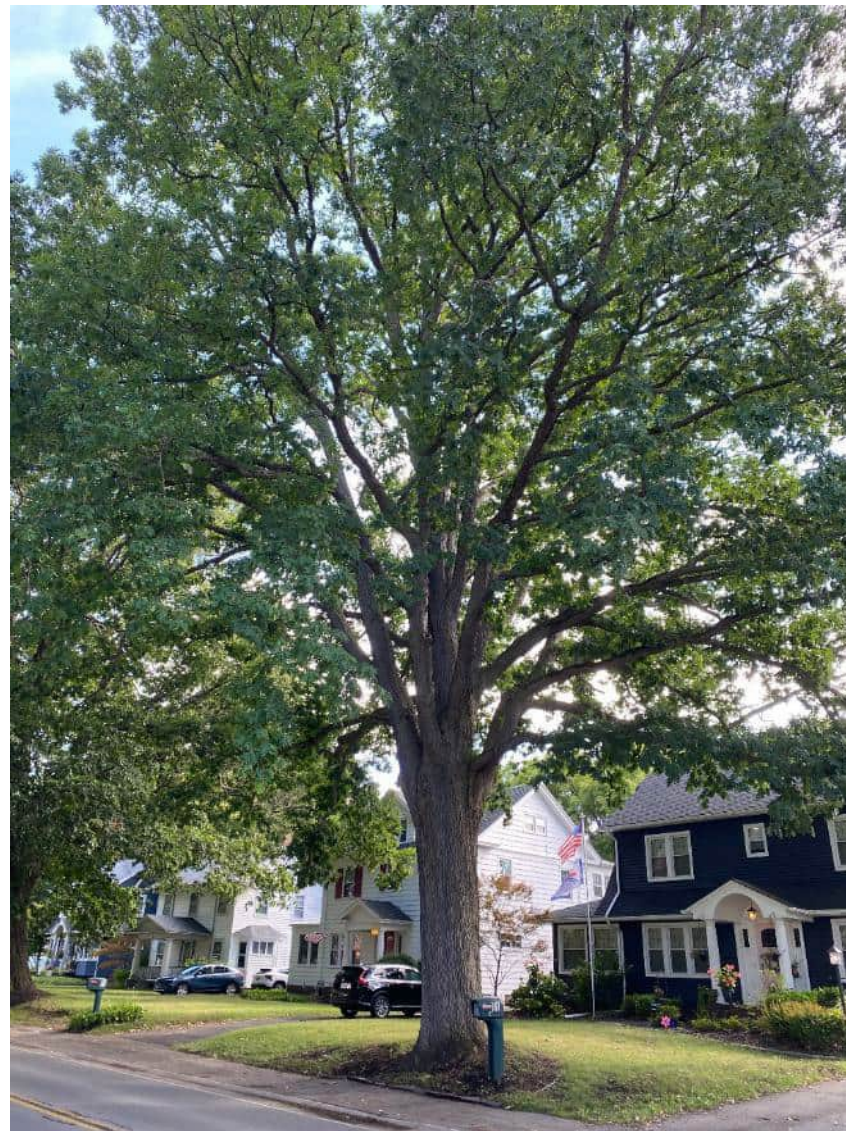
Photo 10: Tree ID No. 10, white oak (48" DBH). View facing south.

Tree ID No. 10 is a white oak tree and poses a risk to Thomas Avenue and three (3) private properties. Many branches are over-extended over Thomas Avenue at poor angles of attachments. The canopy has multiple codominant leaders, and the trunk has a poor taper. CED's recommendation is to prune or remove at least one of the codominant leaders and prune or remove the overextended, low-hanging branches of the tree. However, even if all mitigation recommendations are performed, the tree will still pose an overall moderate residual risk.

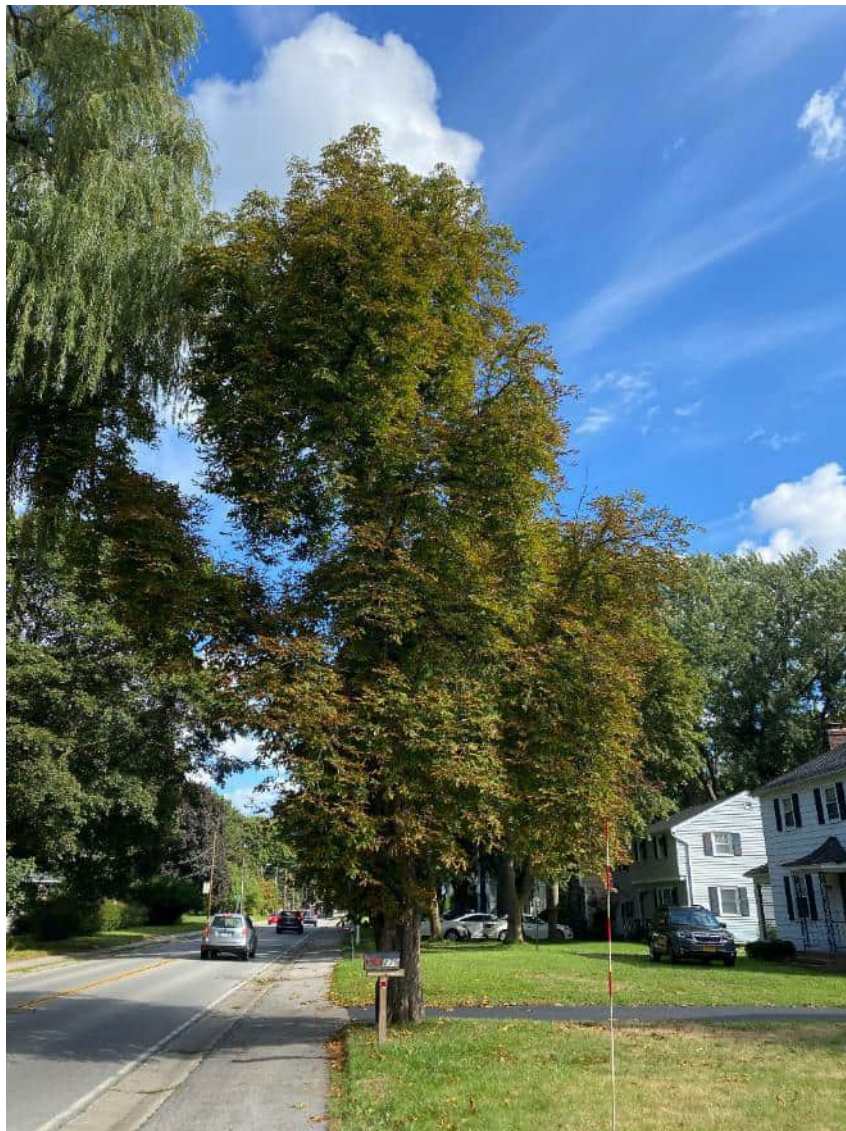
Photo 11: Tree ID No. 11, horse-chestnut (13" DBH). View facing southeast.

Tree ID No. 11 is a horse-chestnut tree and poses a risk to Thomas Avenue and two (2) private properties. Many branches have poor angles of attachment to the trunk and are curving downward. The canopy has a codominant leader, and the trunk has a poor taper. CED's recommendation is to prune or remove the codominant leader, as well as the downward curving branches. However, even if all mitigation recommendations are performed, the tree will still pose an overall moderate residual risk.

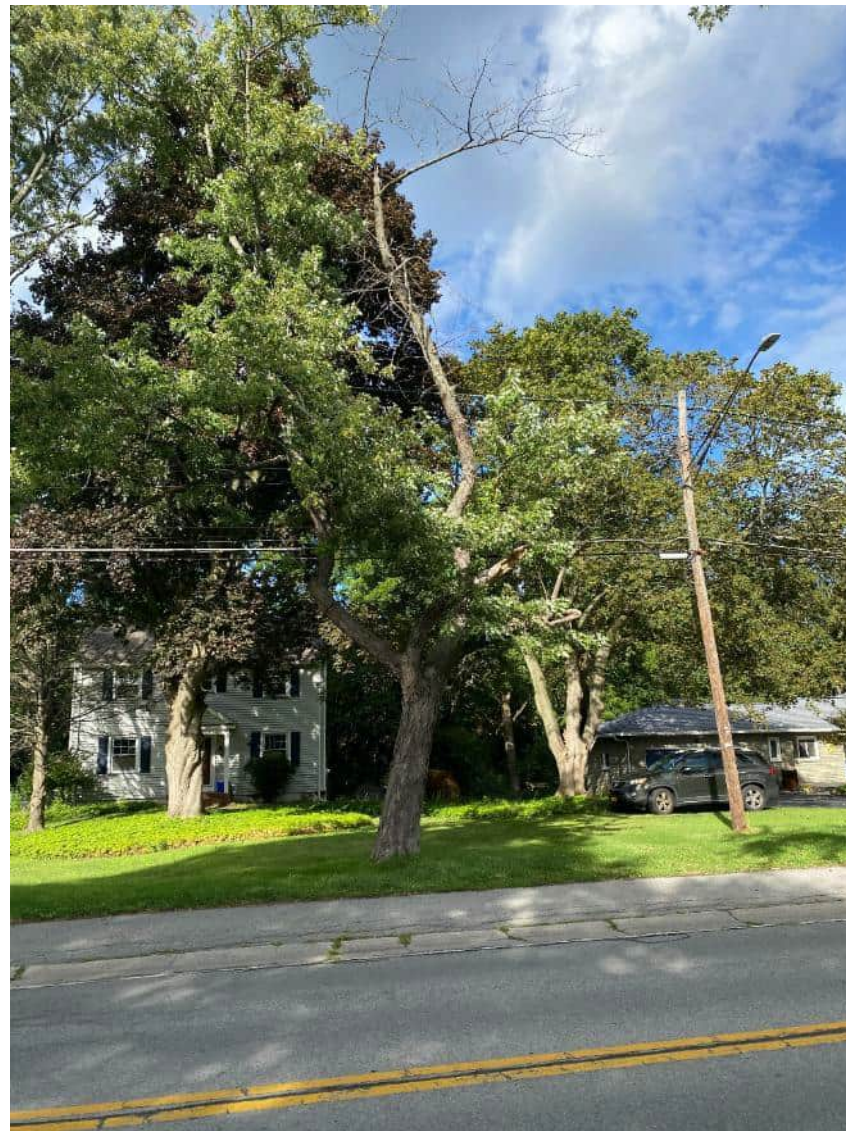
Photo 12: Tree ID No. 12, Freeman maple (23" DBH). View facing northeast.

| Tree ID # <sup>1</sup> | Approx. Address | Scientific Name | Common Name | DBH (in) | Approx. Height (ft) | LCR | Overall Risk Rating | Overall Residual Risk | Tree Defects | Recommended Mitigation | Latitude <sup>2</sup> | Longitude <sup>2</sup> |
|---|---|---|---|---|---|---|---|---|---|---|---|---|
| 12 | 312 Thomas Ave | <i>Acer × freemanii</i> | Freeman maple | 23 | 45 | 45% | HIGH | HIGH | 1 co-dominant stem weakly attached; multiple dead and broken branches, poor overall growth form; leaning trunk; cut roots | Remove tree; prune dead branches | 43.234833 | -77.605704 |

Tree ID No. 12 is a Freeman maple and poses a risk to Thomas Avenue, and the electric line and utility pole on the east side of the street. Overall, this tree has a sickly appearance; at least one-half of the branches on the tree are either dead or broken. Multiple cavities are present on branches in the canopy, also. The trunk is leaning at an angle of 5 - 10°, is partially corrected, and has a poor taper. The roots have also been cut approximately 3 feet from the tree trunk, which weakens the base making the tree more prone to failure. Even if pruning branches is performed, the leaning trunk still poses a higher level of residual risk to the surrounding targets. Due to this, CED's recommendation is to remove the tree. If no corrective action is taken, the entire tree is expected to fail in three years.

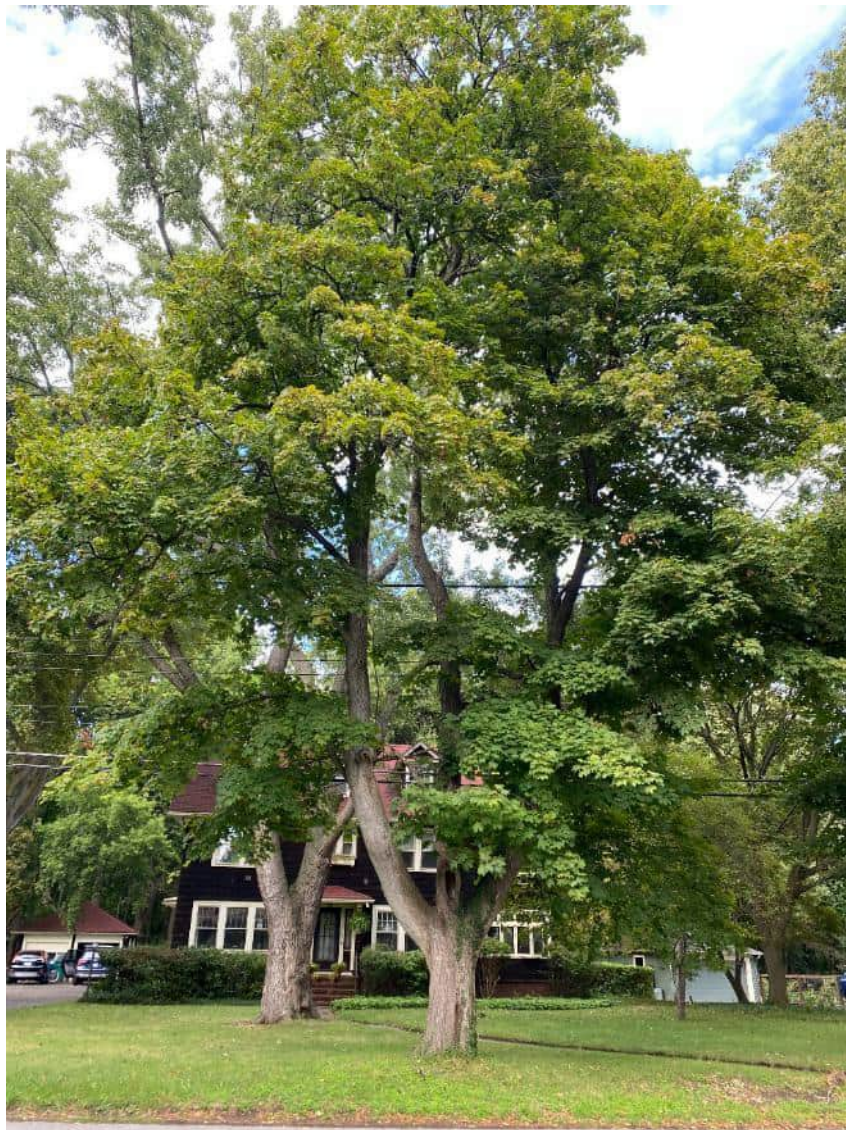
Photo 13: Tree ID No. 13, Norway maple (32" DBH). View facing northeast.

Tree ID No. 13 is a Norway maple and poses a risk to Thomas Avenue, three (3) private properties, and power lines that are present through the crown of the tree. The crown of the tree is unbalanced with dead bark present, and the interior part sparse. The tree has three codominant leaders, and a large cavity present in the central leader. The roots show evidence of being cut approximately 3 feet from the base of the tree trunk. The remainder of the roots are buried. CED's recommendation is to prune one or two of the codominant leaders. However, even if corrective action is taken in the next year the tree will continue to pose a moderate level of risk. If no mitigation is performed on the tree within the next three to four years, and no significant increase in tree vigor is visible within two to three years, removing the tree may be the most viable option.

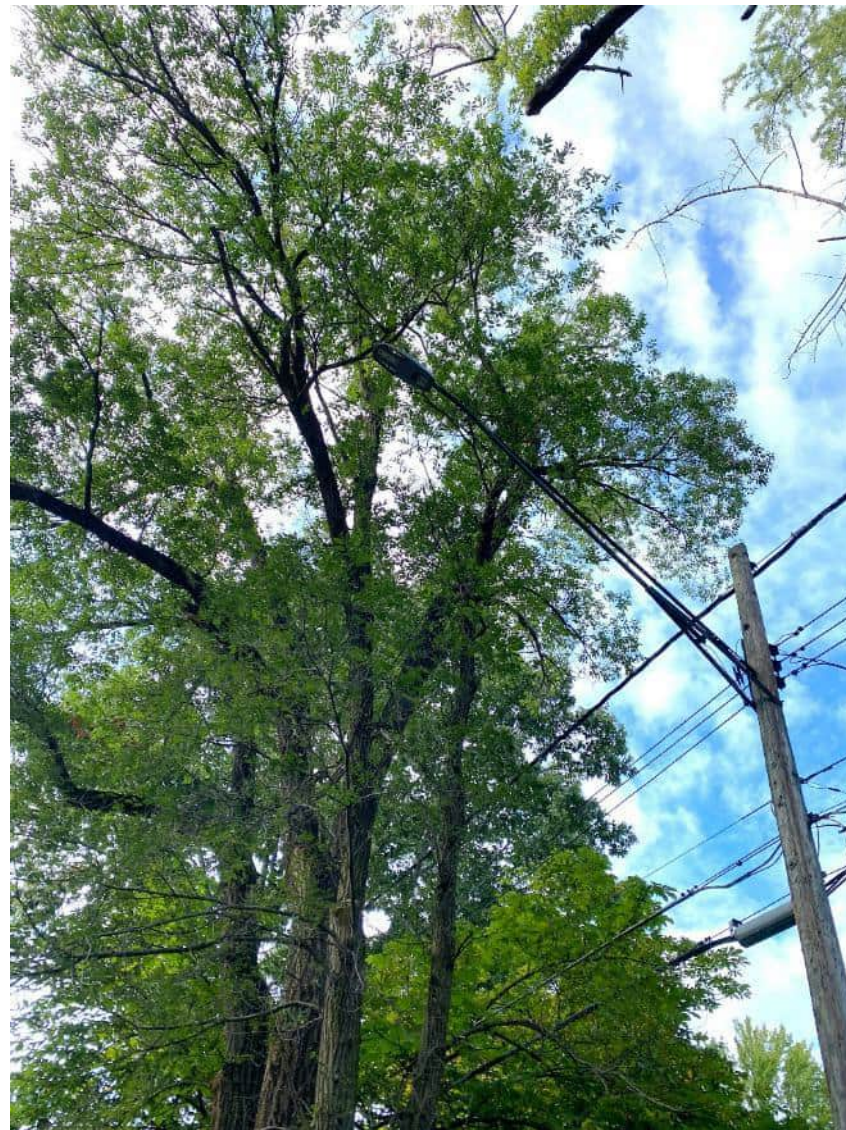
Photo 14: Tree ID No. 14, American elm (13" DBH). View facing east.

| Tree ID # <sup>1</sup> | Approx. Address | Scientific Name | Common Name | DBH (in) | Approx. Height (ft) | LCR | Overall Risk Rating | Overall Residual Risk | Tree Defects | Recommended Mitigation | Latitude <sup>2</sup> | Longitude <sup>2</sup> |
|---|---|---|---|---|---|---|---|---|---|---|---|---|
| 14 | 342 Thomas Ave | <i>Ulmus americana</i> | American elm | 13 | 60 | 30% | MODERATE | MODERATE | Codominant trunk; dead branch in canopy has higher potential of failure (2" diameter); epicormic sprouts near poor prune cut; leaves are small, necrotic, and many leaves are missing from tree; trunk is leaning and has poor taper | Prune dead, overextended canopy branch; remove co-dominant leader; expose root collar | 43.235518 | -77.606735 |

Tree ID No. 14 is an American elm and poses a risk to Thomas Avenue and two (2) private properties. The crown of the tree is unbalanced and has many overextended branches, at weak attachment angles, over Thomas Avenue. Evidence of previous flush cuts, dieback, and branch failures were also observed in the crown. The tree has a codominant leader, and cracks were observed in the trunk with signs of discoloration. The tree's leaves are also scarce, necrotic in places, and stunted in size, which would suggest the tree is in poor health. There was also a large cavity observed at the base of the tree. CED recommends immediate corrective action by pruning back dead canopy branches and pruning or removing the codominant leader. If the dead branches in the canopy are pruned and not removed the tree will still pose a moderate residual risk. If the dead branches in the canopy are removed the tree will pose a low residual risk. If no mitigation is performed for the tree within the next three years, the likelihood of failure is predicted to increase, and tree removal may be the most viable option.

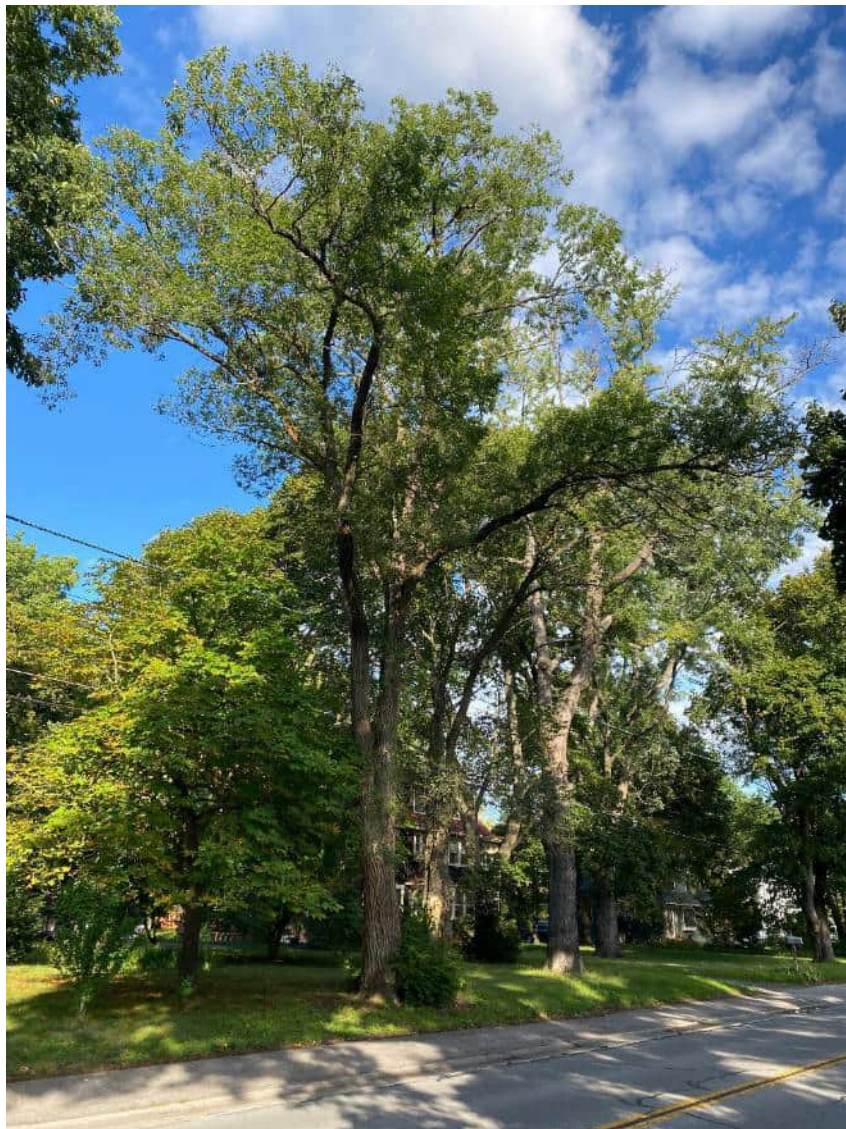
Photo 15: Tree ID No. 15, American elm (28" DBH). View facing east.

| Tree ID # <sup>1</sup> | Approx. Address | Scientific Name | Common Name | DBH (in) | Approx. Height (ft) | LCR | Overall Risk Rating | Overall Residual Risk | Tree Defects | Recommended Mitigation | Latitude <sup>2</sup> | Longitude <sup>2</sup> |
|---|---|---|---|---|---|---|---|---|---|---|---|---|
| 15 | 342 Thomas Ave | <i>Ulmus americana</i> | American elm | 28 | 80 | 25% | HIGH | MODERATE | Overextended branch over Thomas Ave; co-dominant leader; cavity at trunk base suggests decay, previous failures in canopy observed; open cavities in upper canopy; trunk is leaning and has poor taper | Prune overextended canopy branch; prune or remove co-dominant leader; remove tree | 43.235531 | -77.606748 |

Tree ID No. 15 is an American elm and poses a risk to Thomas Avenue and one (1) private property. The tree is also located adjacent to Tree ID No. 14. The crown is unbalanced and has branches overextending over the street and private property. At least two other codominant leaders were observed in the canopy. Many branches were curved in multiple directions. Open cavities are present in the crown and the trunk. The tree's leaves are also scarce, necrotic in places, and stunted in size, which would suggest the tree is in poor health. CED recommends removing over-extended, poorly attached branches and the co-dominant stems. If the codominant leaders cannot be either pruned or removed, the tree will continue to pose a moderate residual risk. If no corrective action can be taken within the next four years the tree's likelihood of failure will increase and tree removal may be the most viable option.

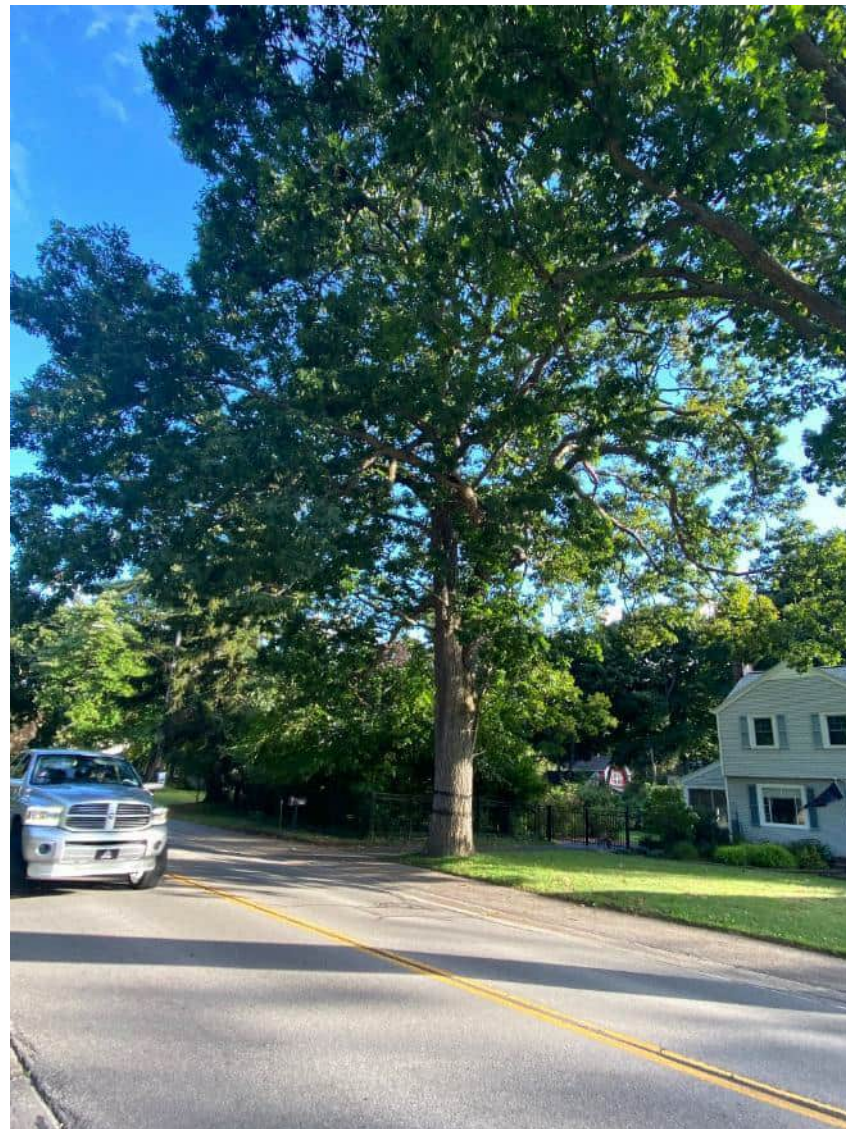
Photo 16: Tree ID No. 16, white oak (42" DBH). View facing south.

Tree ID No. 16 is a white oak tree and poses a risk to Thomas Avenue and one (1) private property. Many branches are over-extended over Thomas Avenue and the private property at poor angles of attachment to the trunk. The tree canopy has multiple, co-dominant stems curving in multiple directions. The trunk has a cavity and poor taper, with multiple codominant leaders. CED's recommendation is to prune the overextended branches of the tree to reduce the overall load on the tree. At least one of the codominant canopy stems should also be either pruned or removed. Tree removal is also a possible option for this tree. However, if the appropriate mitigation is performed the tree will eventually pose an overall low residual risk.

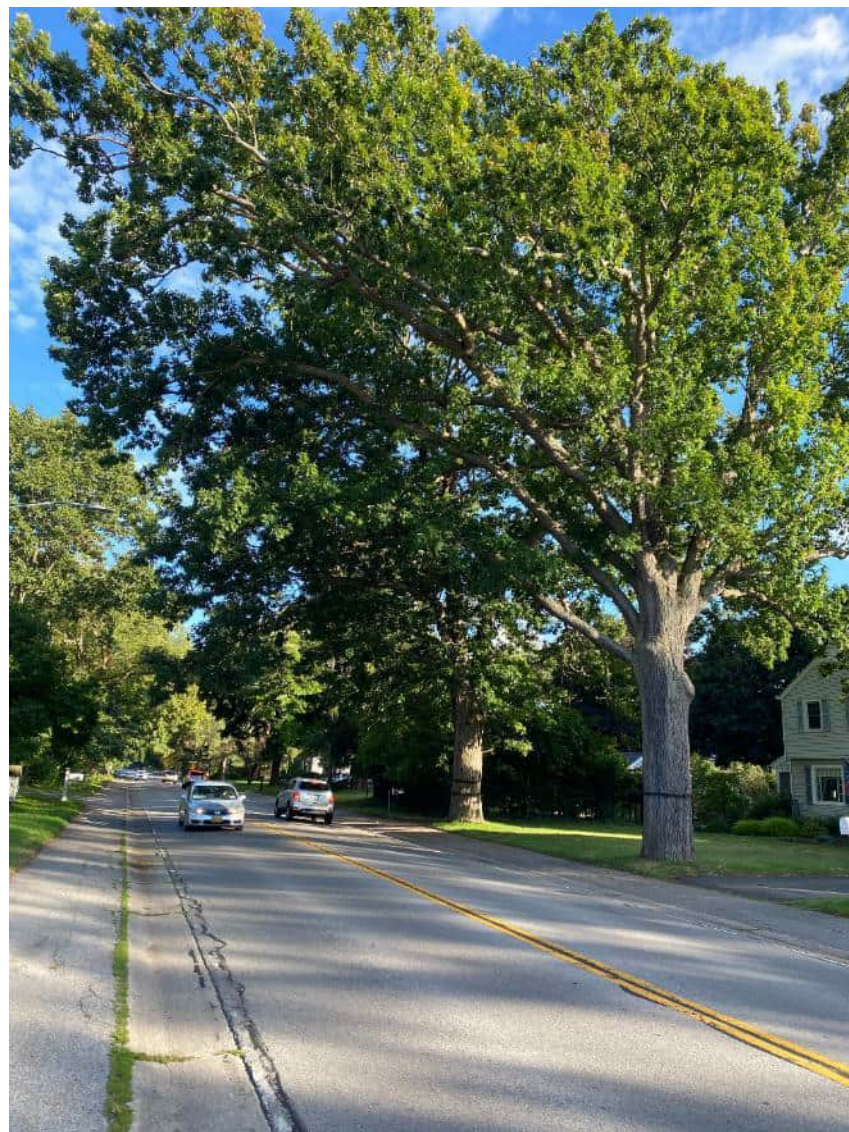
Photo 17: Tree ID No. 17, white oak (43" DBH). View facing south.

Tree ID No. 17 is a white oak tree and poses a risk to Thomas Avenue and two (2) private properties. Many branches are over-extended over Thomas Avenue and the private property at poor angles of attachment to the trunk. The tree's crown is unbalanced, with little or no branching to the North. The trunk has a cavity and poor taper, with multiple codominant leaders. CED's recommendation is to prune the overextended branches of the tree to reduce the overall load on the tree. At least one of the codominant canopy stems should also be either pruned or removed. Tree removal is also a possible option for this tree. However, if the appropriate mitigation is performed the tree will eventually pose an overall low residual risk.

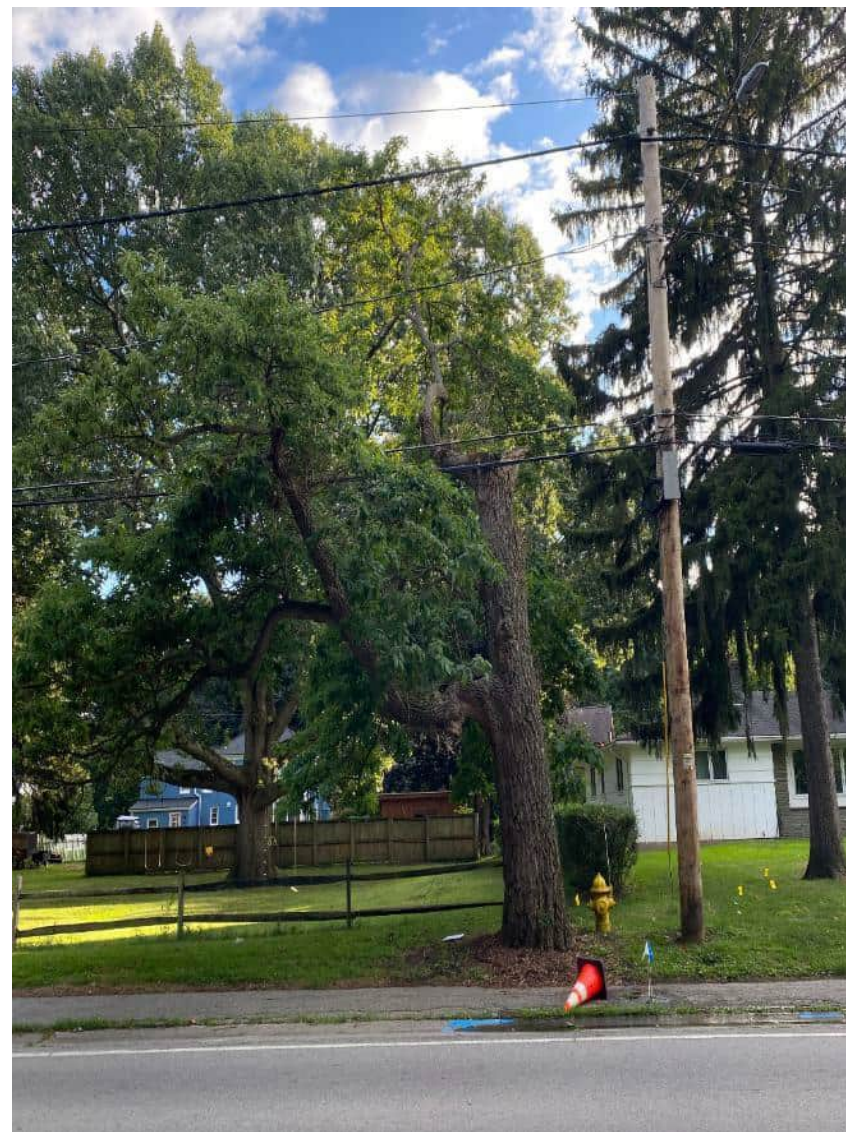
Photo 18: Tree ID No. 18, sassafras (30" DBH). View facing southwest.

Tree ID No. 18 is a sassafras and poses a risk to Thomas Avenue and two (2) private properties. The tree has been topped, and the branches in the canopy are low-hanging or overextended and are attached at poor angles. Additionally, at least one-third of the branches in the canopy are dead, and large cavities are present on branches. The trunk is discolored in places, missing bark in places, and several large, open cavities are present on the trunk. Some of the roots are covered by the asphalt path behind the gutter. The roots have also been cut in places approximately 2" from the tree trunk, which weakens the base making the tree more prone to failure. Even if pruning branches is performed, the leaning trunk still poses a higher level of residual risk to the surrounding targets. Due to this, CED's recommendation is to remove the tree. If no corrective action is taken, the entire tree is expected to fail in three years.
