# Department of Transportation

*Monroe County, New York*

## **THOMAS AVENUE IMPROVEMENTS PROJECT**

### *TREE SURVEY REPORT*

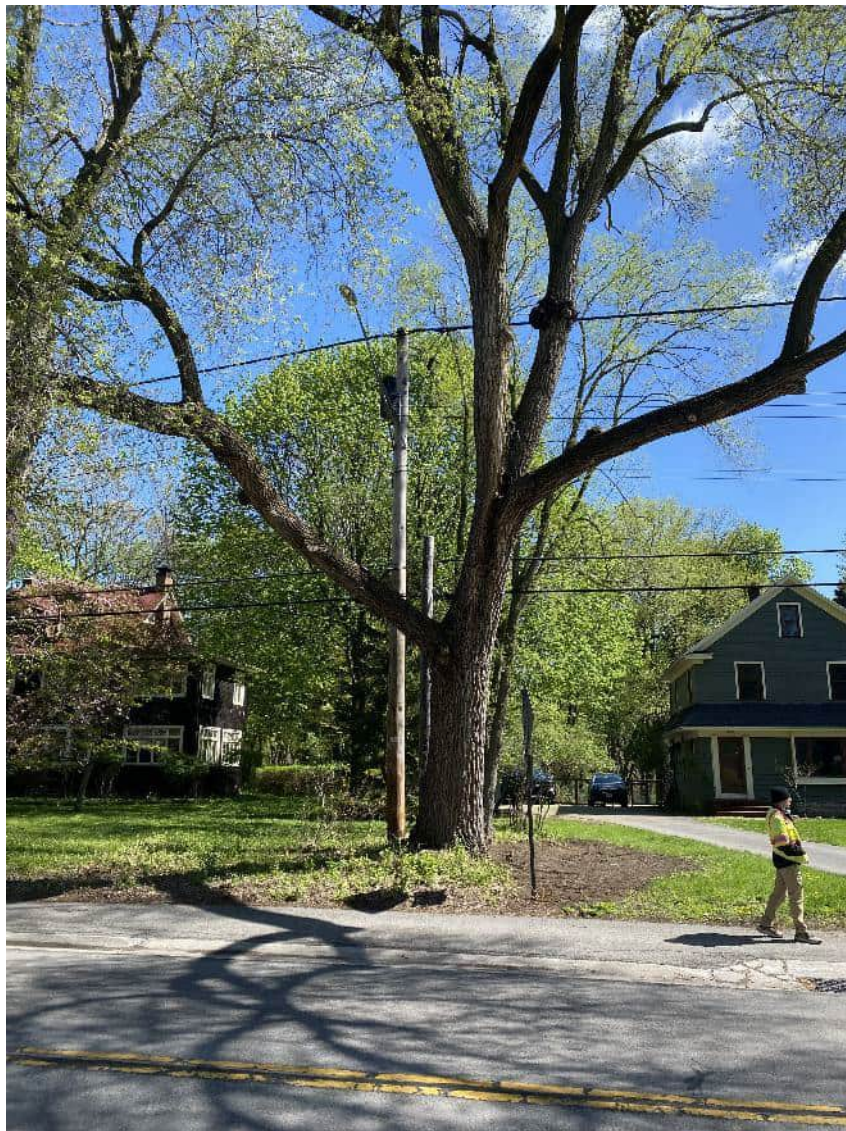
Photo 19: Tree ID No. 19, American elm (39" DBH). View facing northeast.

Tree ID No. 19 is an American elm and poses a risk to Thomas Avenue and three (3) private properties. The tree's crown is unbalanced, and one large, low-hanging branch extends over the entire road to 343 Thomas Avenue on the opposite side of the street. This branch poses the highest risk to surrounding targets and CED recommends either pruning or removing the branch promptly. If the branch is treated appropriately the tree will pose a low residual risk. However, if no corrective action can be taken within the next four years the tree's likelihood of failure will increase and tree removal may be the most viable option.

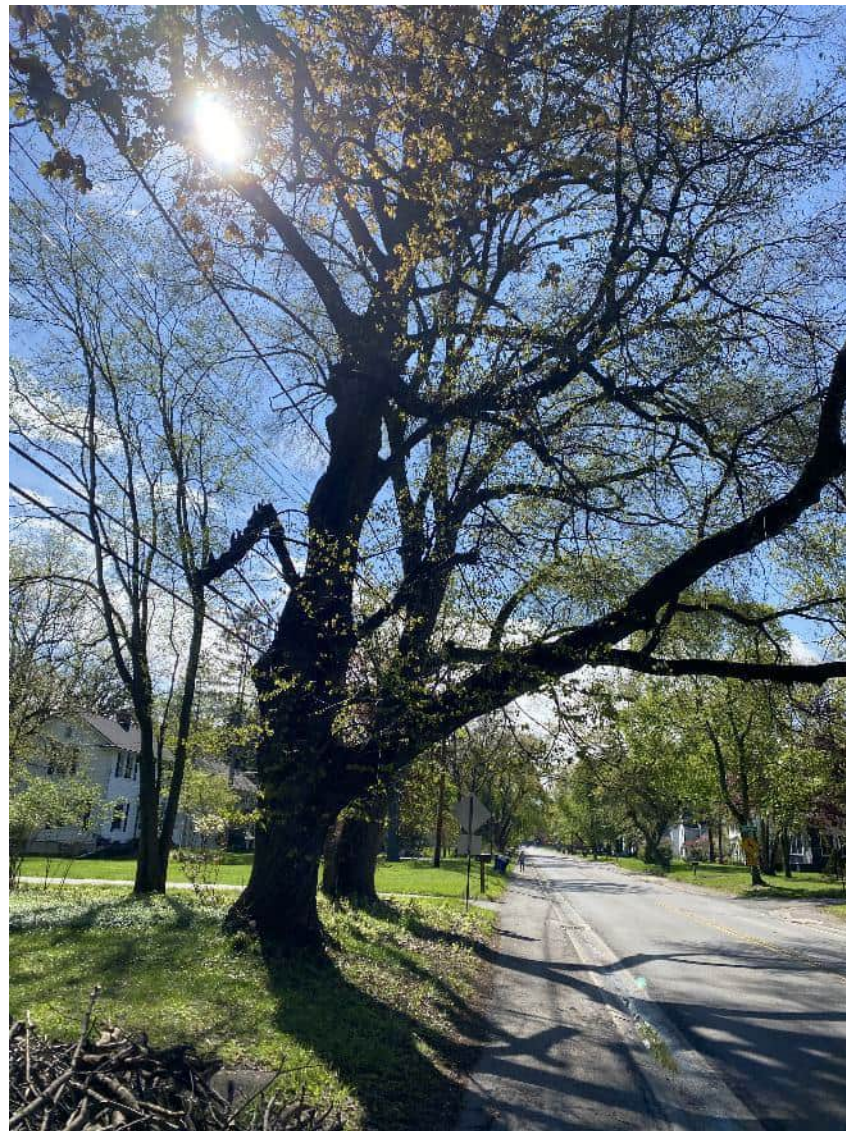
Photo 20: Tree ID No. 20, European linden (37" DBH). View facing southeast.

attachment angles. One large, low-hanging branch extends over the majority of the road's width. This branch poses the highest risk to surrounding targets and CED recommends either pruning or removing the branch promptly. If the branch is treated appropriately the tree will pose a low residual risk. However, if no corrective action can be taken within the next four years the tree's likelihood of failure will increase and tree removal may be the most viable option.

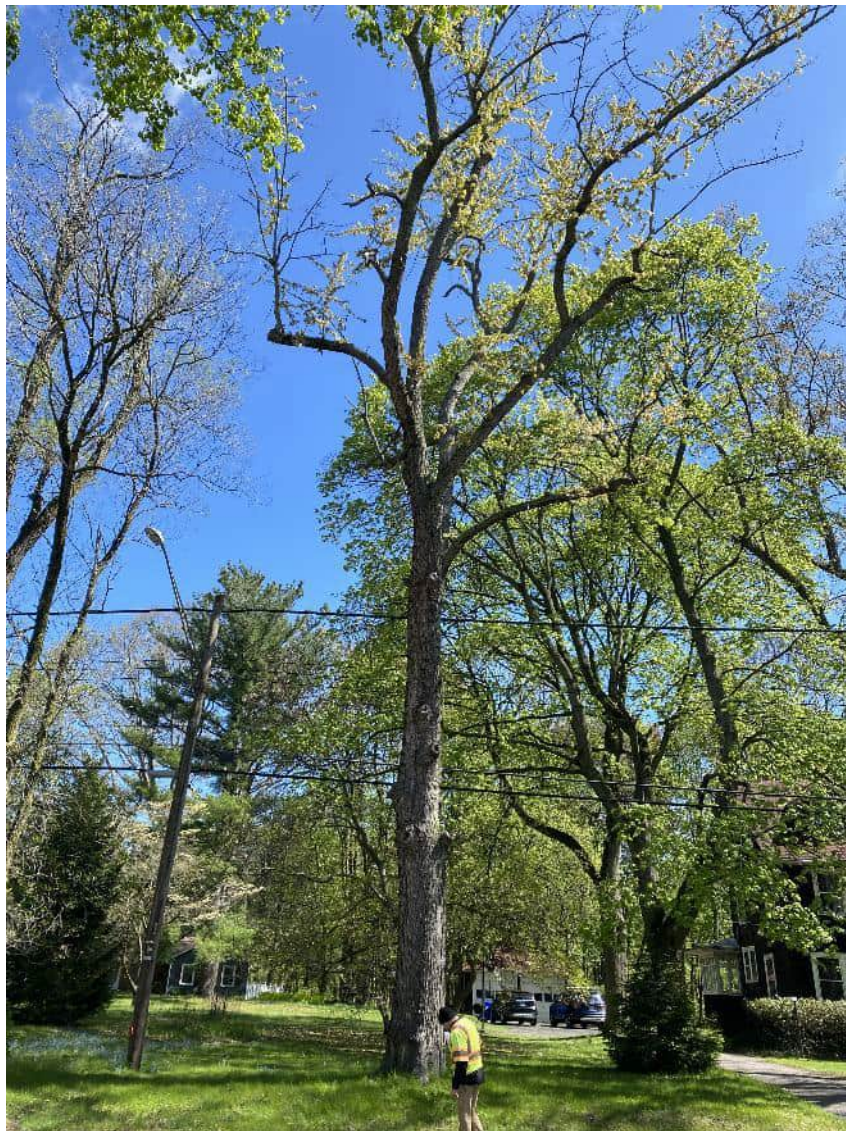
Photo 21: Tree ID No. 21, red maple (32" DBH). View facing northeast.

Tree ID No. 21 is a red maple and poses a risk to Thomas Avenue and three (3) private properties. The tree is also adjacent to Trees No.'s 14 and 15. The tree appears to have relatively low vigor, with a LCR of only 35% and approximately 40% of the crown's branches are either dead or dying. Many of the branches are curved downwards and have poor attachment angles to the trunk. The tree's trunk has inclusion bark, with sealed cavities where branches have been removed. The tree's roots are visible and extend for at least 5' past the trunk base. Tree decay will accelerate if the roots are damaged during construction work. CED recommends removing dead or poorly attached branches and stabilizing the root system by loosening compacted soil. However, even if pruning and root stabilization are applied the tree will still pose a moderate residual risk. If there is no significant improvement in the tree's vigor within the next two to three years, and no corrective action can be taken within the next three years, the tree's likelihood of failure will increase. In which case, tree removal may be recommended.

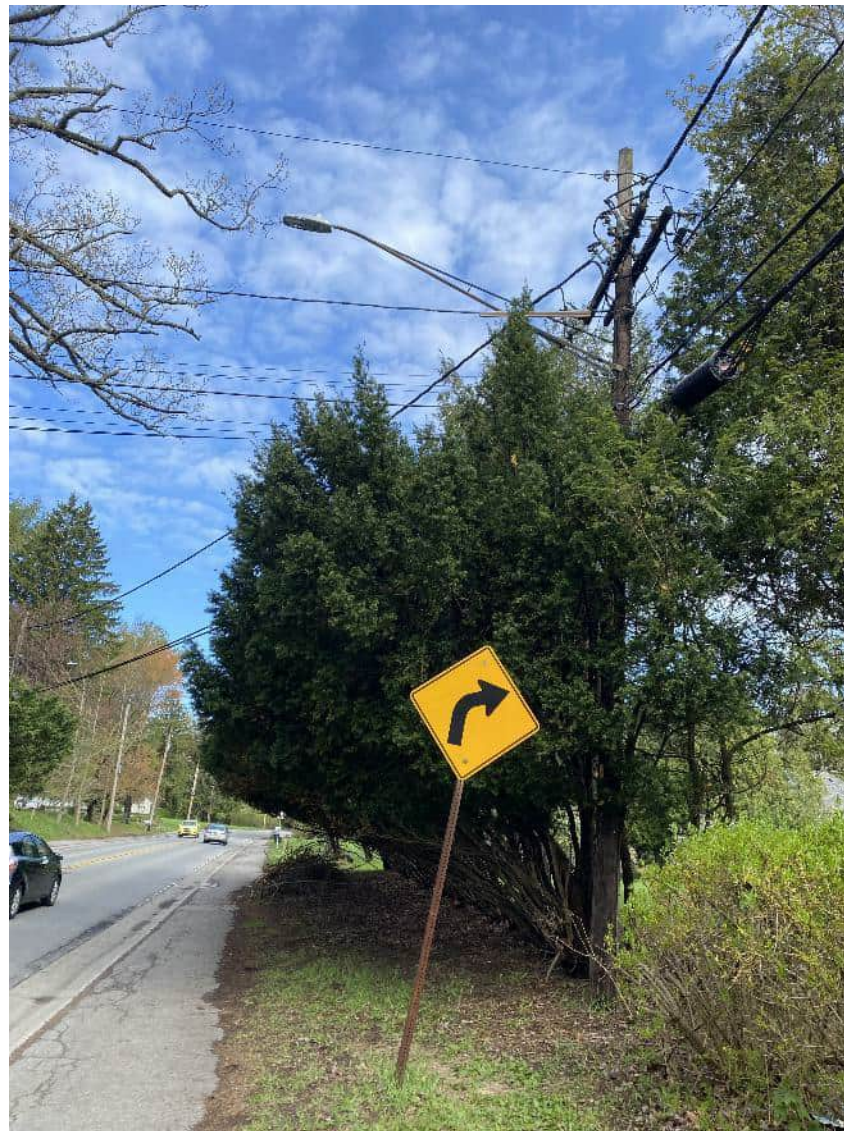
Photo 22: Tree ID No. 22, European yew (3" DBH). View facing northwest.

Two (2) trees assessed are in fairly good health and should be scheduled for maintenance within the next one to two years: Tree ID No's 7, and 22. These trees have multiple co-dominant stems, either in the canopy or the main trunk, as well as over-extended branches. The overextended branches and codominant branches and leaders should either be pruned or removed. Root collars should be uncovered at the base of the tree. These trees currently pose a low-risk rating and a low residual risk. The trees are stable now, but poor angles of attachment increase the likelihood of failure, especially during extreme weather conditions.
