Survey of Lake Ontario Bottom Sediment off Rochester, New York, to Define the Extent of Jettisoned World War II Matériel and its Potential for Sediment Contamination

Open-File Report 99-237

By Gregory Kennedy and William Kappel

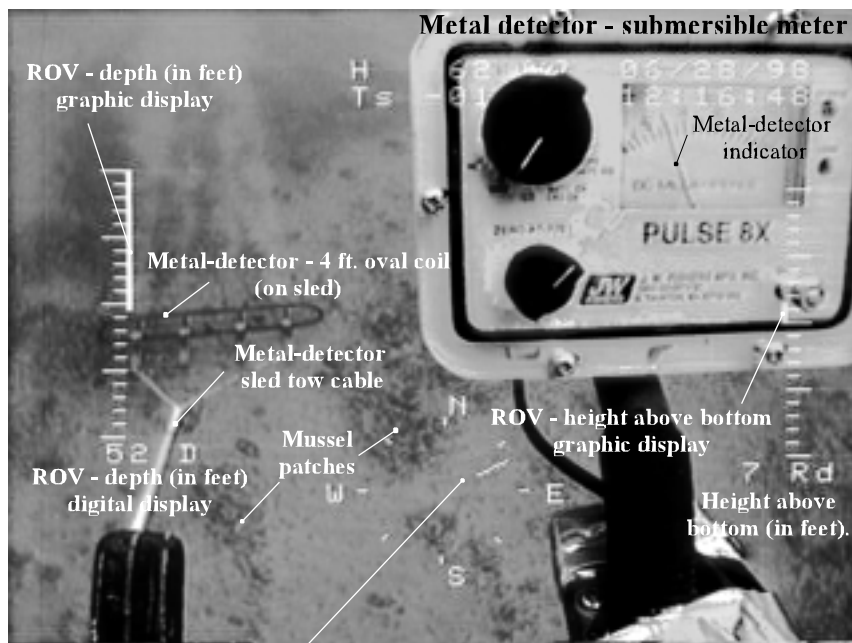
Compass needle graphic, indicating northeast heading
(Direction of view only - ROV is being pulled backwards in a southwest heading.)

Figure 3. Example of ROV image showing towable metal detector used to locate magnetic anomalies in Lake Ontario, north of Rochester, N.Y.

The new sled-mounted metal detector was attached directly to the ROV such that the sled, which was towed along the bottom, and a submersible meter attached to the detector, were in constant view on the video monitor (fig. 3) onboard the *Kaho*. The combined apparatus was pulled along the bottom following the *Kaho*'s drift through the study area (fig. 2). A mapping-grade differential GPS was used to track the vessel's drift for each transect, and subsequent transects were oriented to maximize coverage within the area accessible by SCUBA (depths of 100 ft or less). As the coil passed over or near a metallic object, the meter's needle would fluctuate, and at that moment the GPS position was noted so that the location of the magnetic response indicated by the needle deflection could be relocated later. With the coil and the surrounding substrate in the ROV's video-camera view, the video image would indicate whether the object was visible on the lake bottom (fig. 3). Upon completion of the drift transects, the video tapes were reviewed, and two sites were chosen for sampling on the basis of detector response and the physical characteristics (mounds and depressions) of each area.

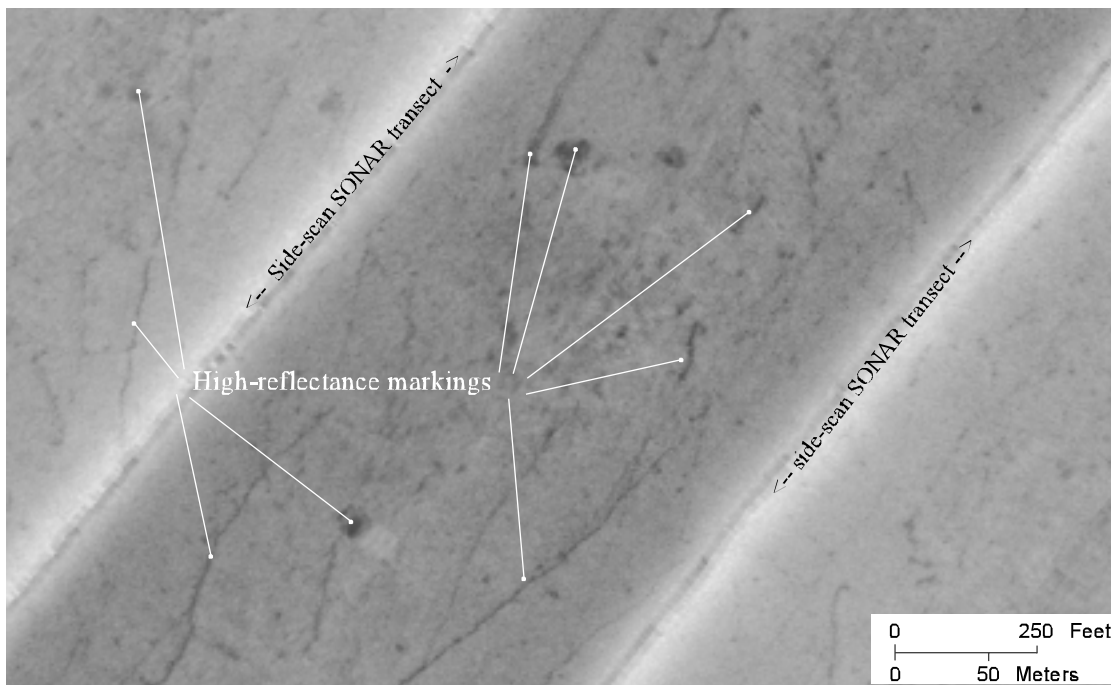
A. ROV video image.

B. Side-scan SONAR image

Figure 4. Sample ROV video image (fall 1997) showing bed of mussels observed during initial ground-truthing dives to inspect high-reflectance targets recorded on spring, 1997 side-scan SONAR survey in Lake Ontario, north of Rochester, N.Y.

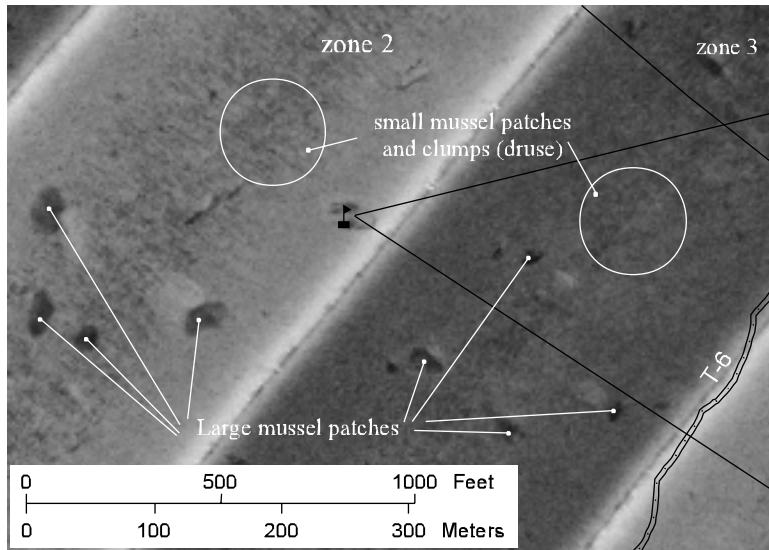
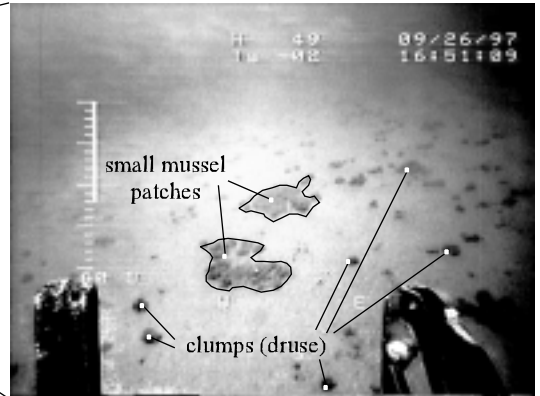
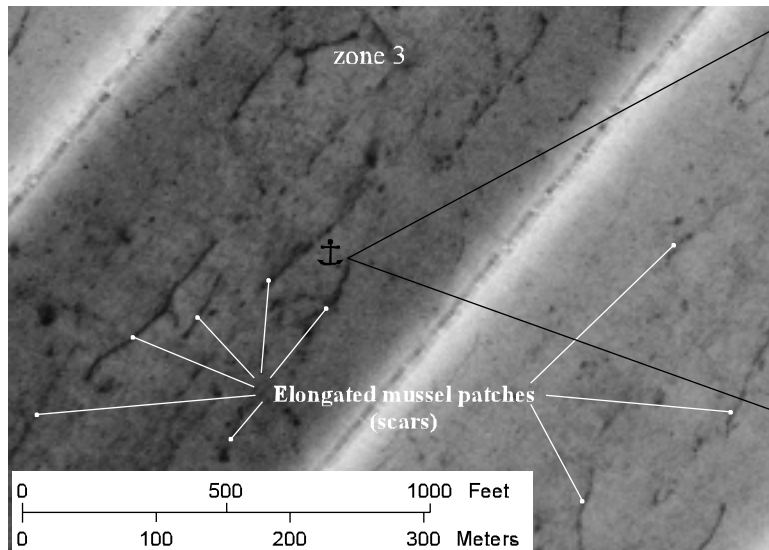
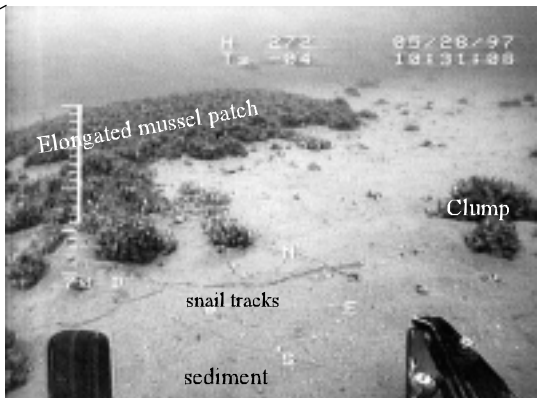
Small patches in this image are about 1-2 feet in diameter. Clumps are about 2-6 inches in diameter.

Image shows the trailing edge of an elongated patch that is about 2-3 feet wide, and stretches (beyond the view) for about 100 feet. A small clump (about 3 inches in diameter) can be seen on the right side of the image.

Figure 6. Close-up view of side-scan SONAR mosaic images showing mussel settlement in random distribution (“patches”) in zone 2, and in linear features (“scars”) in zone 3, and ROV dive images: A. Mussel “patches” in zone 2, fall 1997. B. Mussel “scars” in zone 3, spring 1997, in Lake Ontario study area, north of Rochester, N.Y.

Zones 2 and 3 occupy the middle third of the survey area and contain a random distribution of mussel “patches” (fig. 6A) and linear “scars” (fig. 6B). The “patches” (Zone 2) range from 6 to 30 ft in diameter, and the linear “scars” (Zone 3) can exceed 300 ft in length. The sediment in this zone shows a considerable number of furrows that generally run parallel to shore. These furrows may have been caused by the trawl-net “doors” that drag along the bottom and keep the mouth of the net open during the fish-survey tows. Estimated water depth in zones 2 and 3 ranges from 65 ft to 130 ft. ROV video images indicate that mussels cover more than 50 percent of the lake bottom in Zone 2, which is closer to shore than Zone 3, the “scarred” zone, in which mussel coverage was around 25 percent. The linear furrows initially seemed to hold the highest probability for detection of debris, but the ROV surveys found only mussel encrustation.

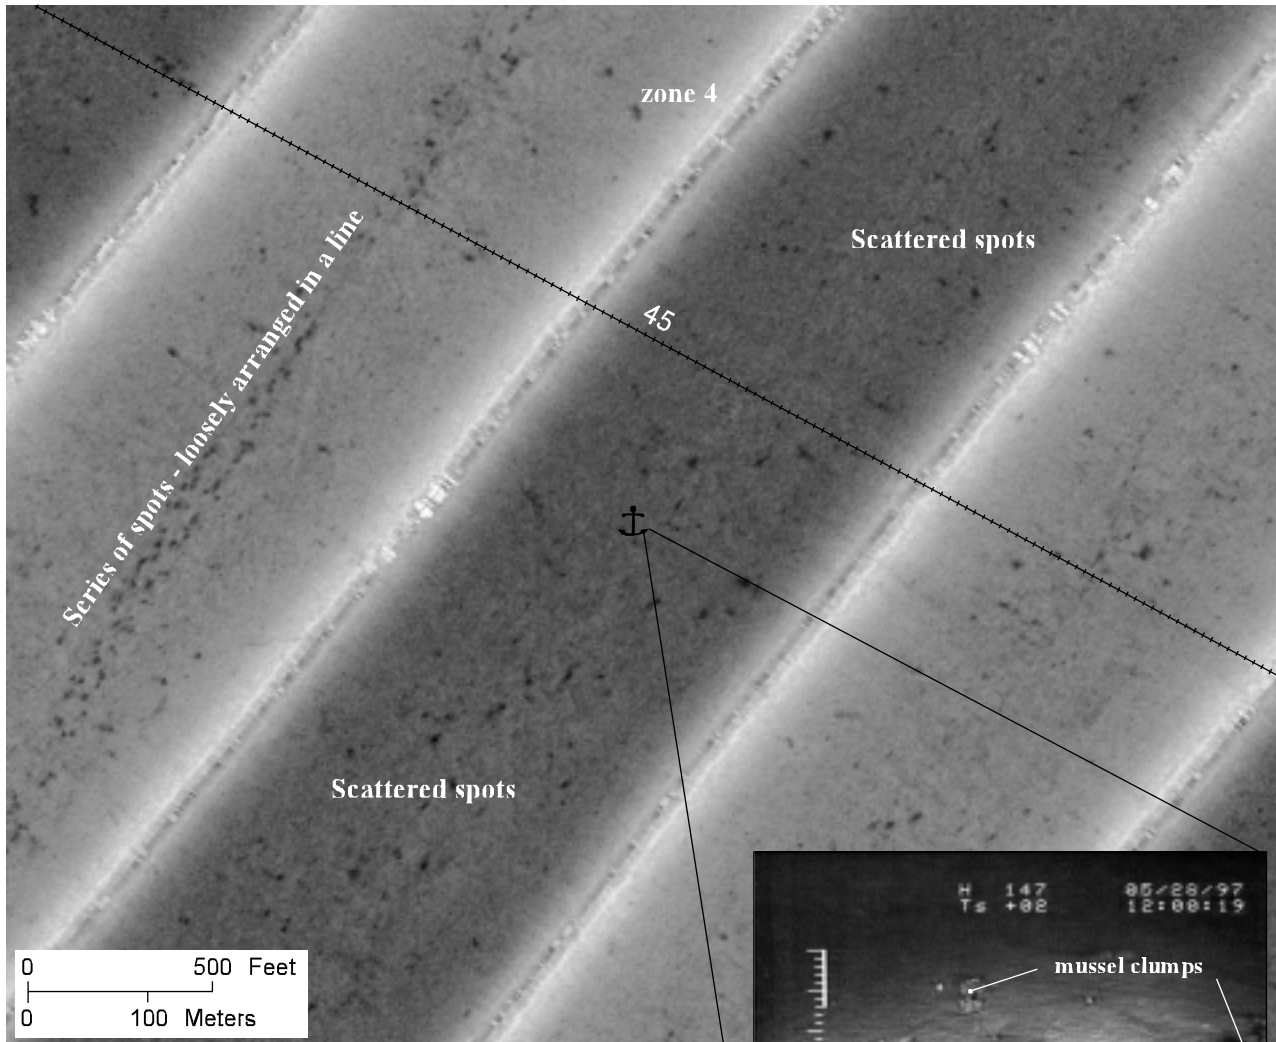
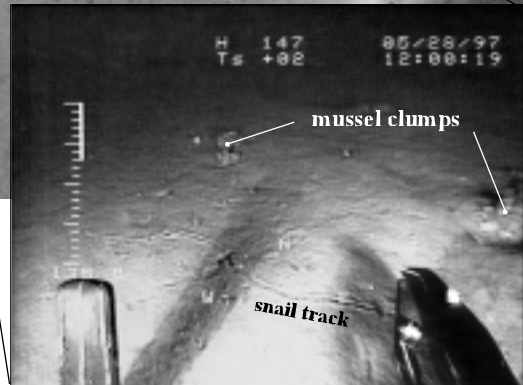
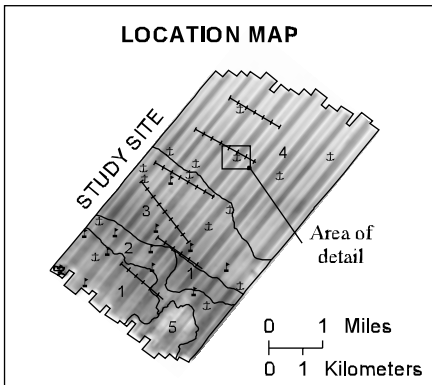
Image from ROV dive 12, typical of what was observed within this zone - mostly soft sediment with very widely scattered, small clumps of mussels.

Figure 7. Close-up view of side-scan SONAR mosaic image showing widely scattered and small reflectance patterns typical for zone 4, and image from ROV dive 12 (spring 1997) in the Lake Ontario study area, north of Rochester, N.Y.

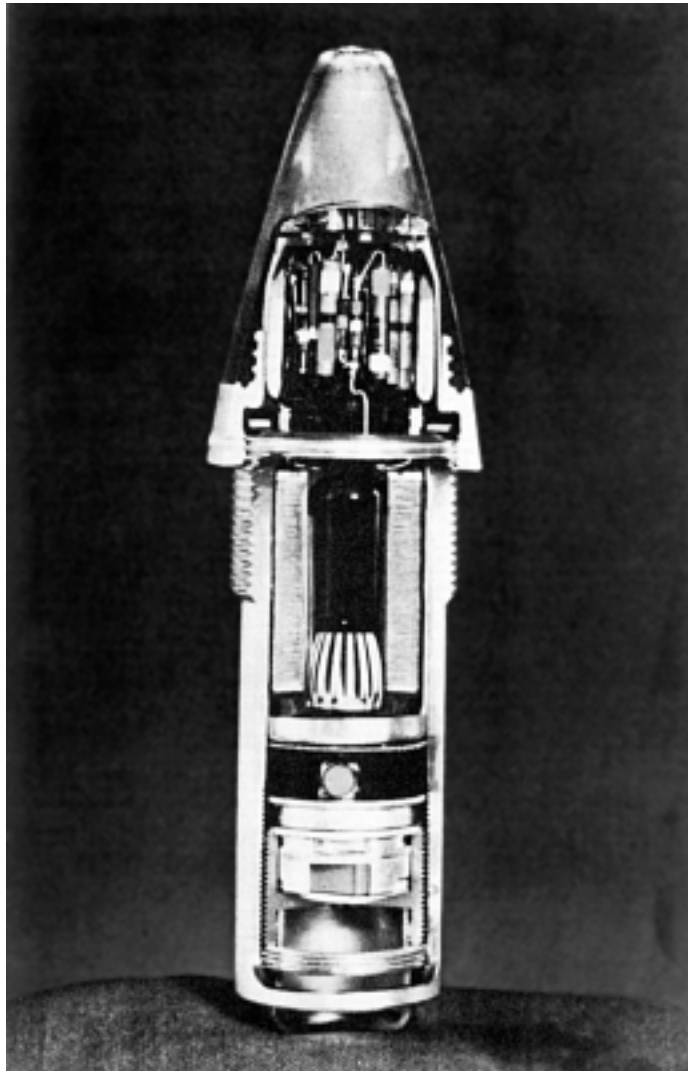
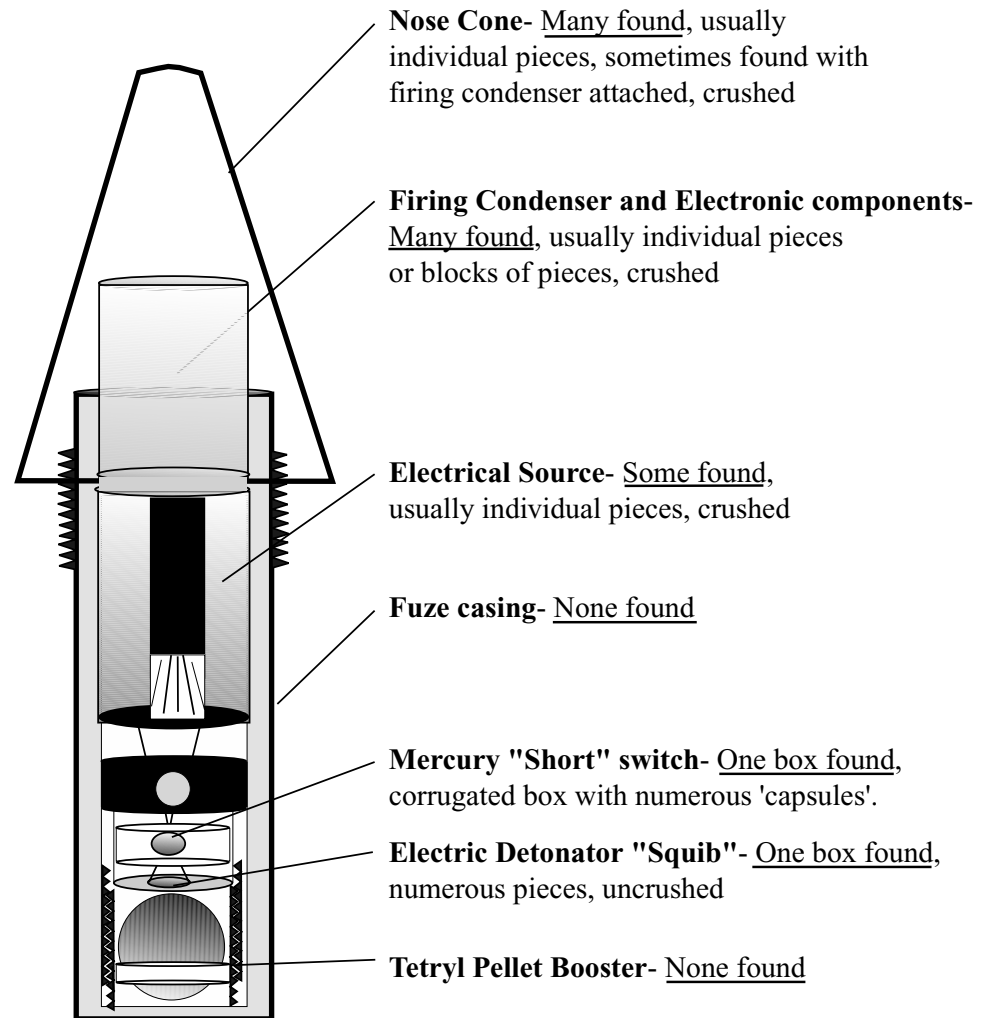
A. Mark 45 Fuze

B. Fuze Diagram

Figure A-1. Proximity fuze of the type found by Lake Ontario Biological Station during fish trawls, 1974-96: A. Interior view of fuze. (with permission of Eastman-Kodak). B. Diagram showing major components of fuze, frequency of detection off Rochester, and condition of parts found.

The most common type of material found in the past 20 years of lake-bottom surveys has been the nose cones of shell detonators (proximity fuzes); an inventory is given in Table A1, and a photograph and schematic diagram of a proximity fuze is given in figures A-1-A and A-1-B, respectively. All nose cones are crushed, but are about 2 in. in diameter, by about 3.5 in. long, and appear to have two sections— a lower cylindrical section and an upper cone section.

The fuze is simply a specialized radio set. There is a battery whose electrical energy is released by a setback, the shock of the firing of a gun. The battery furnished three different voltages: one for the filaments of the vacuum tubes, one for the plates, and one for the grids. One of the tubes is an oscillator. In the nose of the fuze is a metallic cap, which together with the rest of the shell acts like a dipole. The oscillator tube thus has an antenna and emits a high-frequency radio wave in particular directions from the shell. This continuous radio wave surrounds the moving shell, and when the shell passes close to a target, the latter reflects a small amount of radio wave energy back to the fuze where it is detected by the same tube as sent out the wave in the first place. The plate voltage is “modulated” by the reflected wave, which is at a slightly different frequency than the outgoing wave due to the relative motion of the shell and target. Thus, a beat note is set up and the plate voltage varies in frequency within the audio range of a few, to a few thousand cycles per second. This audio frequency voltage variation is then passed through a three tube amplifier. When the period of the audio frequency wave and also its amplitude or intensity are

exactly right, a thyratron tube, serving as a switch, is discharged. It completes a circuit that releases an electrical charge, which meanwhile has been stored in a condenser. The surge of electricity goes through a tiny wire in an electric squib (detonator), much like a dynamite cap. The wire gets hot and the explosive in the squib goes off. This tiny explosion sets off...[another] sensitive explosive...at the bottom of the fuze. This explosion sets off the explosive loading of the shell and it bursts the steel shell body into hundreds of high velocity fragments.

Background information and examination of retrieved proximity fuzes indicated that nearly all debris recovered by the *Kaho*, other than the box of mercury components and the box of detonators (squibs) referred to in figure A-1-B, were merely the upper ends of proximity fuzes; that is, the nose cone and the condenser. Nearly all of the recovered components were crushed. Crushing was apparently a required means of destroying defective components (every component was tested and required to meet strict quality-assurance standards during the manufacturing process); crushing also was a means of preventing any of the components from reaching enemy hands during the war; as indicated by Baldwin (1980, p. 111).
