**The Stormwater Coalition of Monroe County and
Monroe County Department of Environmental Services**

Prepared for:
New York State Environmental Protection Fund — Round 10

Section 1. Assessment Overview

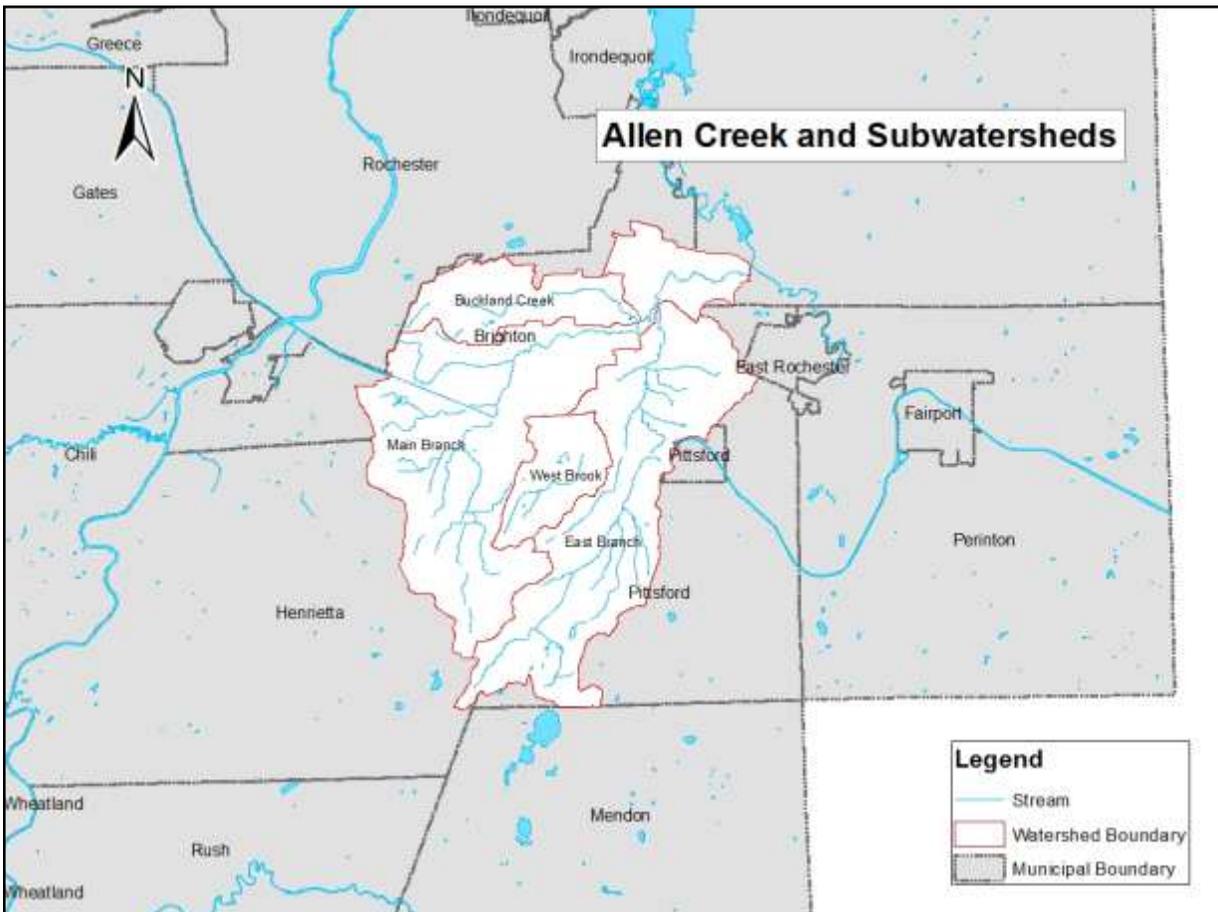
Figure 1: Allen Creek Watershed.

The main branch of Allen Creek begins at the southern end of the Town of Henrietta and flows north into the Towns of Brighton, Pittsford and Penfield. Allen Creek consists of two significant and diverse subwatersheds, Main branch and East branch (Figure 1). After merging with the East branch in Pittsford, the Creek flows through Brighton and then discharges into Irondequoit Creek in Panorama Valley (Penfield). Because of their size and diversity, the two branches were assessed separately (see also “Green Infrastructure Rapid Assessment Plan Allen Creek Watershed—East Branch”). A middle branch of the creek, referred to as West Brook, drains into the Erie Canal at lock 32 near Clover Street. Retrofits for that tributary area of approximately 1000 acres were considered in this report.

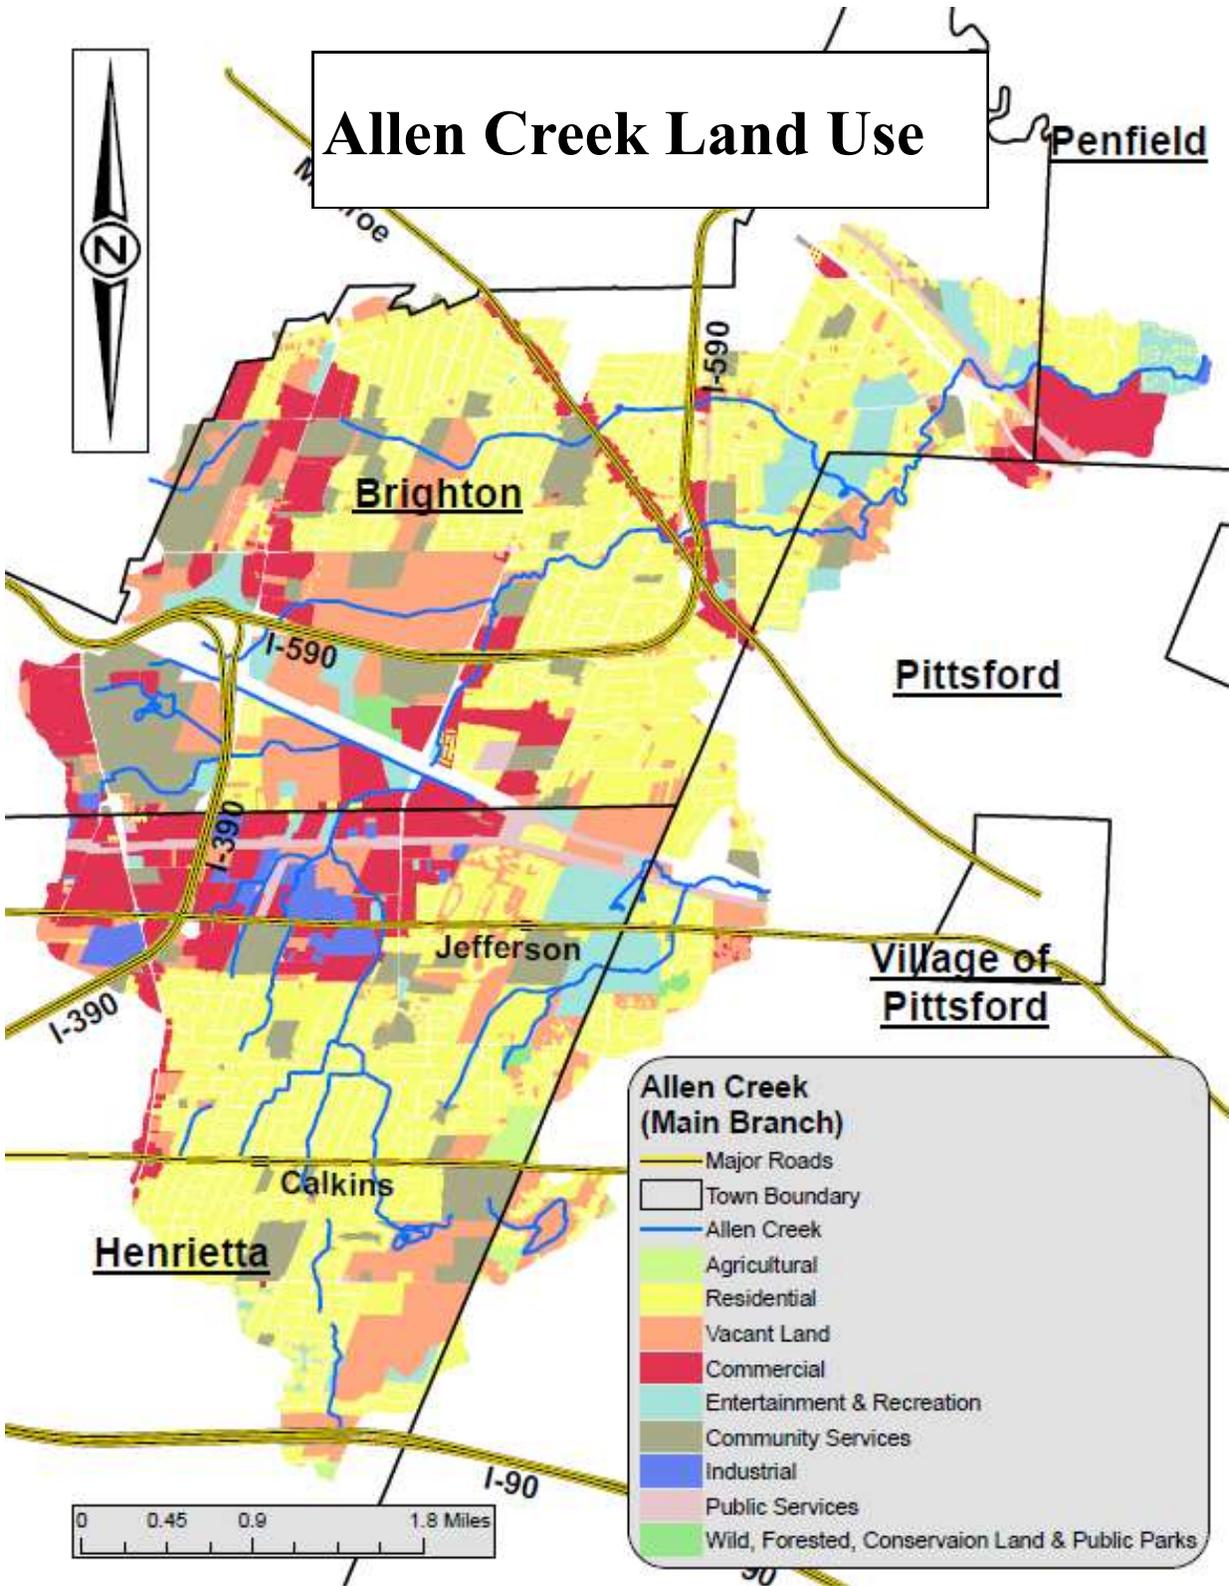
Figure 2: Land use within Allen Creek watershed.

The watershed is dominated by residential land cover in the southern and northeastern areas with approximately 12,000 single family homes. A dense commercial and industrial area in the middle and western portion of the watershed includes a portion of Jefferson Road (Figure 2). Table 1 shows key watershed characteristics of the Main branch which spans

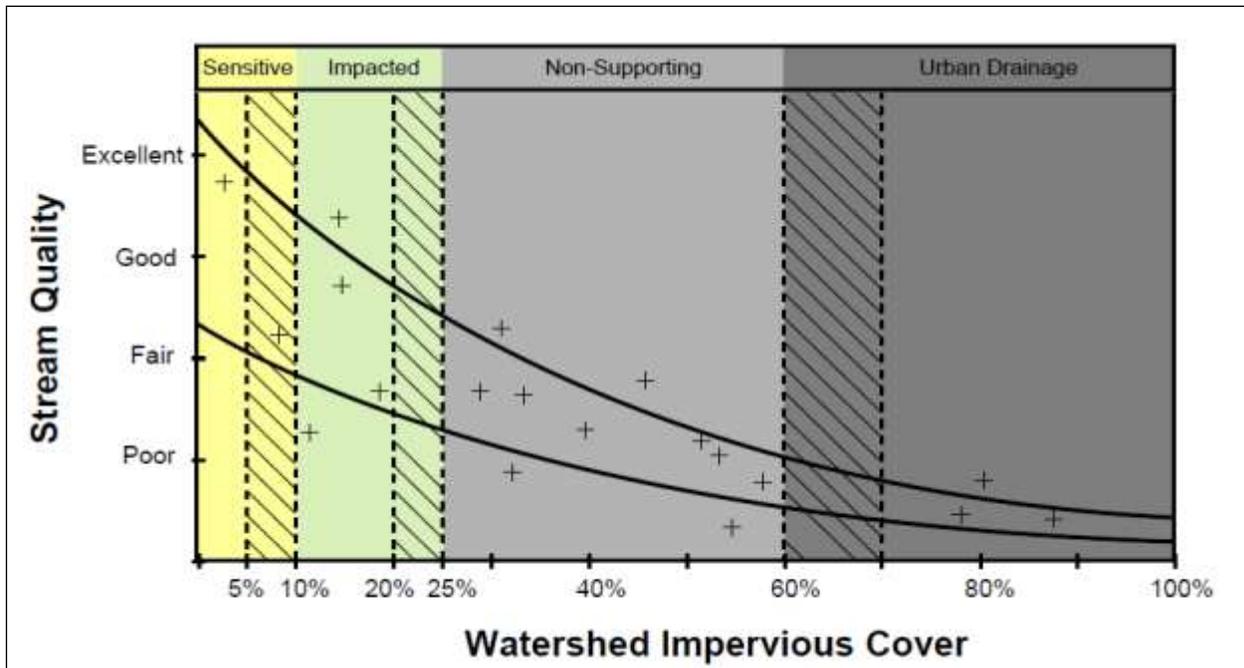
Figure 3: Impervious Cover Model

1.4.2 Impervious Cover Analysis The Center for Watershed Protection created the “Impervious Cover Model” (ICM) to predict a typical stream’s health using the relationship between subwatershed impervious cover and stream quality indicators. This relationship has been confirmed by nearly 60 peer-reviewed stream research studies (Figure 5). The ICM shows stream quality decline becomes evident when the watershed impervious cover exceeds ten percent. The Main Branch has an average of 33 percent impervious cover identifying stream quality somewhere between poor and fair and non-supporting of aquatic

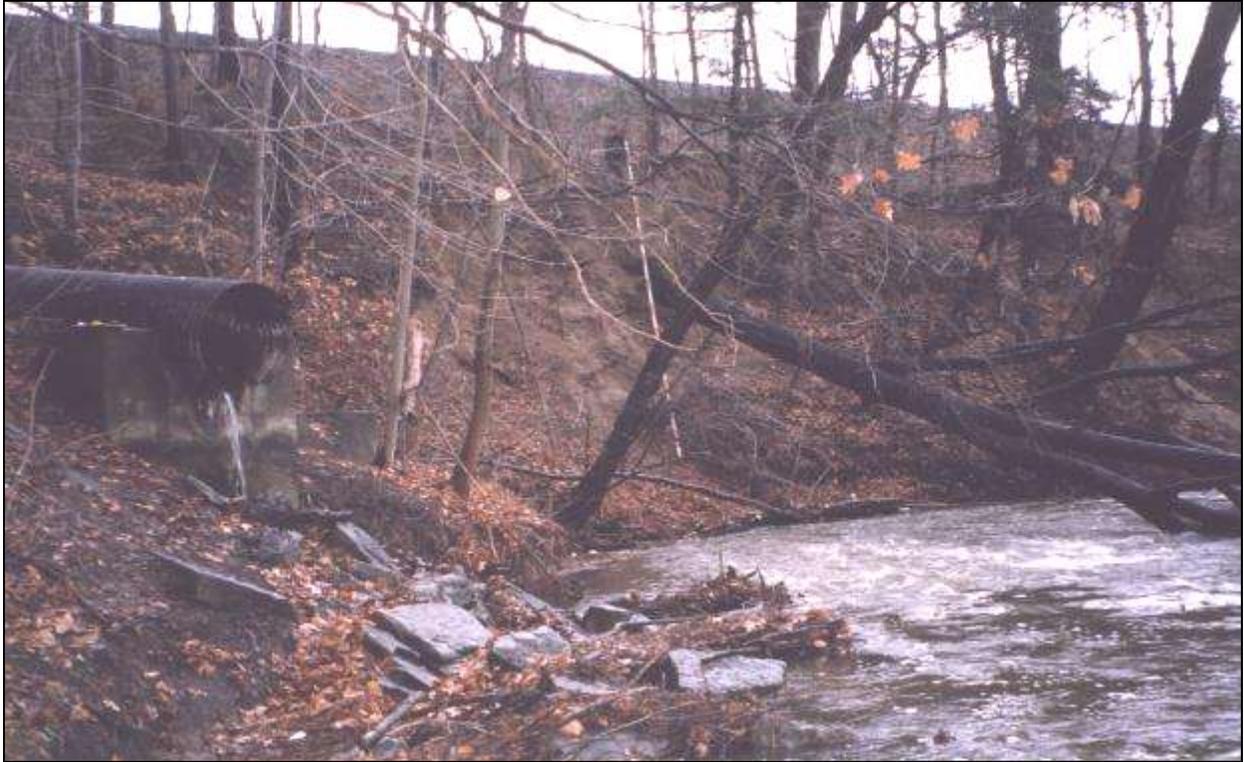
Figure 3: Severe streambank erosion above Corbett's Glen (note railroad embankment at top of bank)

Streambank Erosion The Creek has numerous locations of eroding stream banks and has been armored through most of the developed portions of the watershed, but is most severe in its lower reach (Figure 4). Here the Creek moves from an upper plain elevation near the intersection of NYS 490 and 441, 390 feet down into the Irondequoit Creek valley to the confluence of Irondequoit Creek at elevation 275 feet. This section contains open space with waterfalls that the Town of Brighton purchased creating the Corbett's Glen Nature Park with residential and commercial land uses downstream in the Town of Penfield.

The Town of Penfield commissioned a study of this area, *Preliminary Geomorphic Assessment of Allen Creek* (Barton & Loguidice 2011). Excerpts related to the dynamic nature of stream channels and how the rate of erosion is affected by adjacent and upstream land use are copied below:

If left unaddressed, the ongoing destabilization of the Allen Creek channel will continue... These changes in channel form will result in continued erosion of streambanks and development of areas of excessive streambed scour and deposition. Likewise, excessive deposition of these eroded bed and bank materials through various portions of the channel will lead to more frequent and intense flooding in these areas, as continued sediment deposition continually reduces flood capacity of the channel. This process will also lead to continued streambank erosion as the channel continues to widen in an attempt to reestablish adequate bankfull flood capacity...Consequentially if left unaddressed, the condition of the stream corridor will lead to continued flooding, bank erosion, and streamside property loss...Allen Creek will continue to result in a decline in the quantity and quality of instream habitats and populations of fish and other aquatic organisms, directly impacting the quality of the recreational fishery provided by this stream...The best results will be achieved if the stream management plan is approached at the watershed or systemic scale, addressing issue areas that have the most significant impact on adjacent downstream areas.

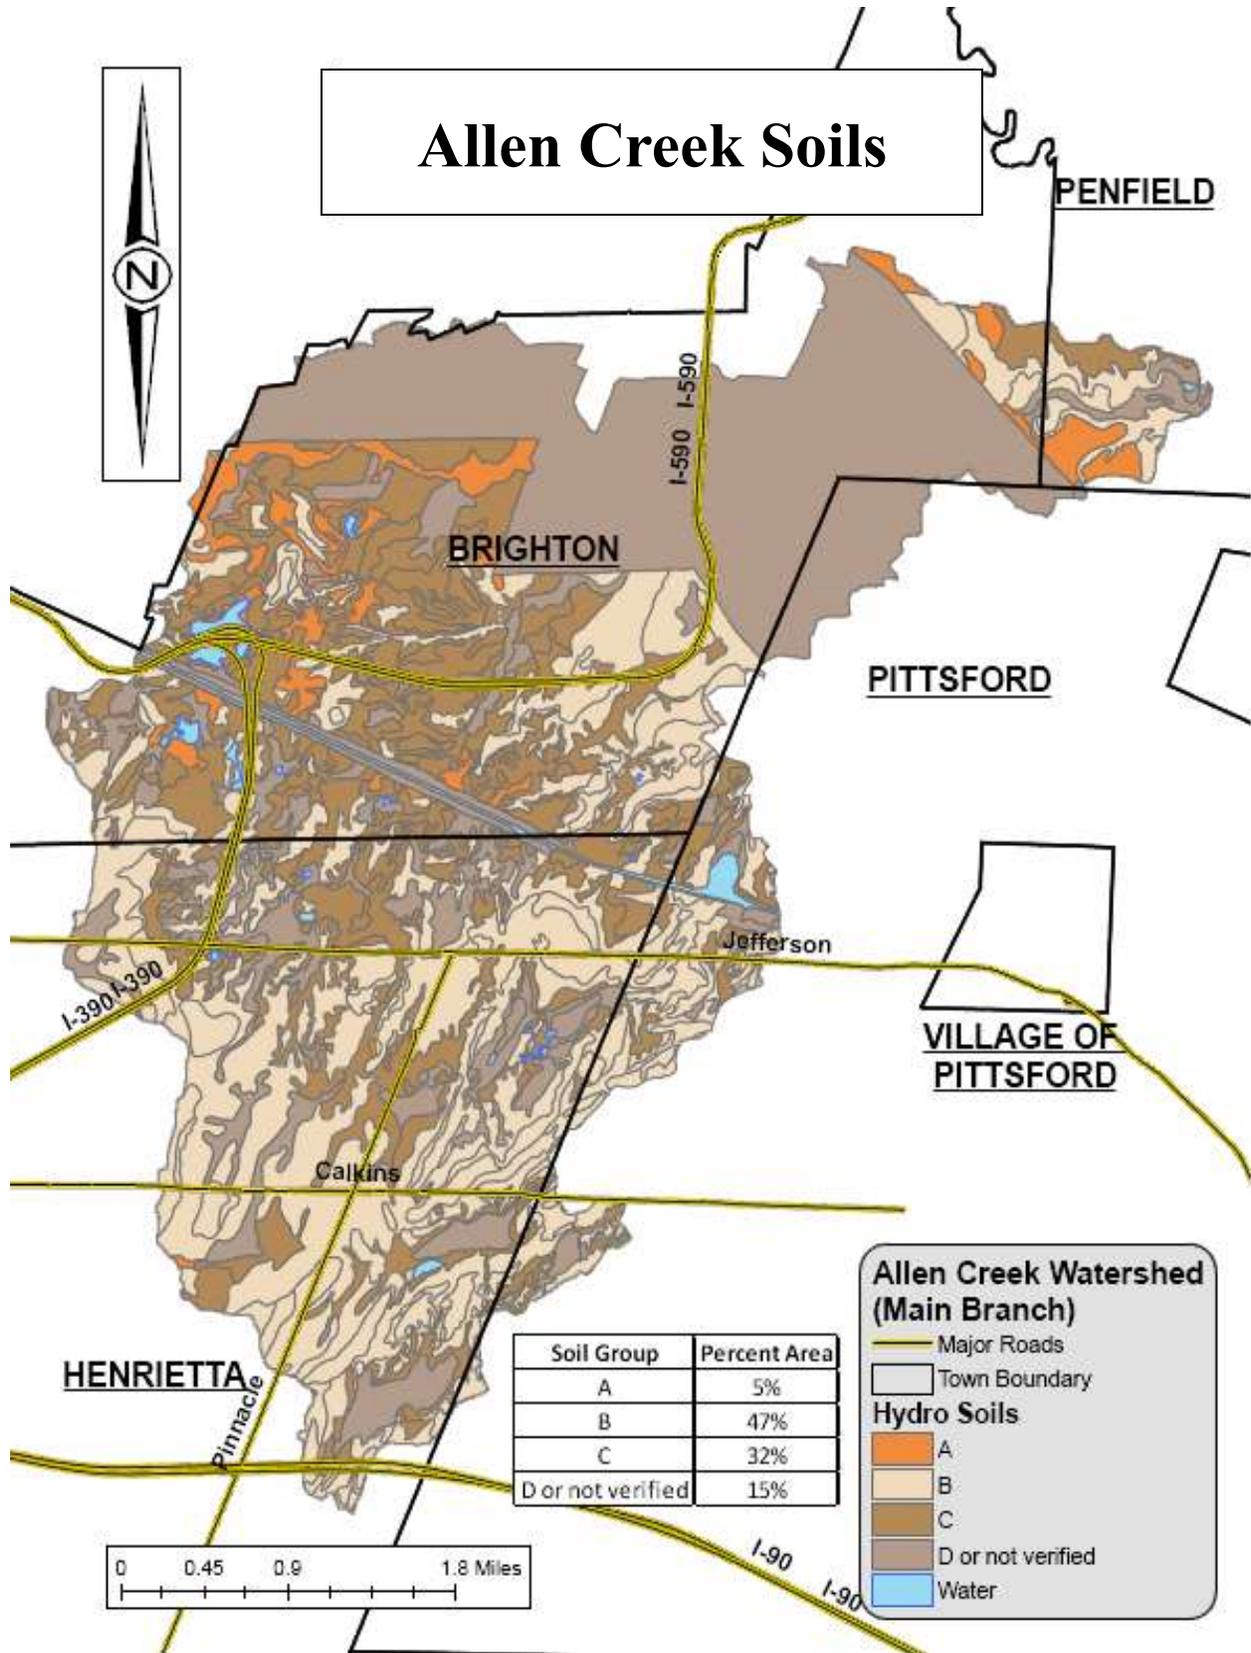
Figure 5: Hydric Soils Map of Allen Creek Main Branch

Soils A simplistic yet useful way to define how much stormwater runs off the pervious land surface is to determine soils' infiltration capabilities, their ability to absorb stormwater. Soil scientists have categorized soils into four categories, A through D. "A" and B soils are well drained and absorb much of the stormwater that drains on or over them. C and D soils are more poorly drained. However, the soils in some parts of this watershed are not categorized, denoting areas that have been so altered by land development that grouping a specific soil type is not feasible. The amount of each soil type in Allen Creek Main Branch is: A soils 5%; B soils 37%; C soils 42%; D soils or not verified 15% (Figure 5).

The large percentage of B soils will allow for infiltration-type stormwater retrofits. These practices installed in the upper parts of the watershed can prevent and reduce flooding, drainage problems, and streambank erosion as well as greatly improving water quality in Allen Creek.

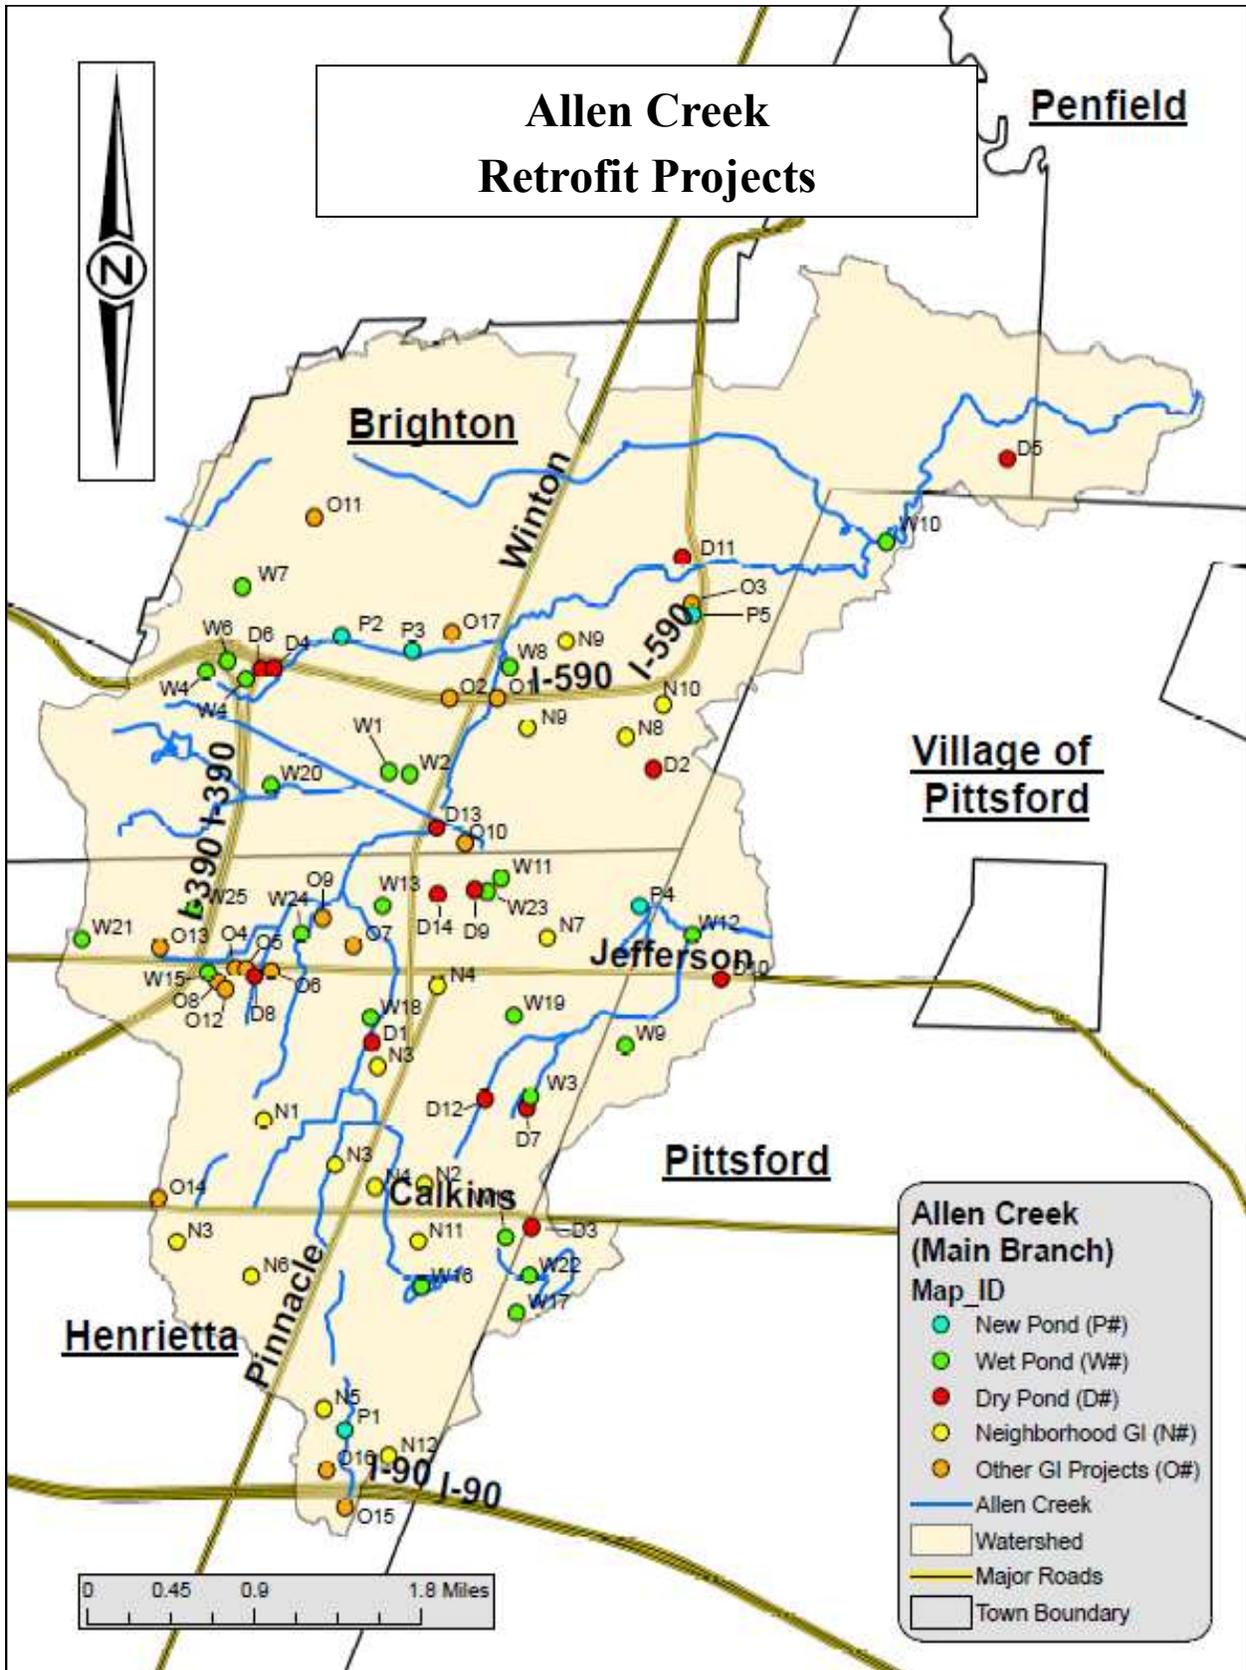
Figure 6: Map of potential projects within the Allen Creek main branch watershed.

Other watershed retrofitting that would help meet water quality goals include the investigation and remediation of any stormwater hotspots (Appendix C) and dechannelization and revegetation of straightened and degraded stream corridors (Appendix D). However these projects are outside the scope of this report and therefore were not ranked. Figure 6 shows project locations and project numbers within the watershed. Table 2 lists project addresses and how they scored. Diagrams of the top scoring projects follow the table.

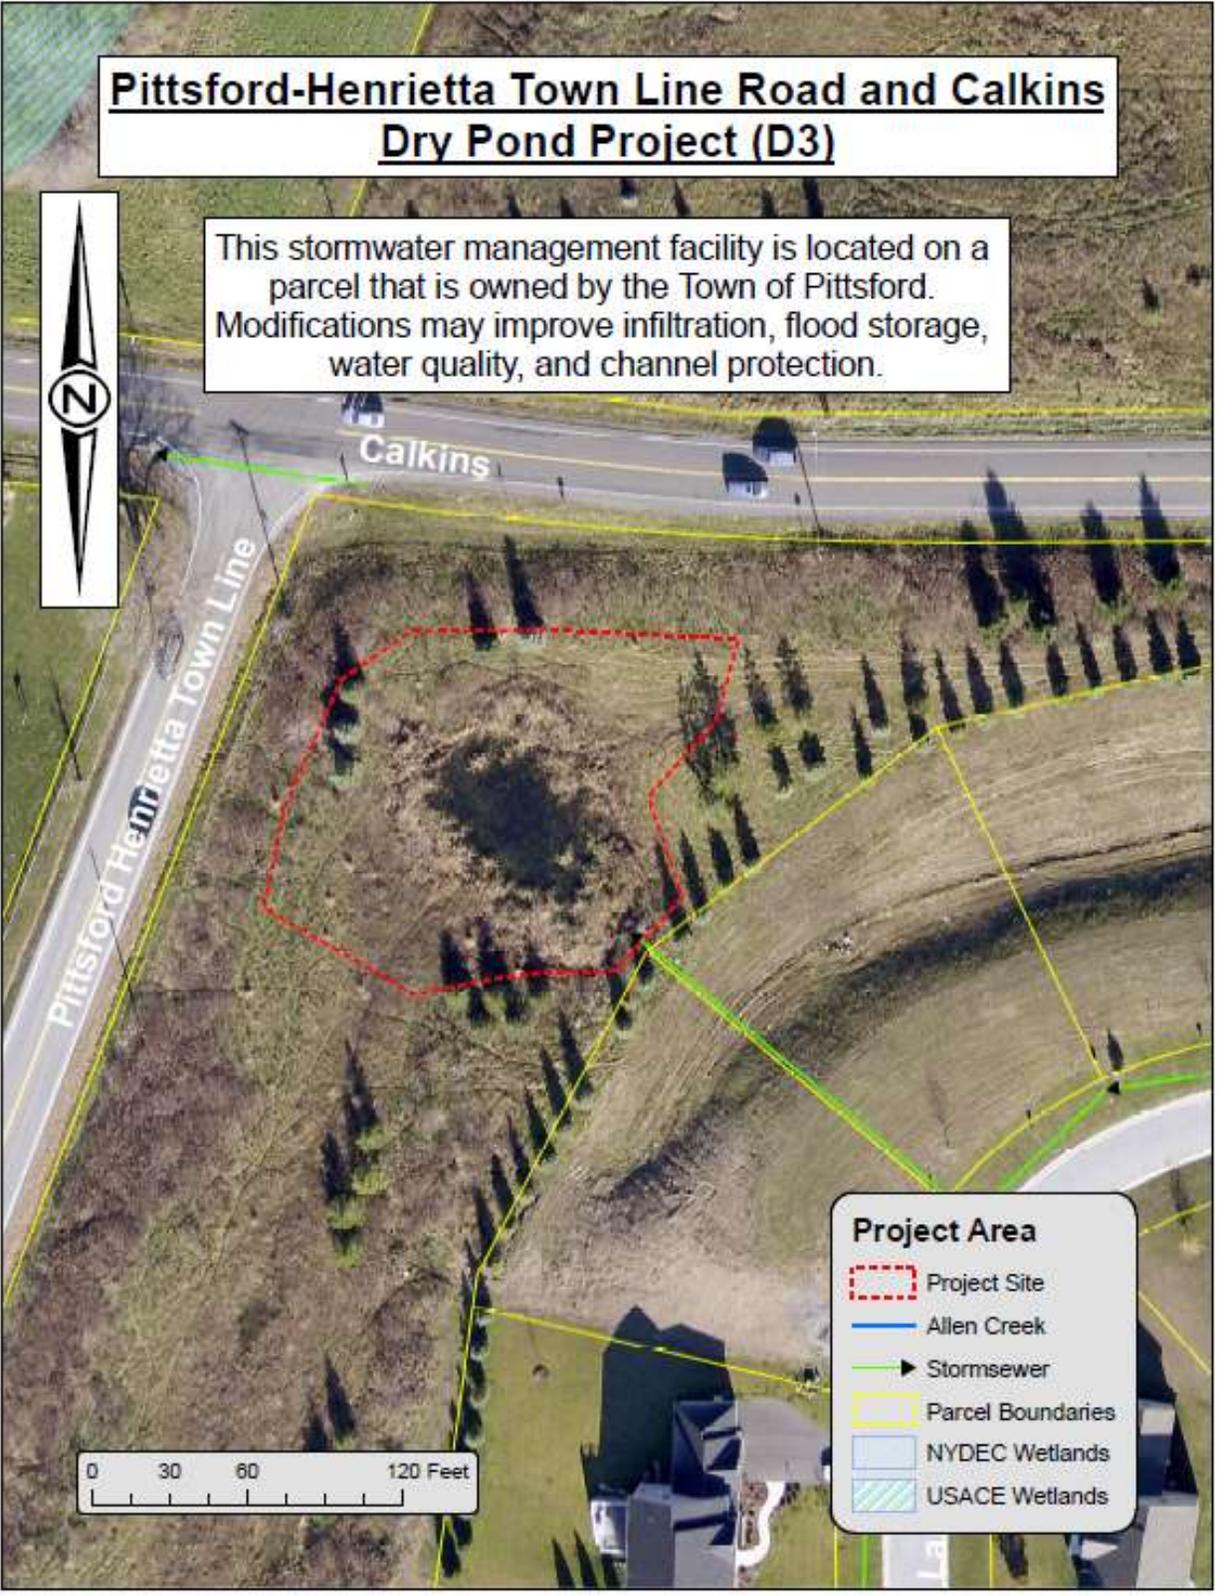
Pittsford-Henrietta Town Line Road and Calkins Dry Pond Project (D3)

This stormwater management facility is located on a parcel that is owned by the Town of Pittsford. Modifications may improve infiltration, flood storage, water quality, and channel protection.

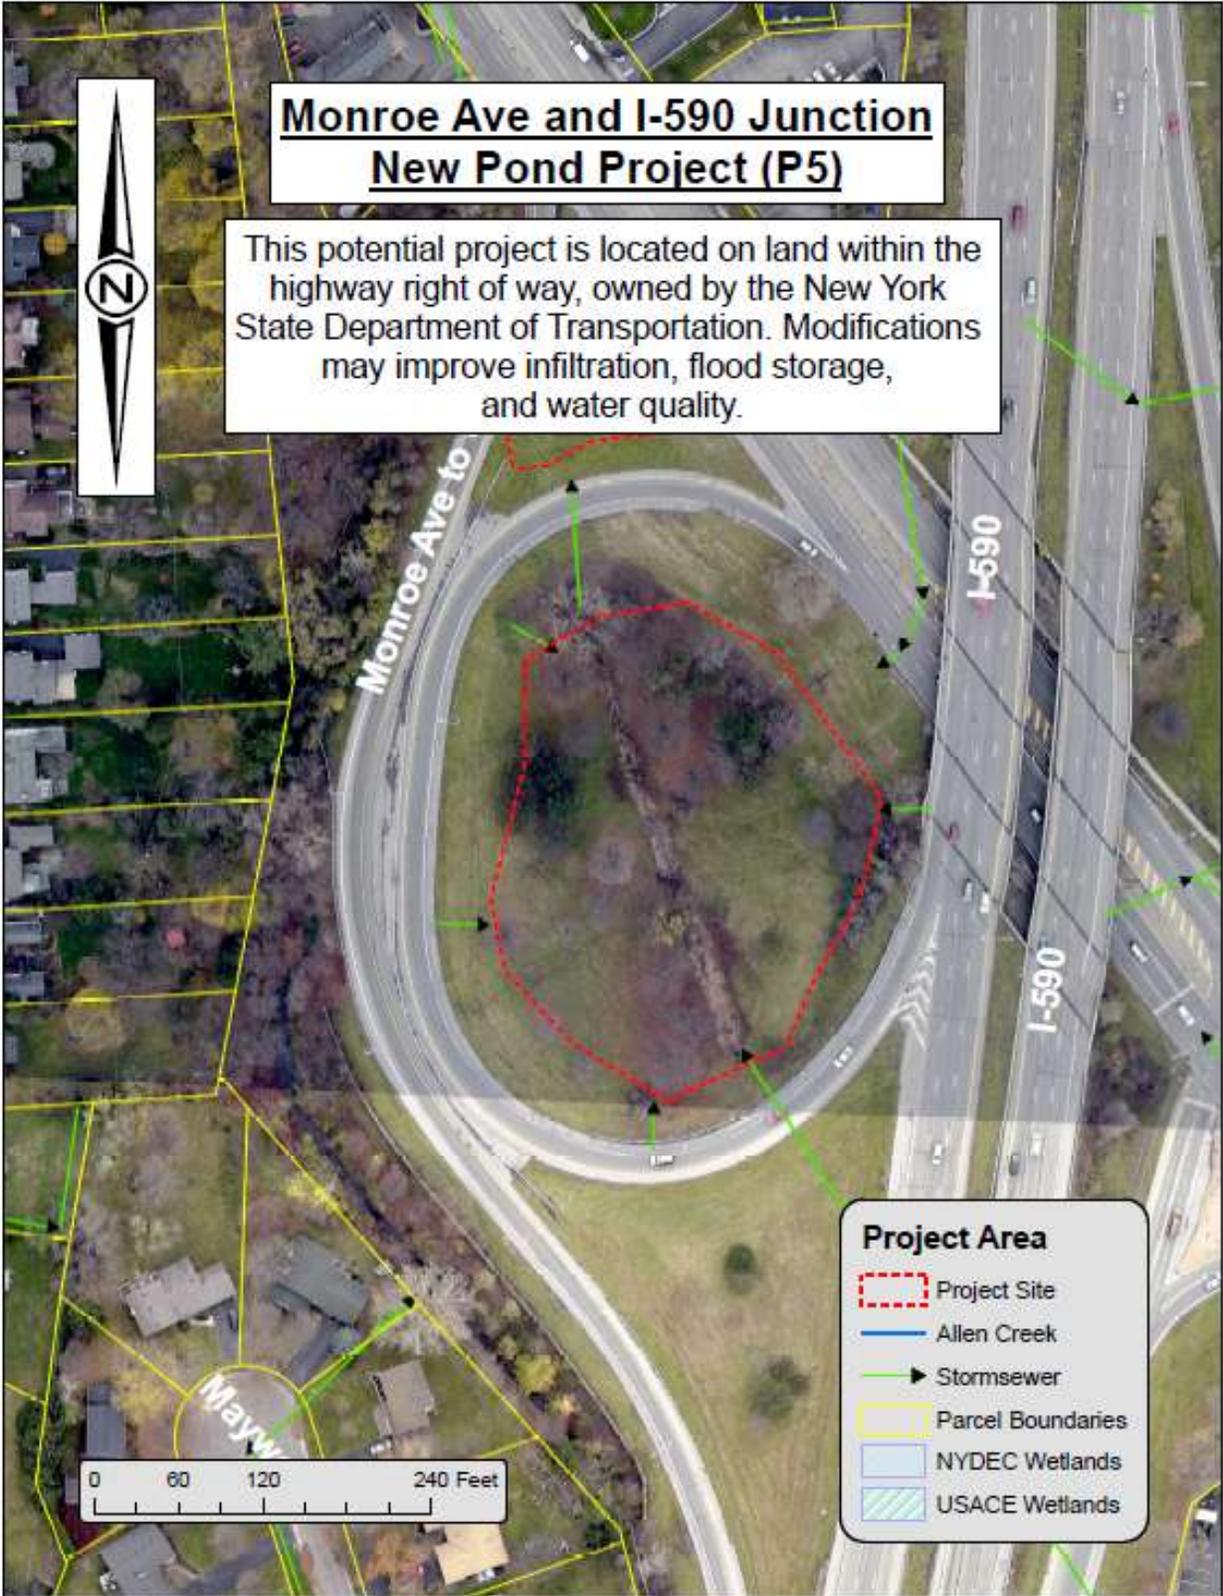
Monroe Ave and I-590 Junction New Pond Project (P5)

This potential project is located on land within the highway right of way, owned by the New York State Department of Transportation. Modifications may improve infiltration, flood storage, and water quality.

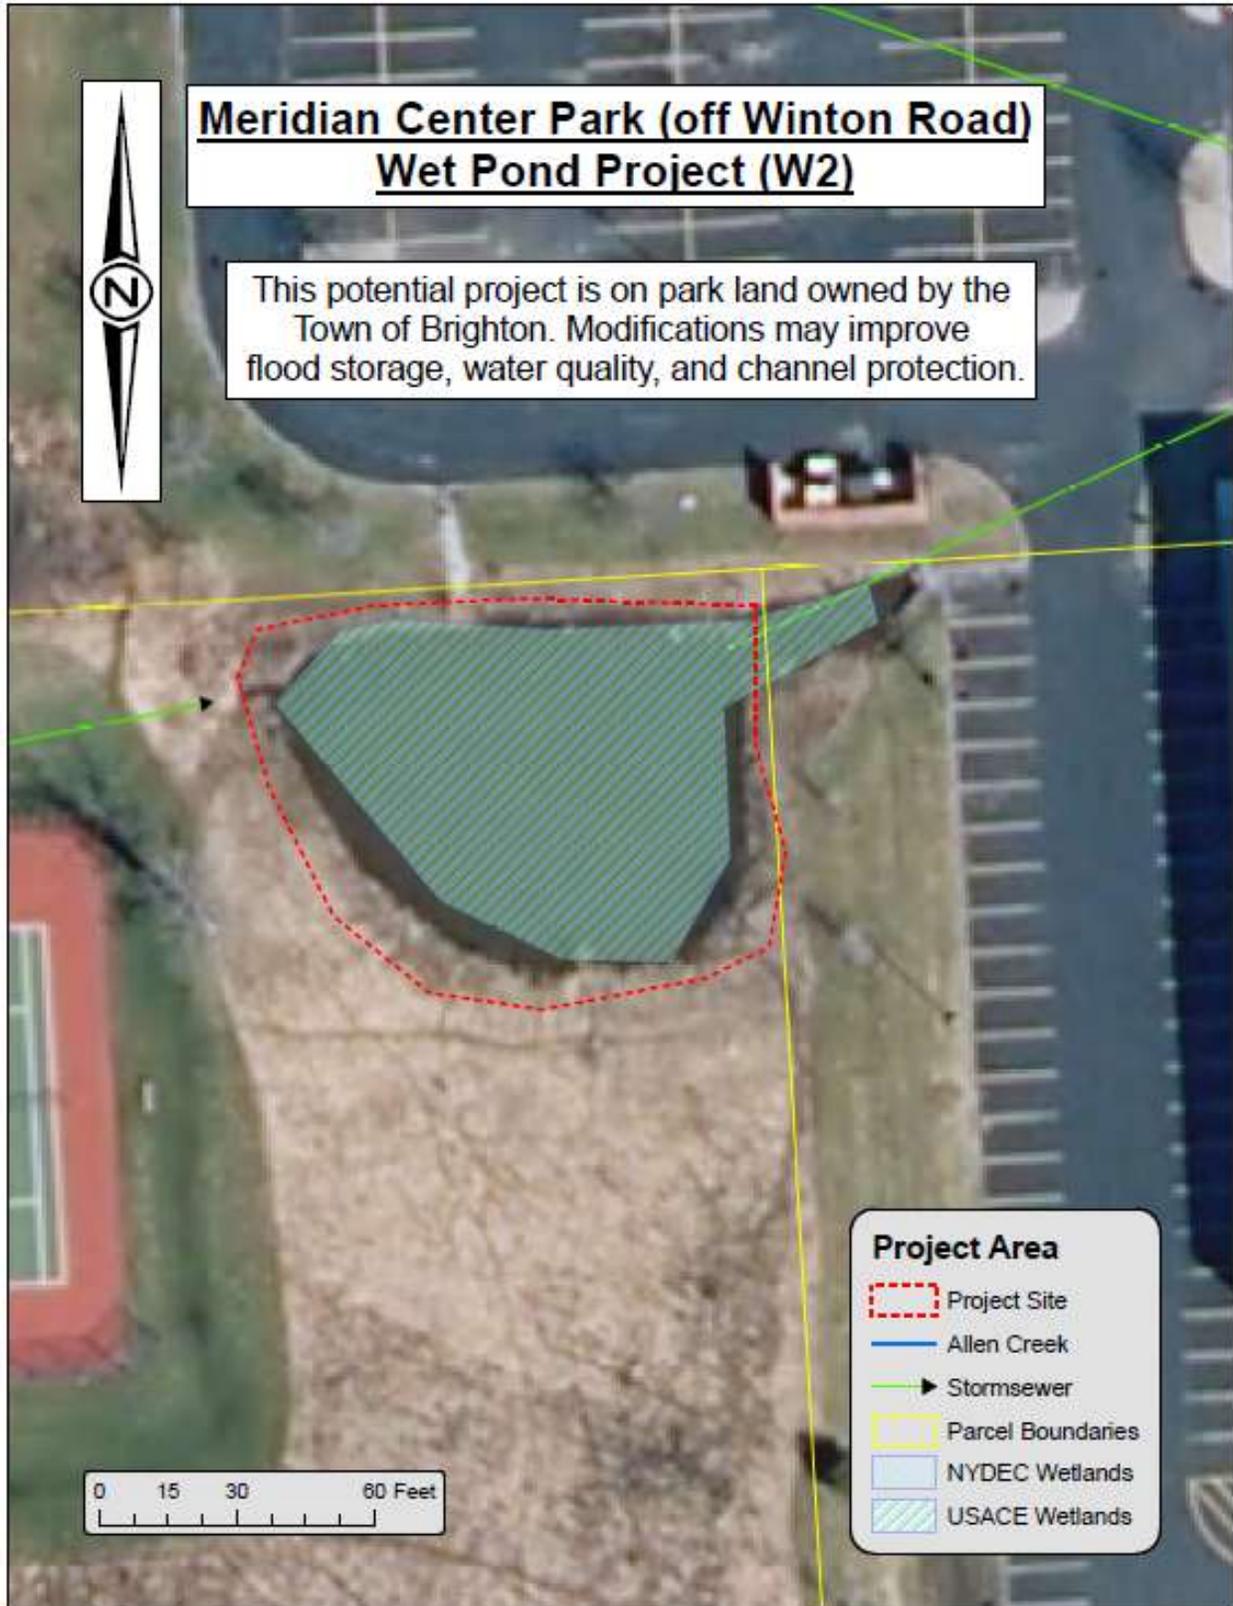
Meridian Center Park (off Winton Road) Wet Pond Project (W2)

This potential project is on park land owned by the Town of Brighton. Modifications may improve flood storage, water quality, and channel protection.

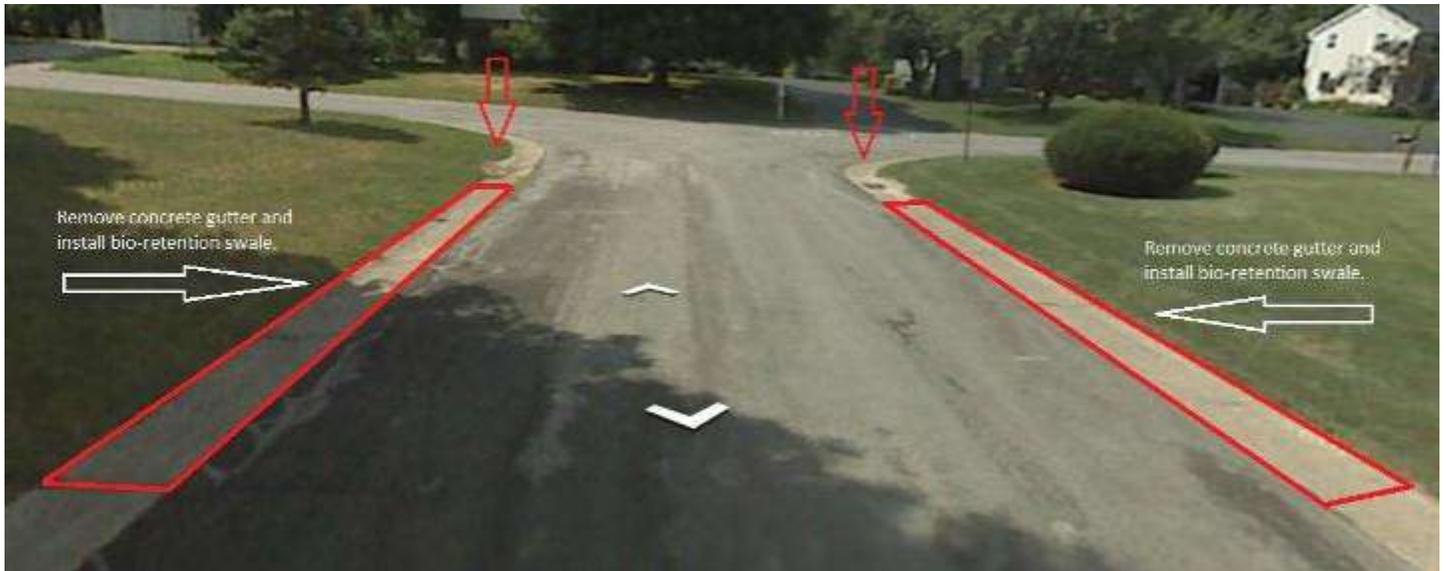
Figure 7: Above is an example typical residential street. Stormwater runoff is channeled into the concrete gutters along the sides of the road and conveyed to the stormwater sewer system through the storm inlets (red arrows). In order to reduce runoff into the stormwater sewer system and increase infiltration, bio-retention swales could be installed. These green infrastructure retrofits would replace the concrete gutter and contain stormwater runoff and allow it to infiltrate back into groundwater.

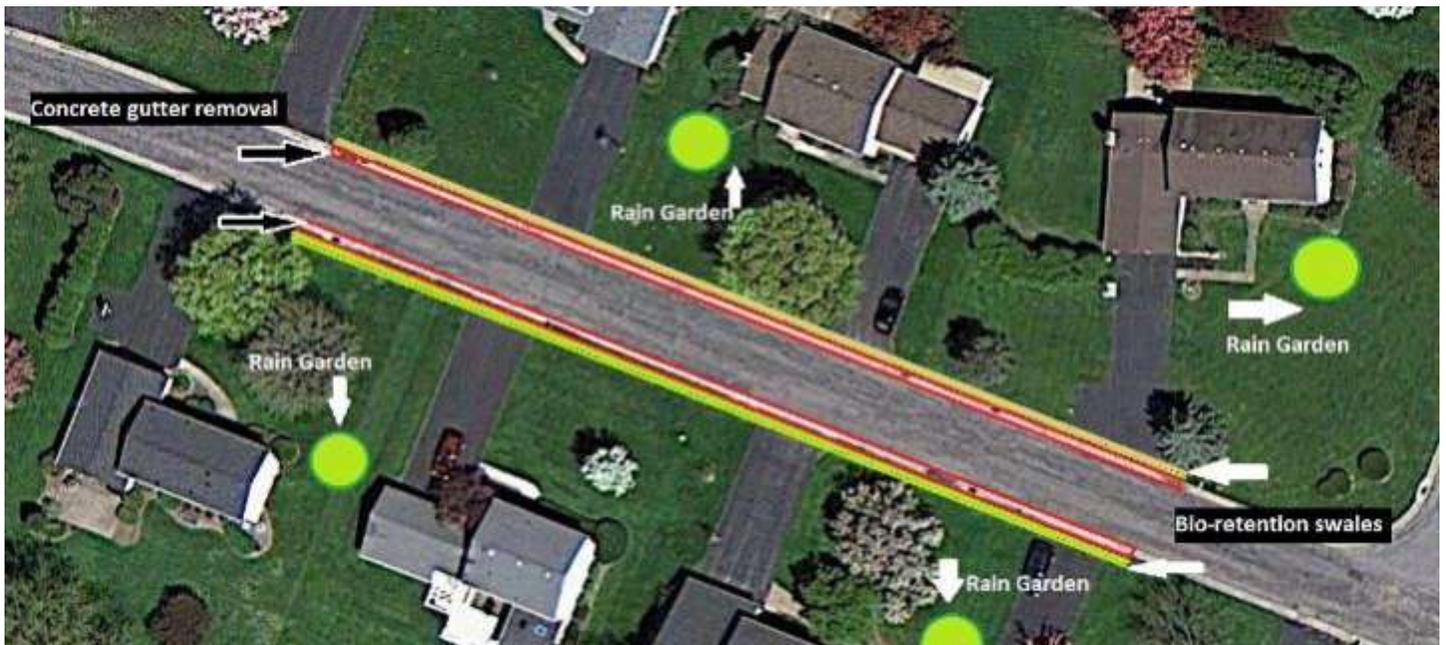
Figure 8: Above is a example of a neighborhood with standard stormwater management practices i.e. concrete gutters along the streets which connect to the stormwater sewer, fair amounts of impervious cover, and roof top connections to the stormwater sewer. Replacing the concrete gutter with bio-retention swales and diverting roof top runoff to rain gardens provide source control and infiltration for stormwater runoff.

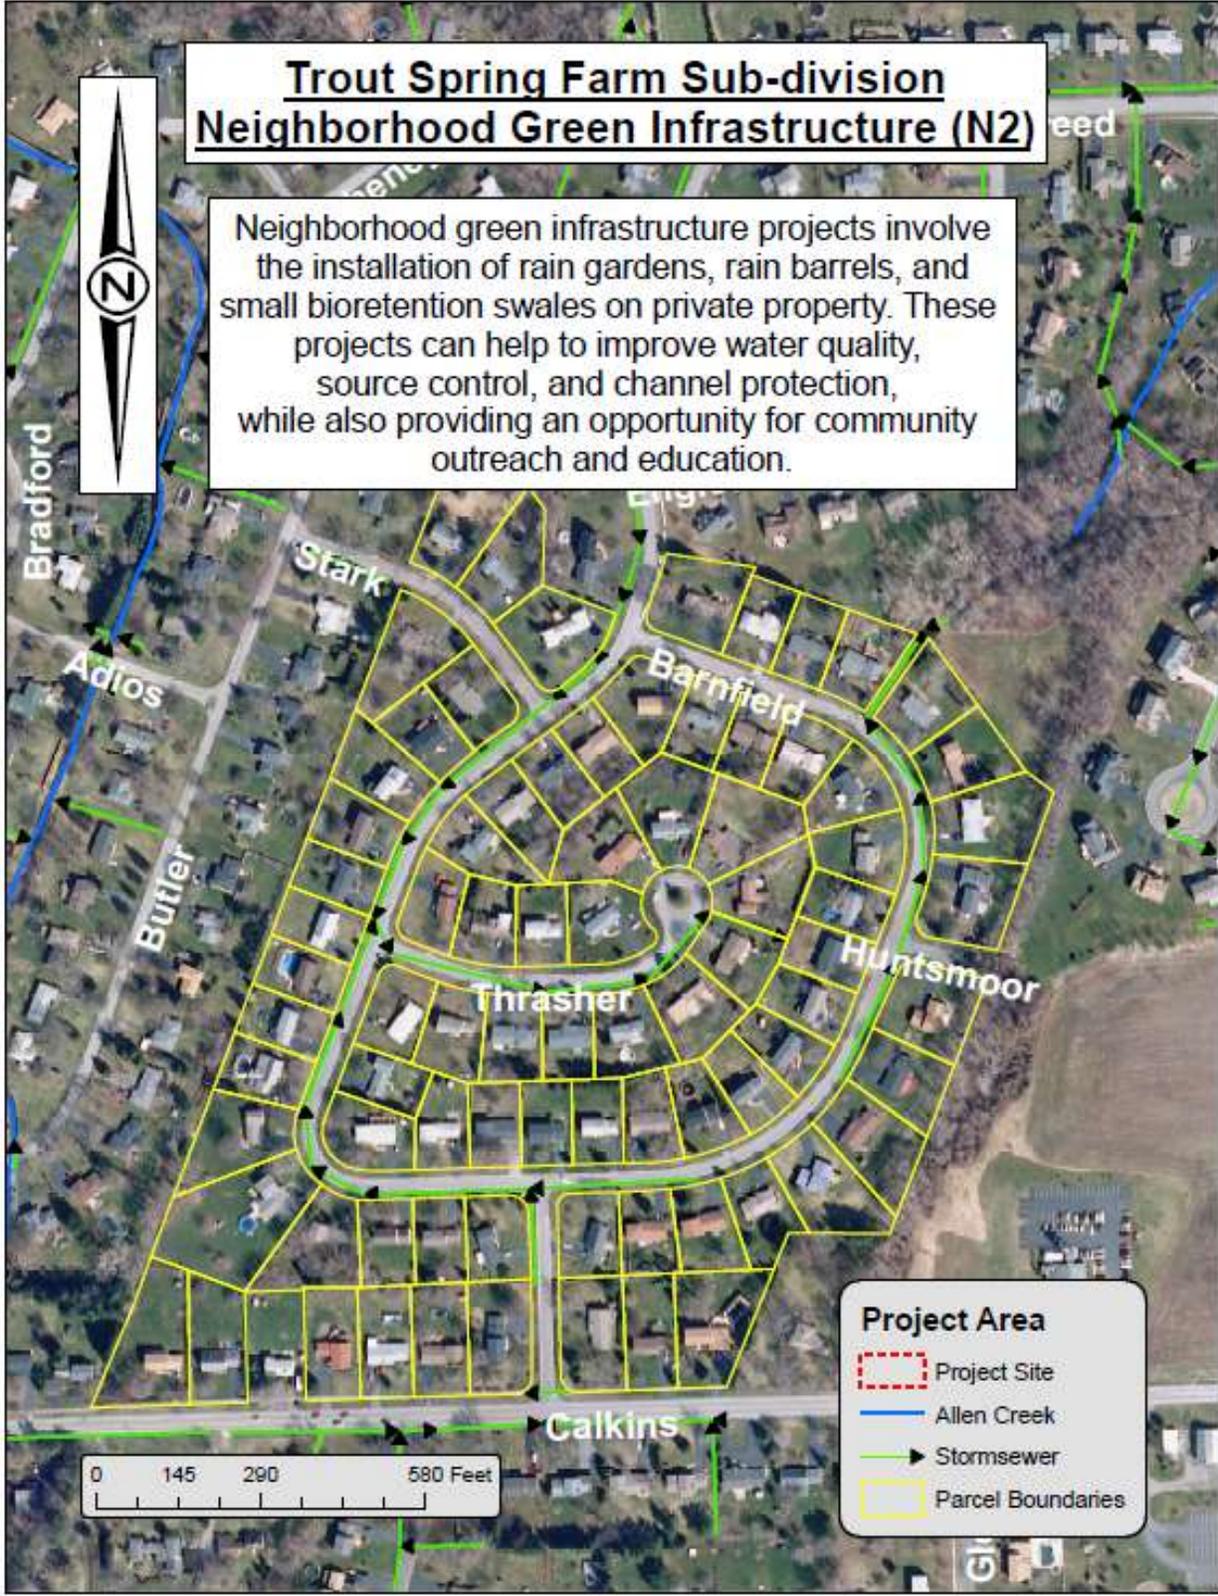
Trout Spring Farm Sub-division Neighborhood Green Infrastructure (N2)

Neighborhood green infrastructure projects involve the installation of rain gardens, rain barrels, and small bioretention swales on private property. These projects can help to improve water quality, source control, and channel protection, while also providing an opportunity for community outreach and education.

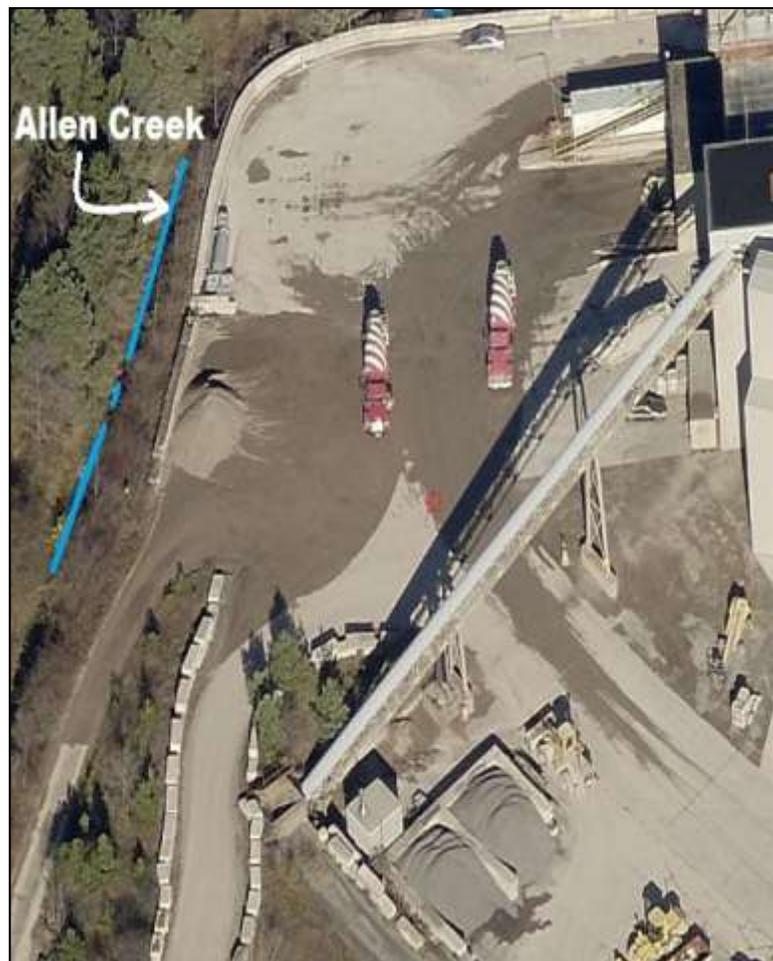
Figure C-1: A concrete plant is a potential

Stormwater hotspots are defined as commercial, municipal, industrial, institutional or transport related operations that produce higher levels of stormwater pollutants, and may present a higher than normal risk for spills, leaks, or illicit discharges. In many cases, a hotspot exists on private property where a change in how the facility is managed is all that is required to prevent water pollution. Pollution prevention is a term commonly used for hotspots and refers to reducing or eliminating the generation of pollutants where they are generated. Another term used is “good housekeeping”, meaning a practical and cost-effective way to maintain a clean and orderly facility, in order to prevent potential pollution sources from coming into contact with stormwater. Good housekeeping practices also help to enhance safety and improve the overall work environment. An example in Allen Creek is the Concrete Batch Plant that is adjacent to the creek. The plants operation involves sand that is stored in the open for easy access (Figure C-1).

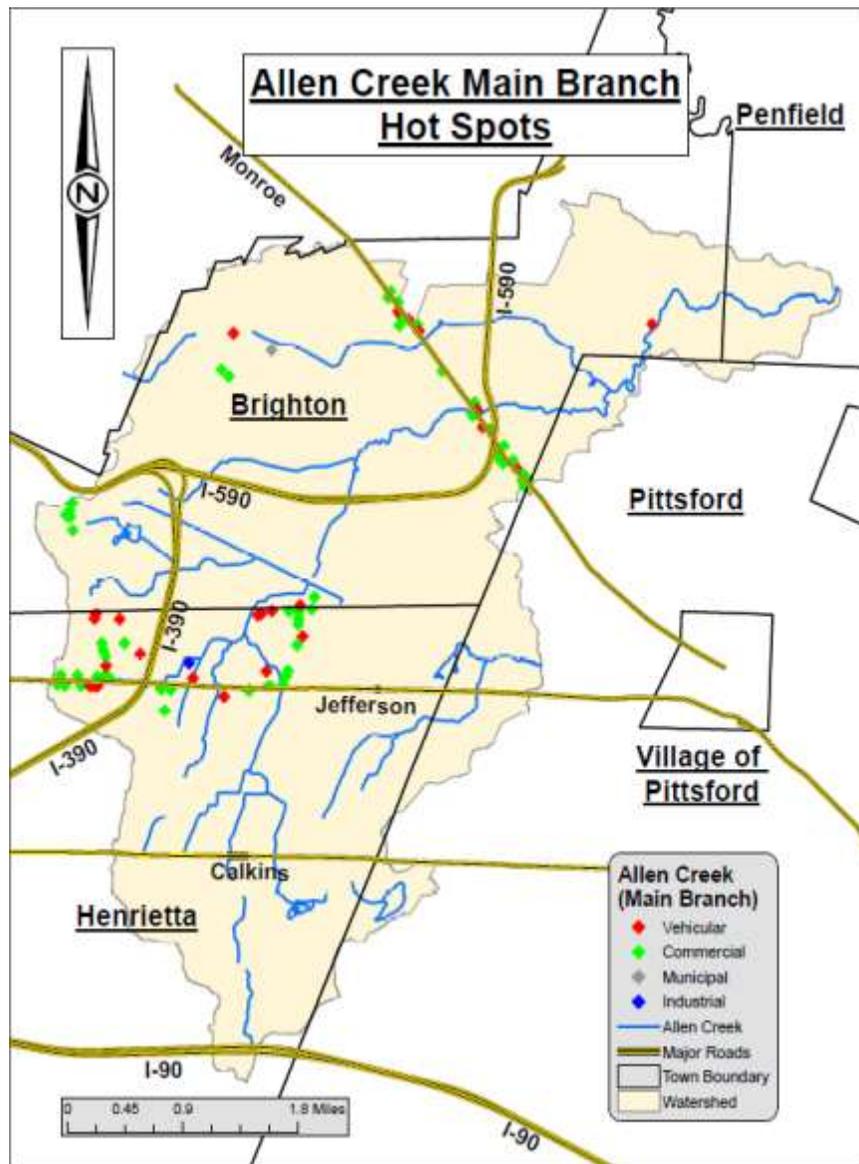
Figure C-2: Locations for potential hotspot within the Allen Creek

Using the watershed parcel records and the parcel property class description, potential hotspots were identified, mapped and listed (Figure C-2 and Table C-1 respectively).
