# Little Black Creek Stormwater Assessment and Action Plan

**Staff of the Stormwater Coalition of Monroe County  
Department of Environmental Services  
444 E. Henrietta Rd.  
Rochester, NY. 14623**

Little Black Creek Stormwater Assessment and Action Plan is a  
Pilot plan of the Monroe County Stormwater Master Plan

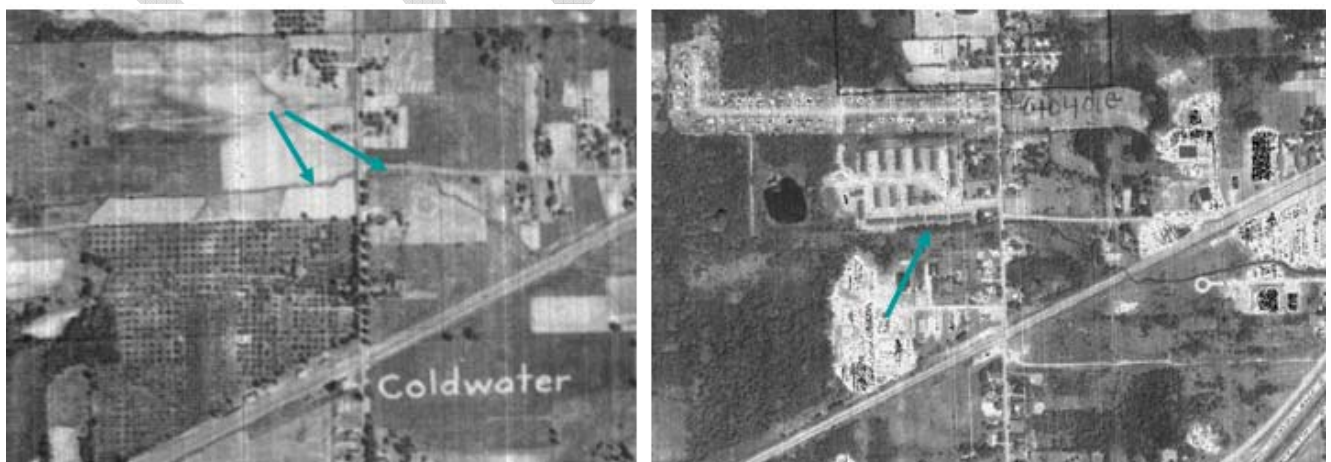
Figure 3. Comparison of land use in Little Black Creek. 1930 (left) and 1980 historic photos of Coldwater Road area (Town of Gates). Arrows point to area of straightened stream sections and, in some stretches, removed streamside vegetation.

A review of aerial photos from 1930 to current day illustrates the straightening, channelizing and stream relocation to accommodate farming and land development. The lower section remained rural until the late 1970's when a burst of growth came from the expansion of adjacent Rochester. A comparison of historic photos is shown in Figure 3. New homes were built as well as new industries and replaced agriculture as the predominant land uses over these last 40 years in Lower LBC.

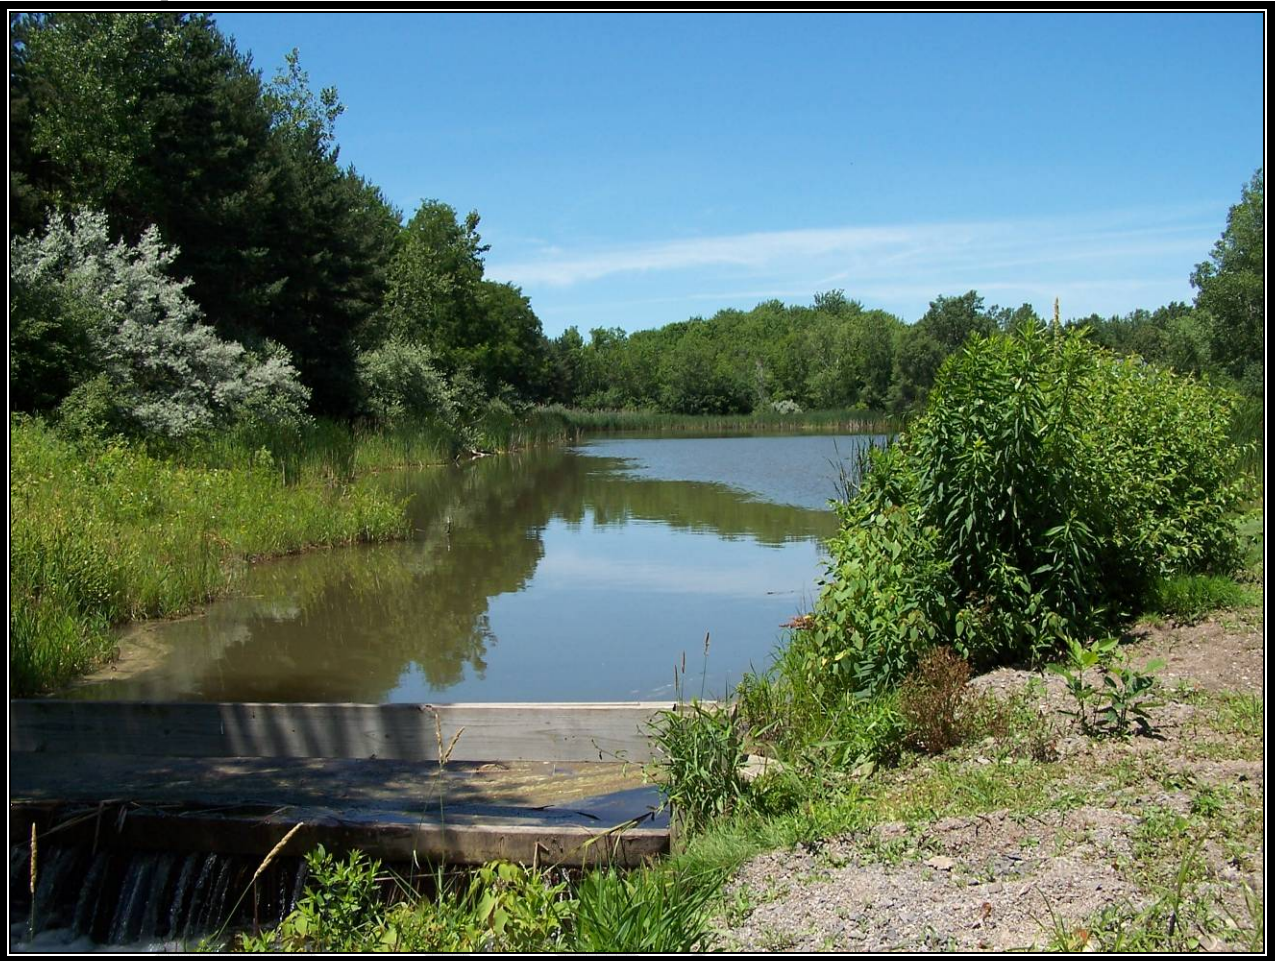
Figure 6. Hidden Valley Pond Outlet – leaking weir lacking water quality or quantity control.

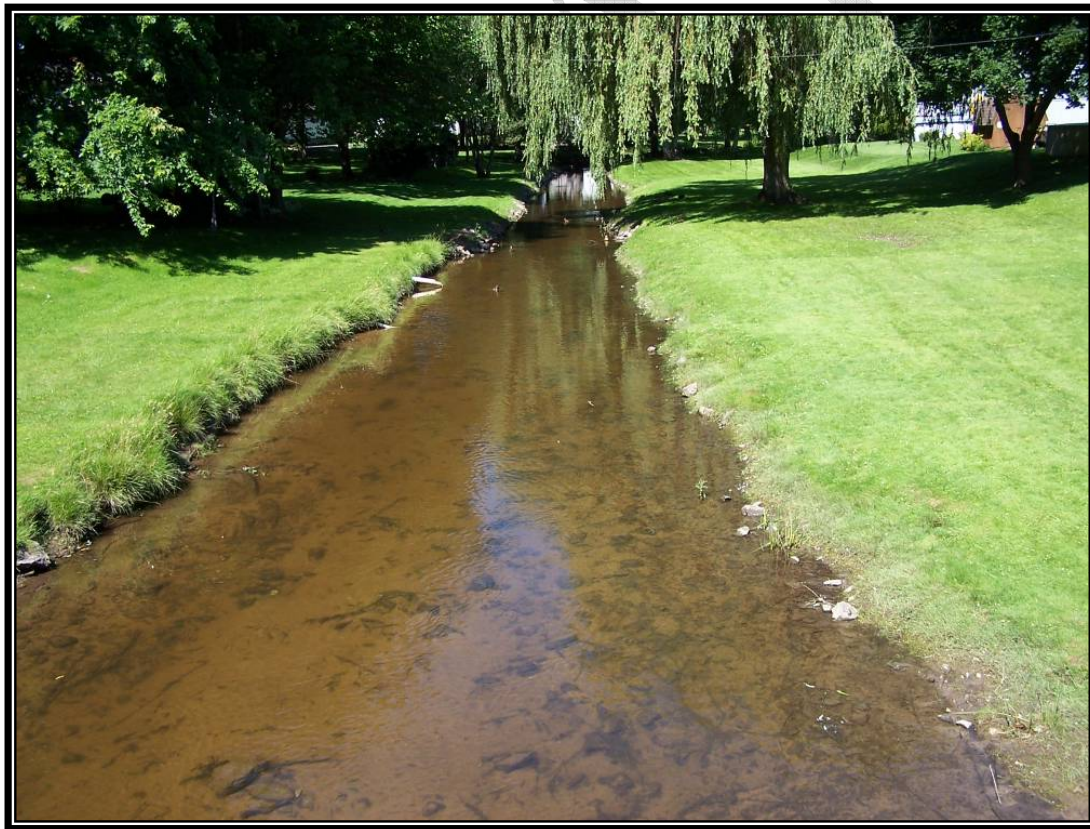
Figure 8. Channelization of Little Black Creek looking west from Harpington Drive bridge (Westmar Village).

An example is in the Westmar Village residential neighborhood (see Figure 8). This sample location has numerous problems. The stream reach has received large amounts of sediment and there is no real stream bed. The sediment is at least a foot deep which makes this stretch of stream unsuitable habitat for benthic macroinvertebrates. In another example, the habitat was suitable for macroinvertebrates, but the population was tolerant of poor water quality, showing that the location was subjected to pollutants recently.

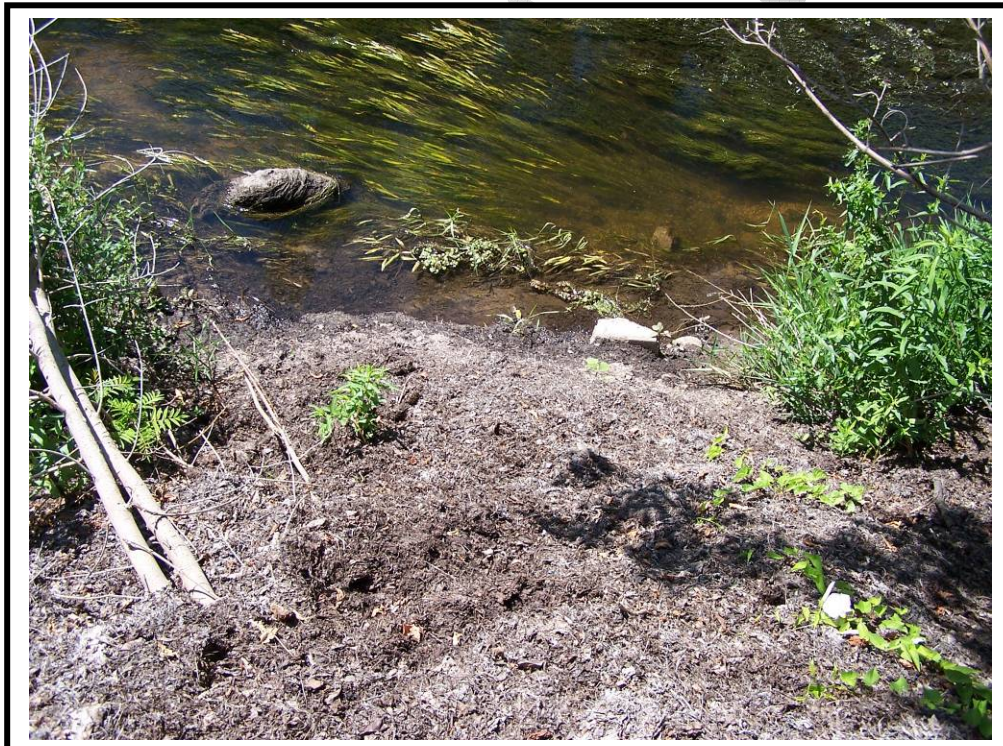
Figure 12. Trash and Debris – yard waste is continually dumped along 100 feet of the stream's bank in Gates.

Three locations were identified as trash and debris hotspots. Materials found ranged from yard waste, pet waste, paper, plastic and automotive products. All locations have high potential for restoration by volunteer clean-ups, education, or removal by municipal staff. Figure 11 shows excessive debris in an industrial area of Gates.

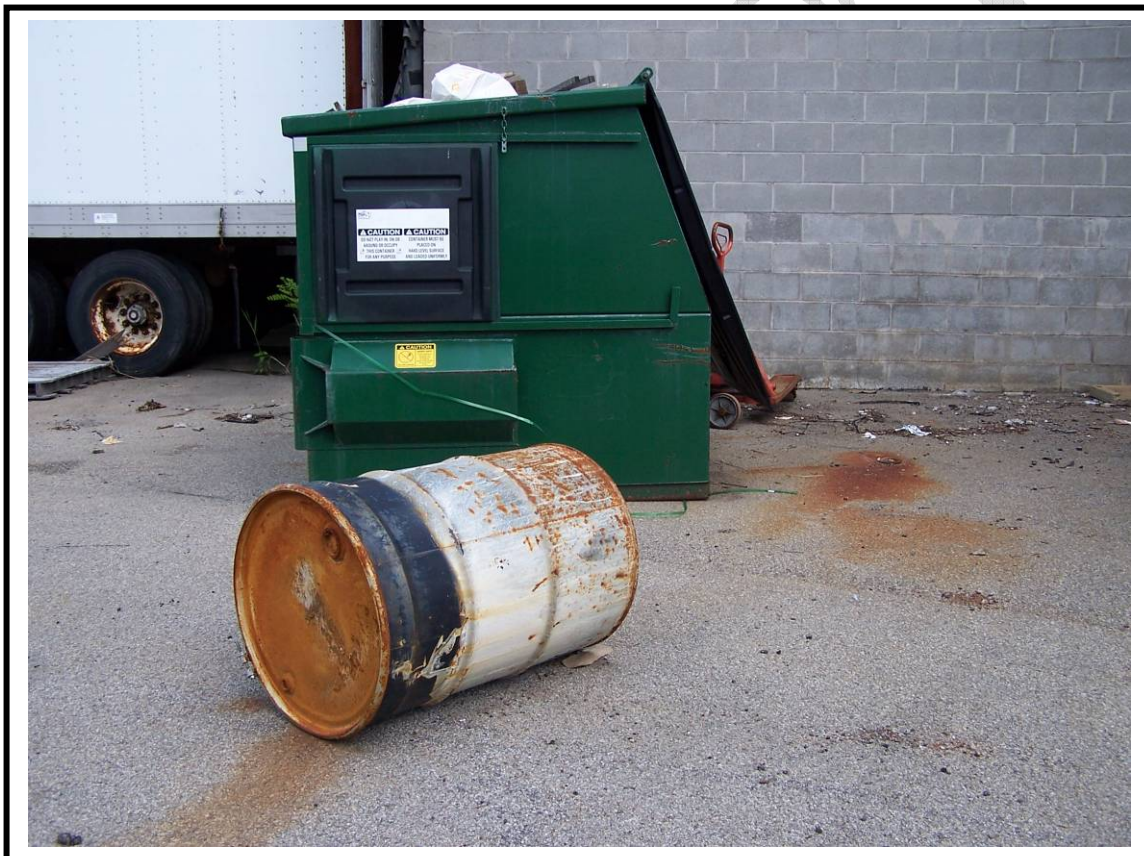
Figure 13. Little Black Creek Watershed Hotspot

Each type of commercial hotspot can generate its own blend of pollutants which can include nutrients, hydrocarbons, metals trash or pesticides. (CWP, 2005). Figure 12 is an example of a small industry in Gates where pollutant generated from outdoor waste disposal travel to nearby LBC.

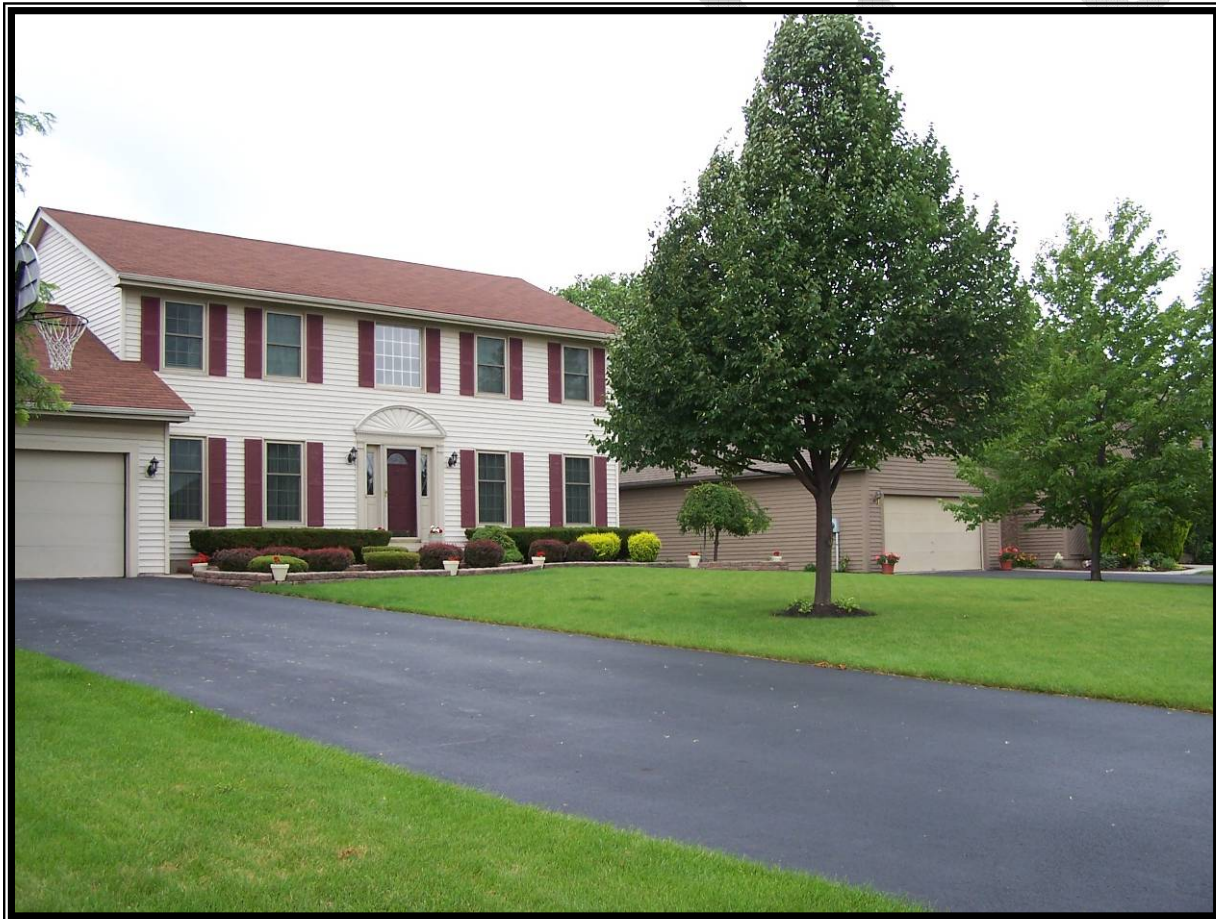
Figure 14. A residential neighborhood identified for its highly manicured lawns

One location that provides an example of how the neighborhood assessment was used to determine the land use impact to LBC is the Country Shire Estates neighborhood in Ogden built in 1988. The neighborhood has well manicured lawns, indicative of large inputs of lawn care chemicals (see Figure 13).

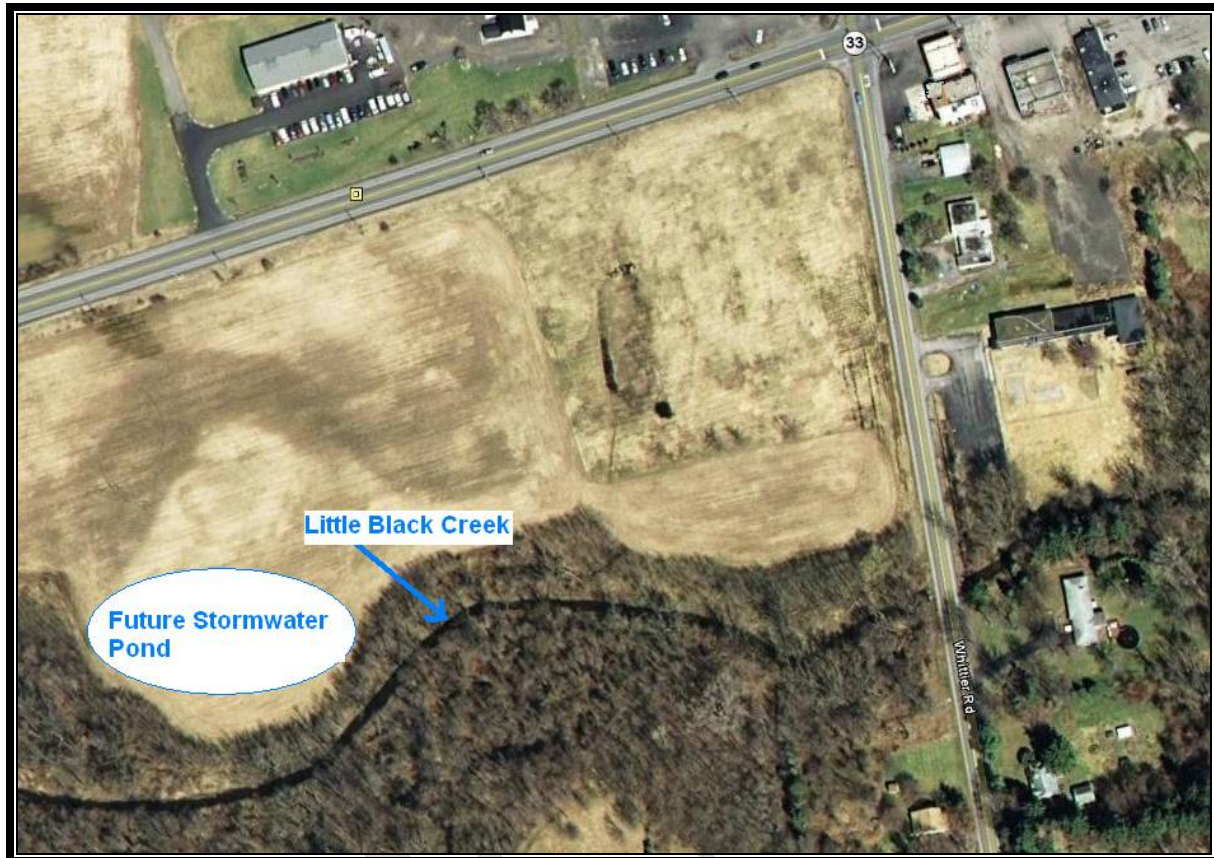
Figure 16. Proposed New Stormwater Management Pond in the Town of Ogden, southwest of Buffalo and Whittier Roads

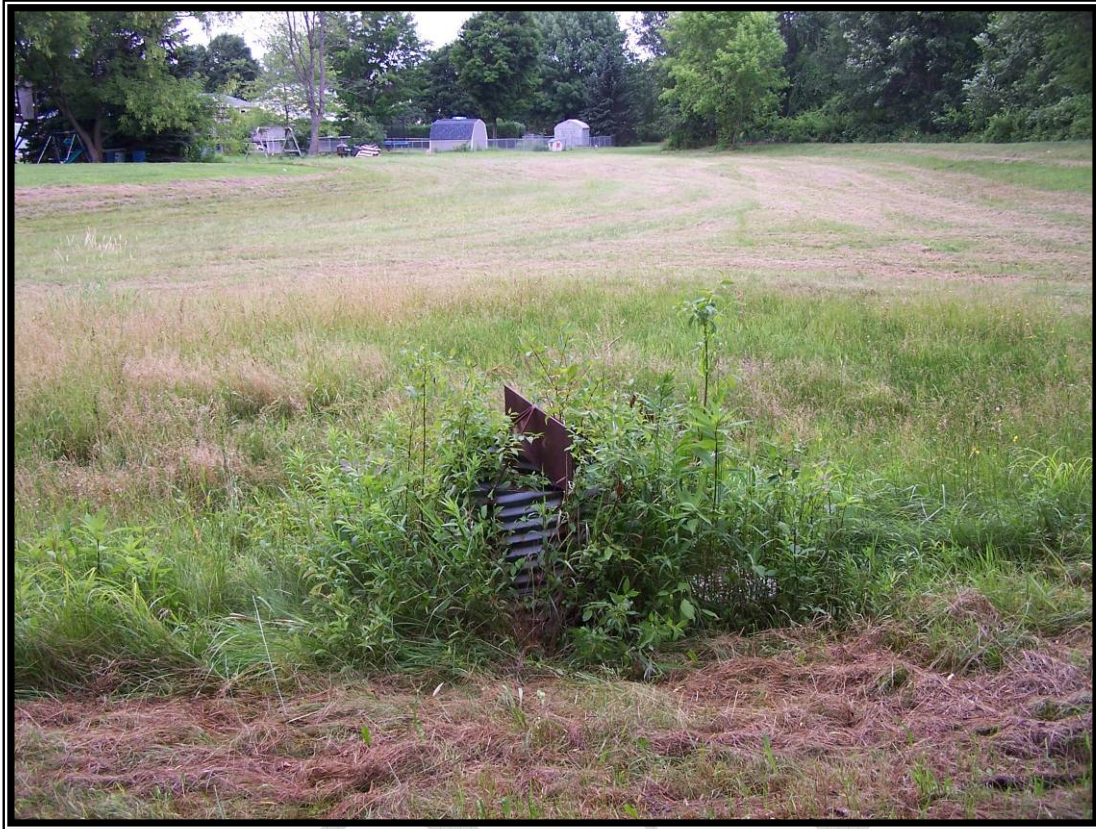
Figure 17. Conventional Flood Control Pond on Reddick Lane in Ogden for Potential Retrofit

Figures 17 and 18 are examples of potential green infrastructure practices that could be installed in the LBC watershed. For further details and examples of these practices, see Appendix F.

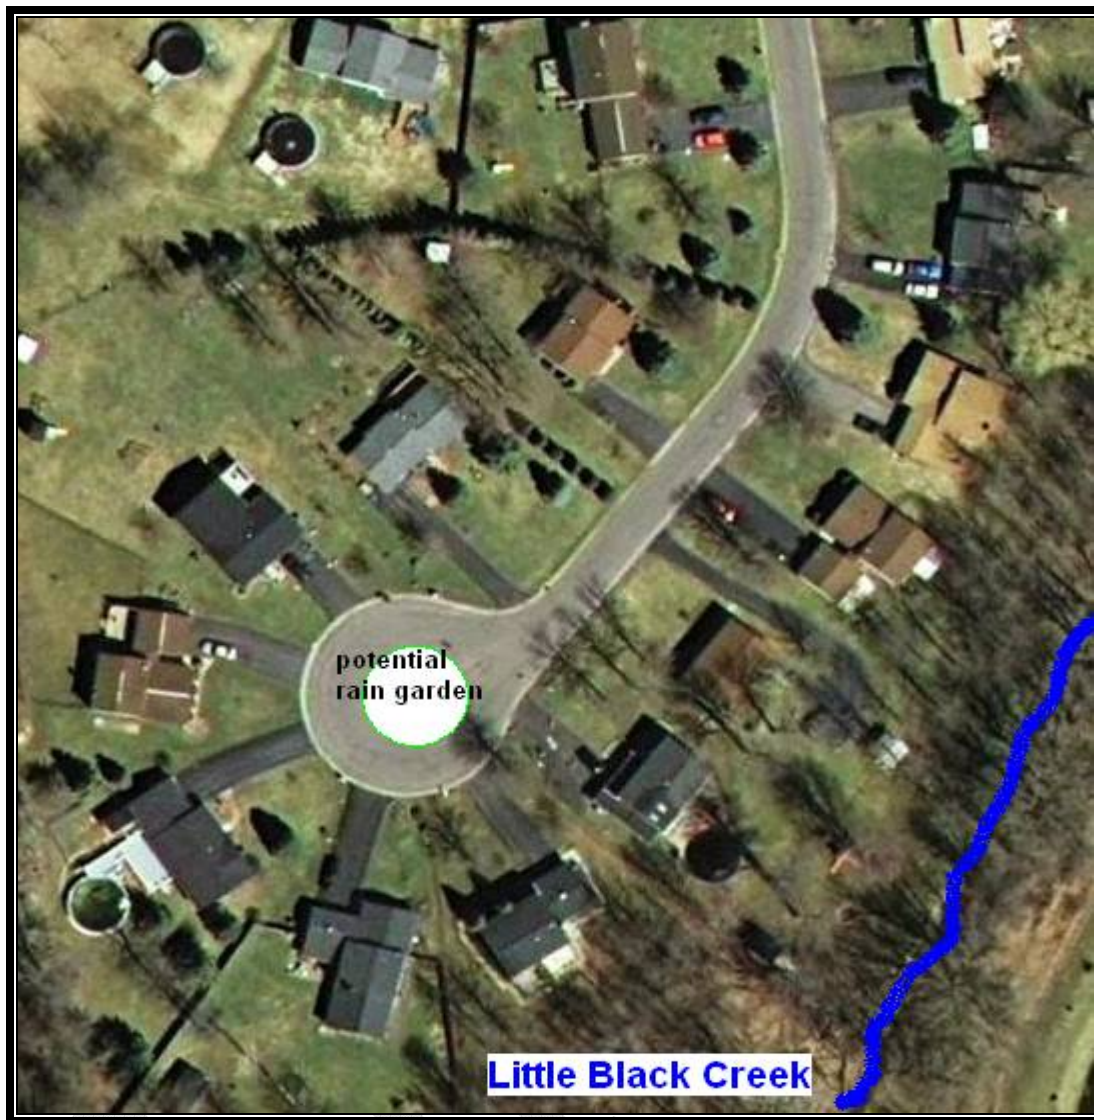
Figure 18: Proposed Cul-de-sac Rain Garden on Matthew Circle in Ogden

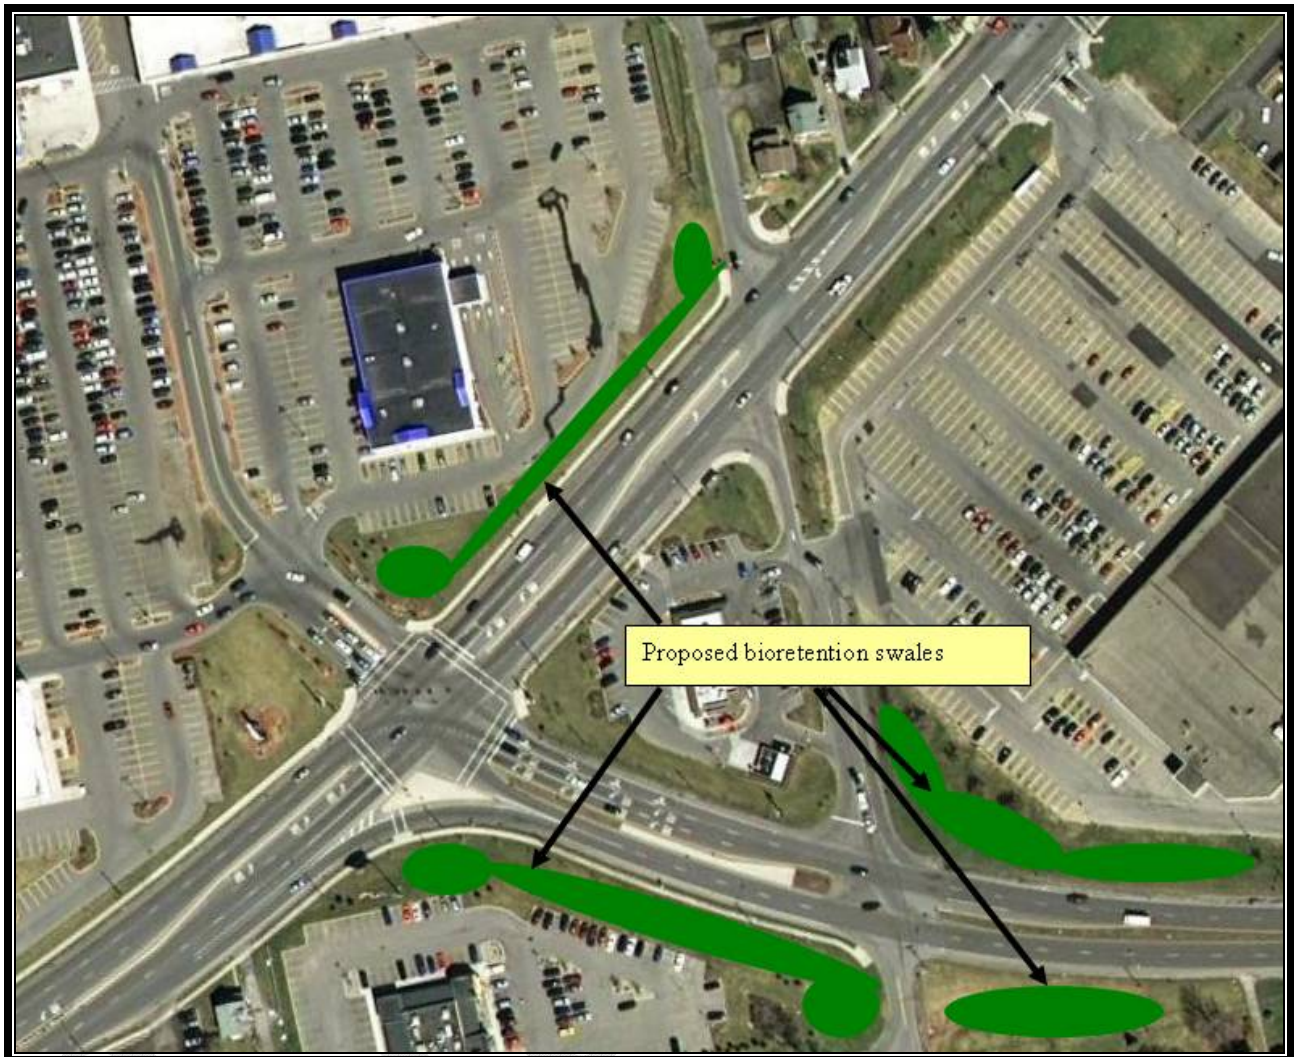
Figure 19: Proposed Vegetated Bioretention Swales at the intersection of Brooks Road and Chili Avenue

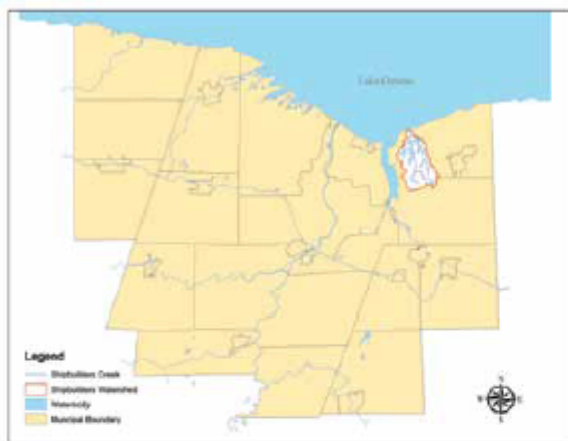
Figure 2. Shipbuilders Creek watershed, which drains directly to Lake Ontario.

Shipbuilders Creek (SC) lies east of the City of Rochester, New York, originating in the town of Penfield and ultimately discharging to the Rochester Embayment of Lake Ontario (Figure 2). SC was elevated to the New York State 303(d) list of impaired waters in 2008, with impairments including
