Shipbuilders Creek Stormwater Assessment and Action Plan

Monroe County
Department of Environmental Services
444 E. Henrietta Rd.
Rochester, NY. 14623

Shipbuilders Creek Stormwater Assessment and Action Plan is a
Pilot plan of the Monroe County Stormwater Action Plan

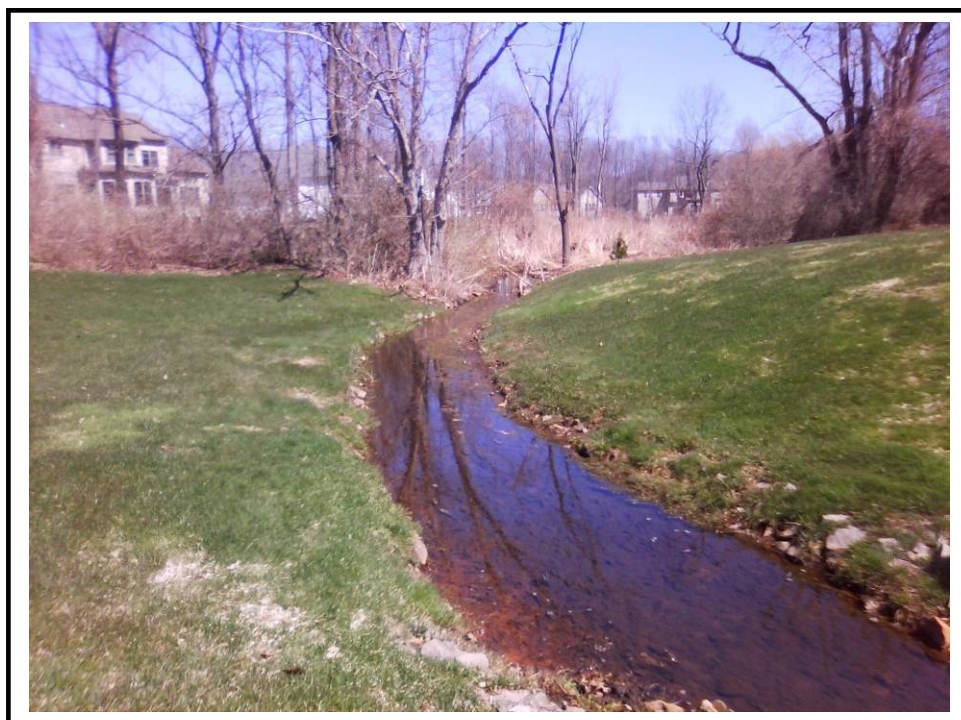
Figure E. 2 Stream Reach with no Stream Buffer

Many stormwater professionals report that achievable and sustainable results are best accomplished through study, planning and implementation at the subwatershed level – an area approximately 2 to 15 square miles (1,200 -10,000 acres). The SC assessment process included six steps: desktop assessment of watershed characteristics; water quality sampling; stormwater modeling; stream corridor assessment; an upland survey of “stormwater hotspots”; and a restoration inventory. Figure E.2 shows a section of stream on SC where typical streamside vegetation has been removed. Stream bank or riparian vegetation creates habitat for aquatic organisms and buffers the stream from impacts from land development such as lawn care chemicals and temperature increases.

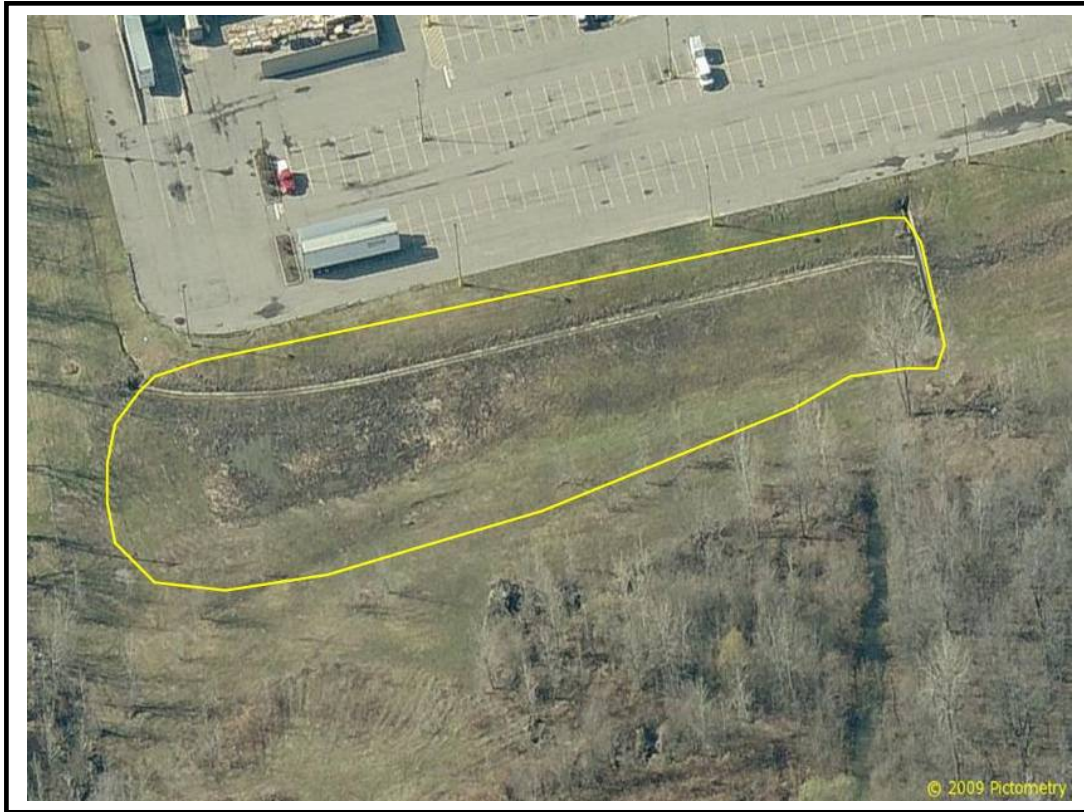
Figure E.3 Candidate Site - Upgrade Conventional Stormwater Pond

Figure E3 shows an existing dry basin “pond” with a concrete channel for flow conveyance. The dry pond provides storage for large storm events but small events typically stay in the channel and are conveyed downstream. Upgrades to existing stormwater ponds can involve removing existing concrete channels to allow for greater infiltration and water quality treatment for small events. These types of restoration projects have been shown to have the best cost-benefit.

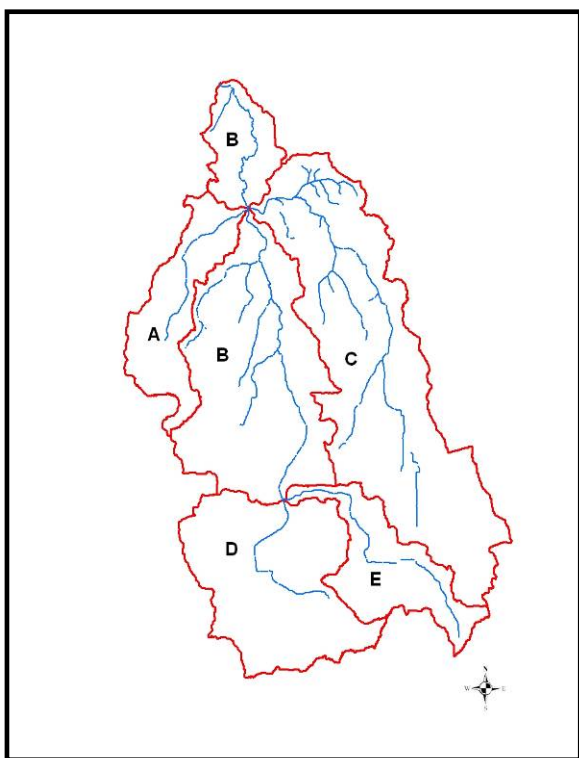
Figure 2. Delineation of Shipbuilders Creek Subwatersheds

An accurate delineation of the Shipbuilders Creek (SC) Watershed and subwatersheds was needed to perform the assessment. Previous drainage studies completed for the Towns of Penfield and Webster (MRB 2001; Costich 1981) that delineated the watershed were reviewed as well as the county's Geographic Information System (GIS) watershed map layer (data source is unknown). The USGS StreamStats online tool was also used. StreamStats is an integrated GIS application developed through a cooperative effort of the USGS and ESRI, Inc. More information on the use and application of StreamStats can be found in Appendix F. County staff evaluating these sources made adjustments creating a new delineation that was used to calculate all subwatershed characteristics (i.e., stream miles, land use, impervious cover estimates) and to break up the field assessments into reasonable partitions. Figure 2 shows subwatersheds A-E.

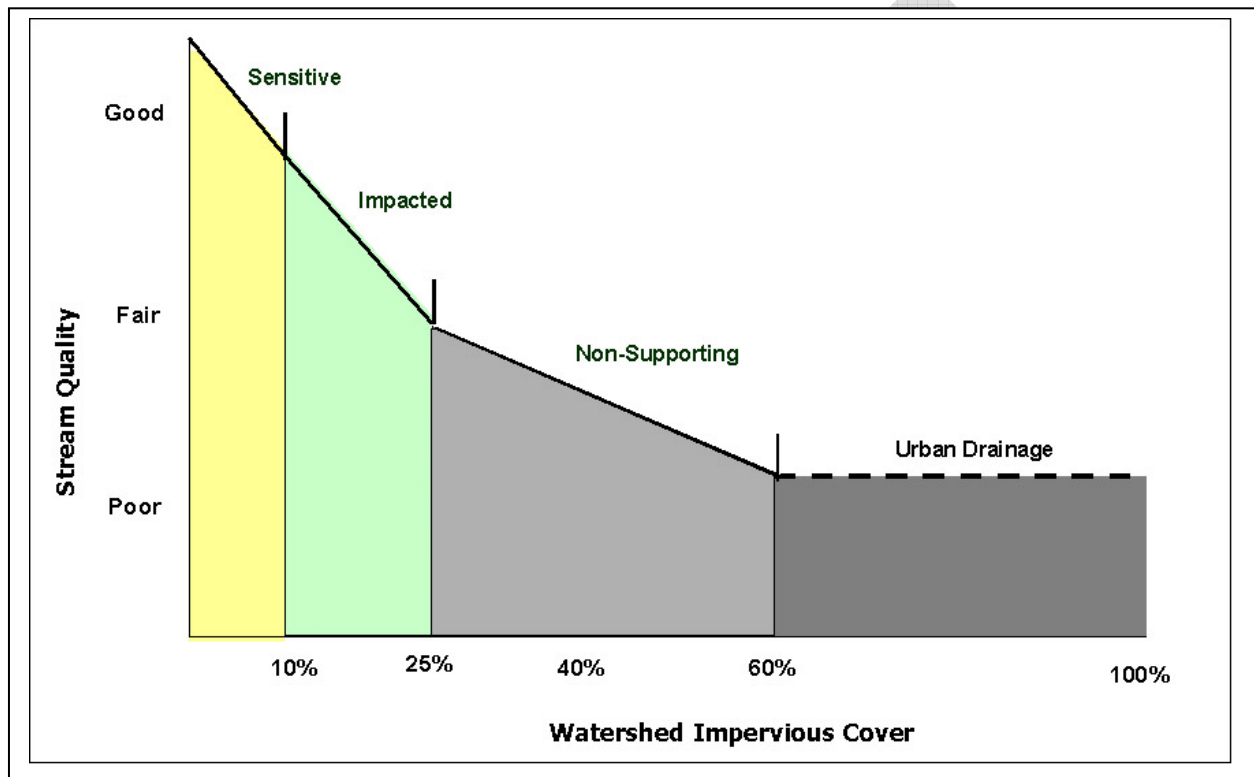
Figure 4. The Center for Watershed Protection Impervious Cover Model

shown that the amount of impervious cover within a watershed can be directly linked to the health of its receiving stream. From this research, the Center for Watershed Protection created the “Impervious Cover Model” (ICM). The ICM is best illustrated by a simple graph with the percentage of impervious cover in a watershed plotted against stream health. The horizontal scale of the graph divides impervious cover percentage into four ranges that correspond to four levels of stream water quality. As shown in Figure 4, the model predicts that most stream quality indicators decline when watershed impervious cover exceeds ten percent, with severe degradation expected beyond 25 percent.

Based on the desktop assessment, each of the five SC subwatersheds have between 14 and 24 percent impervious cover and fall under the Impervious Cover Model’s “Impacted” range. According to the model constructs, streams in this range show clear signs of declining health with indicators such as increased summer stream temperatures, pollution tolerant aquatic organisms, and high bacteria levels. Future impervious cover in Shipbuilders Creek, based on zoning build out, is projected to be in the range of 18 to 28 percent.

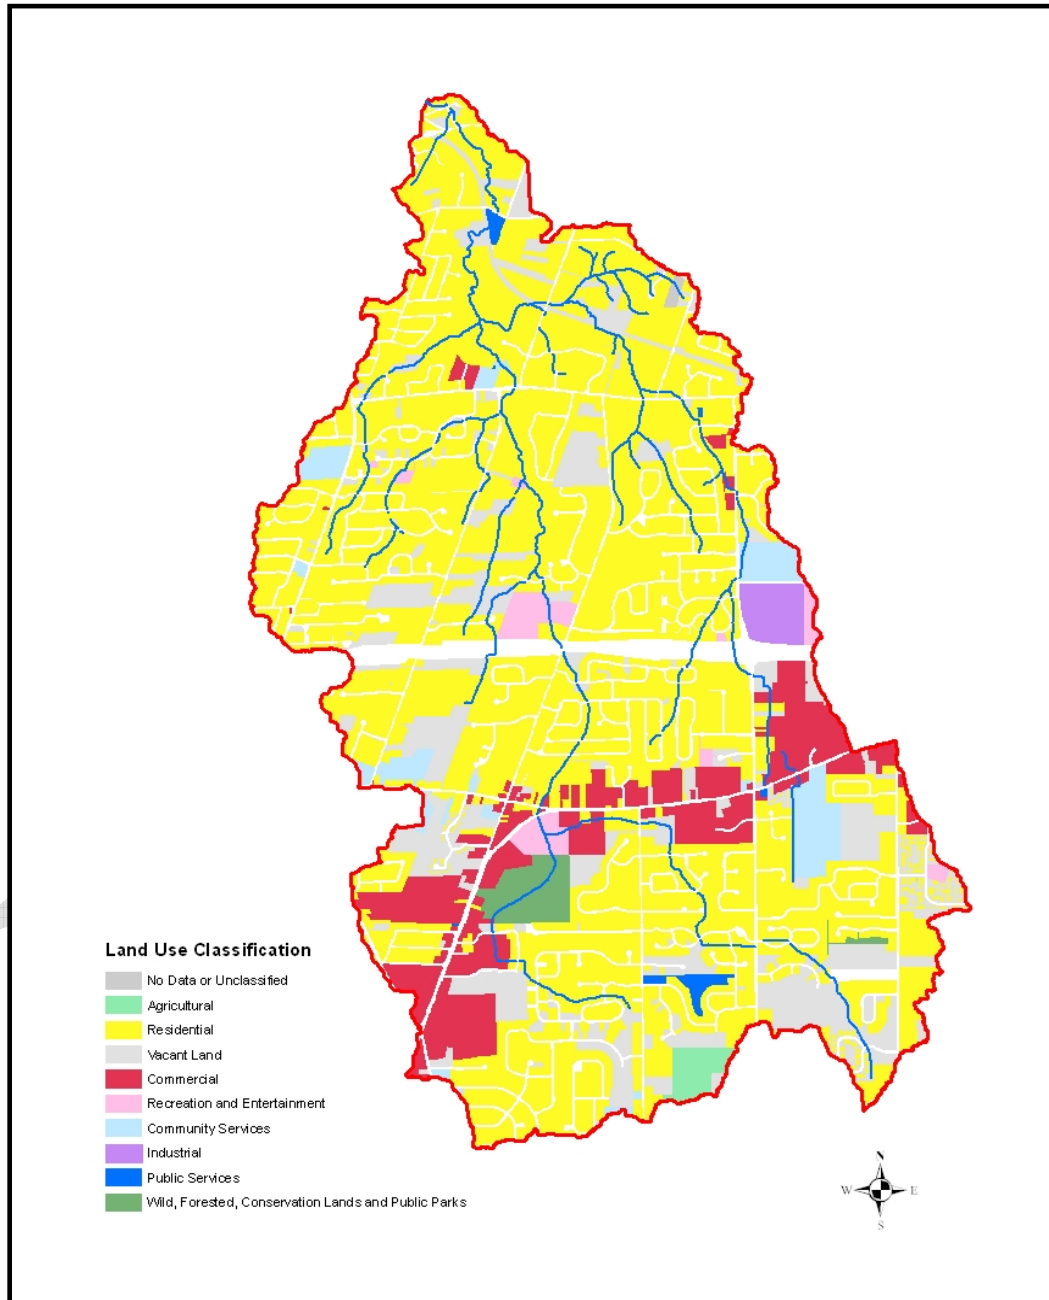
Figure 5. Shipbuilders Watershed Land-Use Classification

Using the current Monroe County property classification it was determined that the predominant land use in the watershed is residential, which accounts for 75 percent of the watershed (Figure 5)

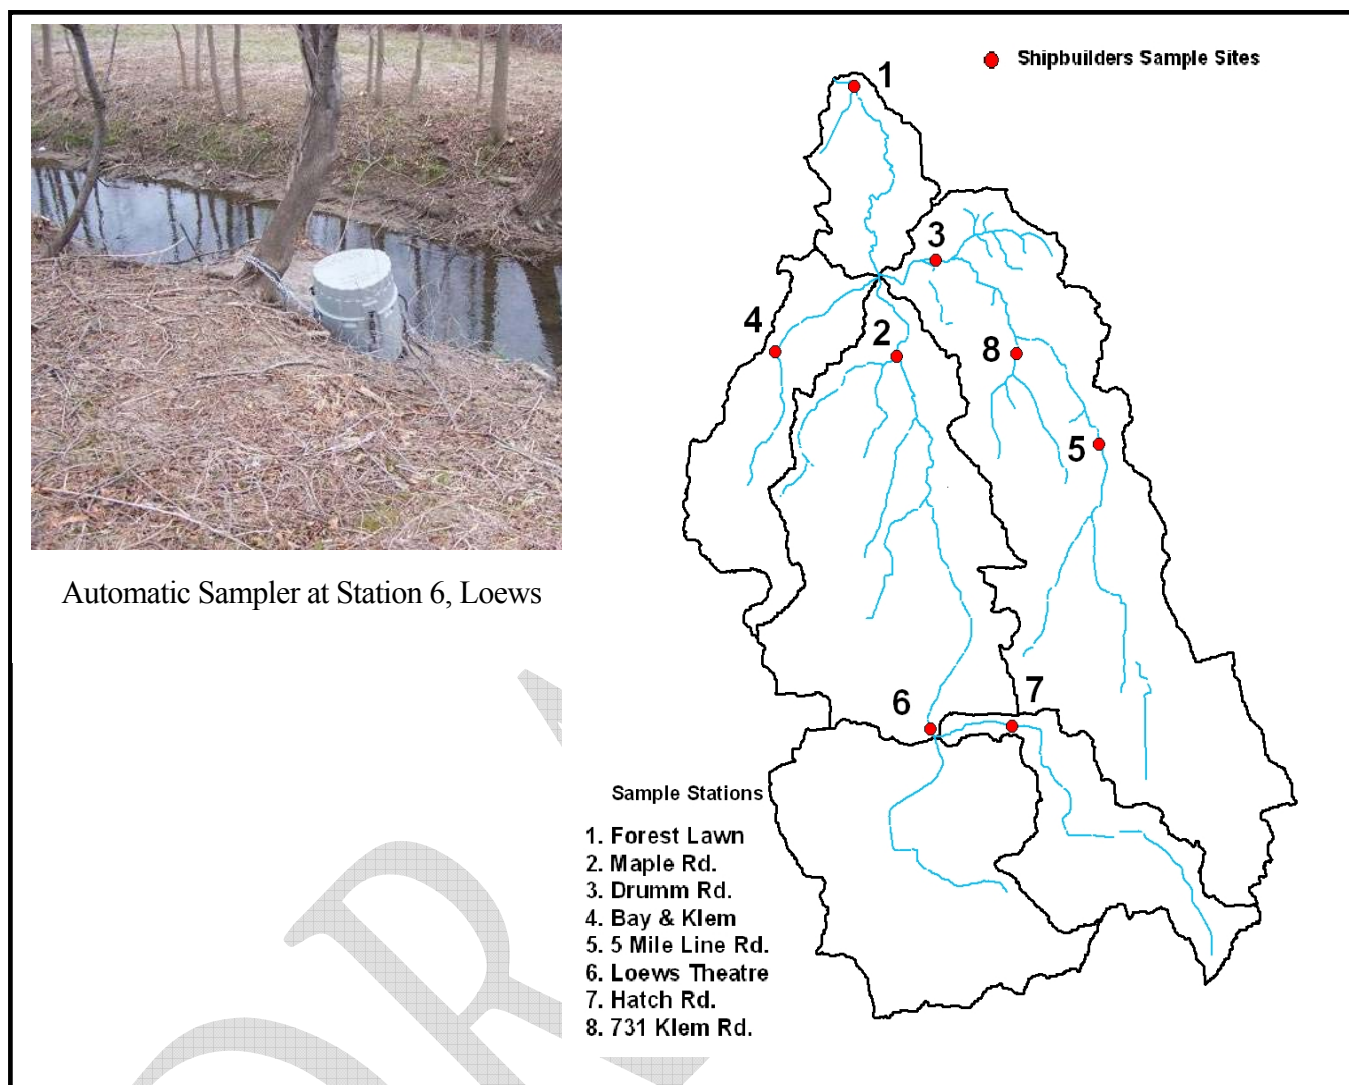
Figure 6. Shipbuilders Sampling Stations

Baseflow data is useful to identify areas with potential base flow contamination. The results of baseflow sampling are presented in Table 3. In addition, a set of wet weather grab samples were collected during a rain event of 1.17 inches on July 23rd, 2009.

In 2009, Monroe County staff assessed benthic macroinvertebrates at six sample locations. At each site, macroinvertebrates were sampled with a kick net and each species was identified and counted. The stream bed habitat was also assessed at each location. Results can be found in Table 5 (site locations numbers are shown on the map in Figure 6).

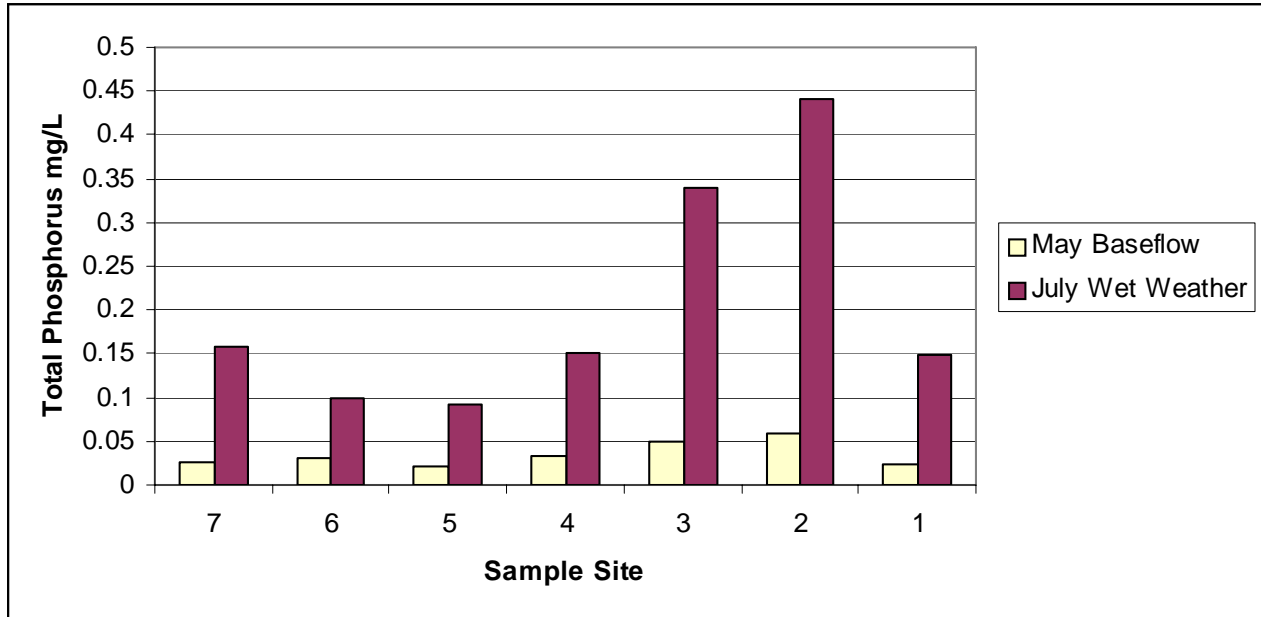
Figure 7. Comparison of baseflow and wet weather total phosphorus results

As expected, all wet weather samples showed significant elevation in values as compared to the May baseflow results. Stations 1, 2 and 3 had the highest values for most parameters. For example, wet weather total phosphorus at station 2 was seven times higher than the baseflow value. Figures 7, 8, and 9 show comparisons between baseflow and wet weather sample results for the watershed pollutants of concern, Total Phosphorus, Total Suspended Solids and Ecoli at all stations. Appendix A provides full results from all watershed sampling.

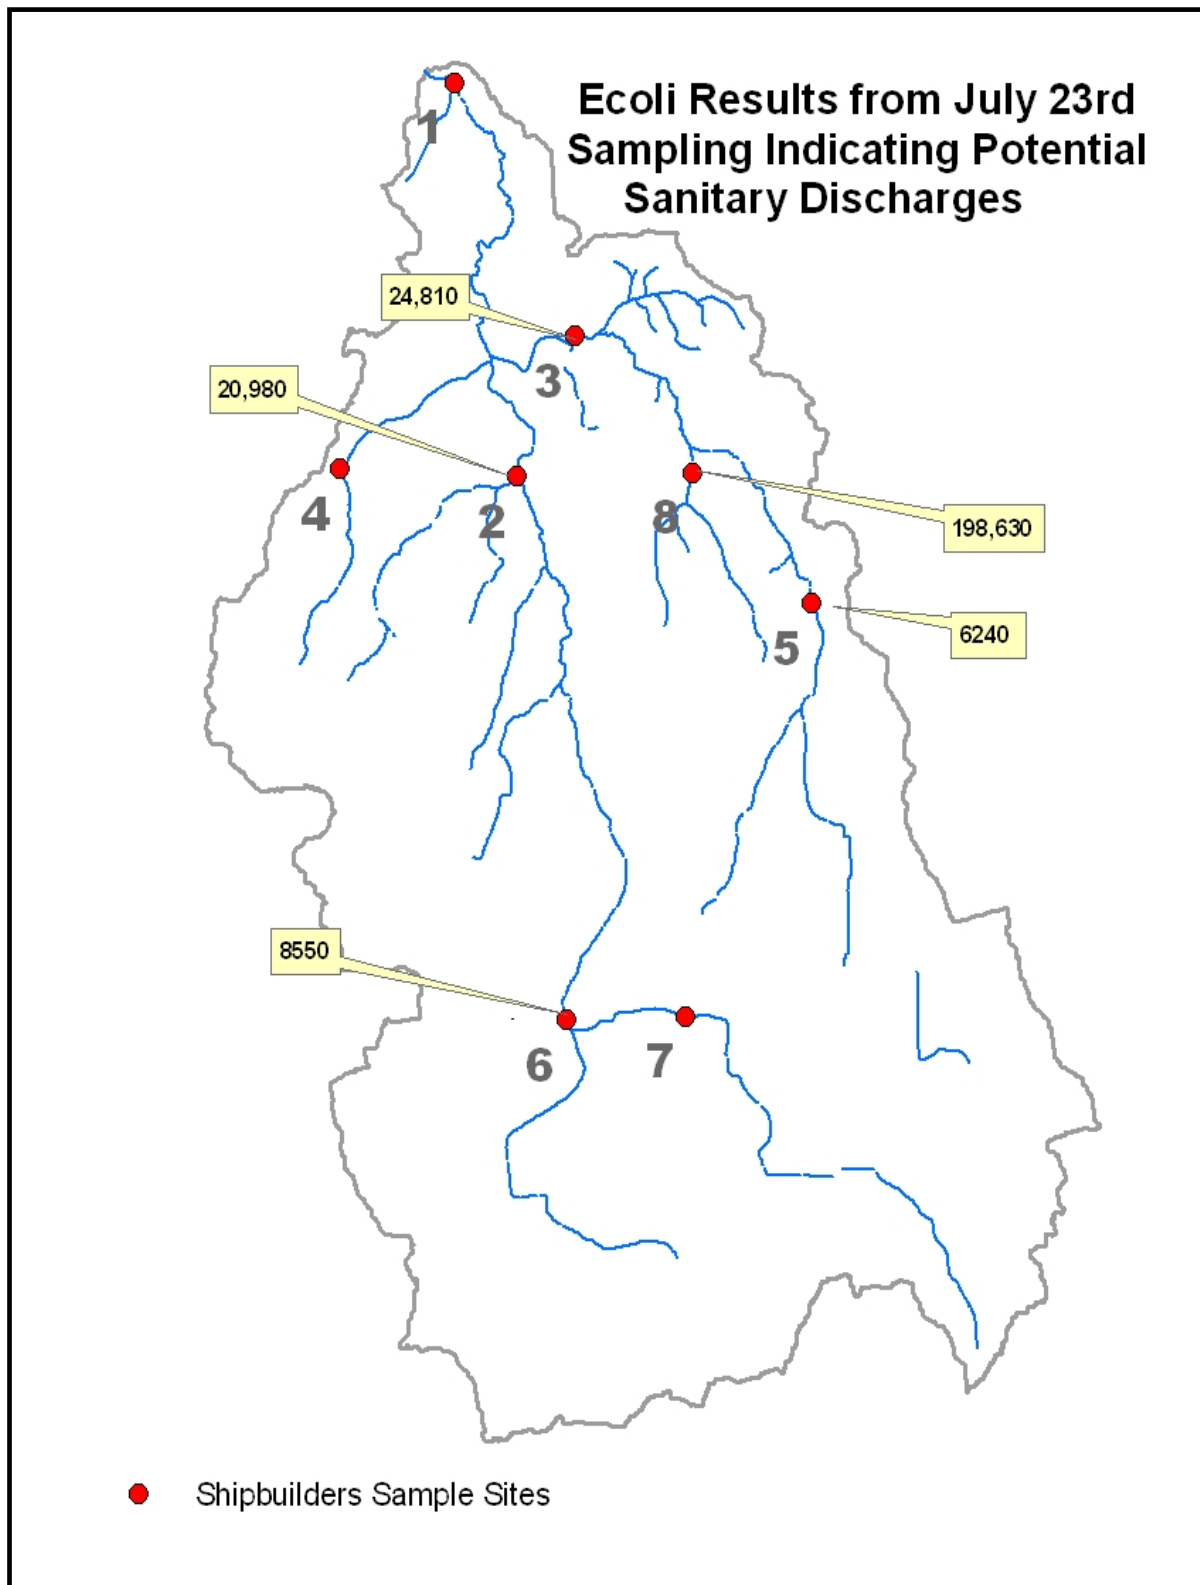
Figure 10. Ecoli Results from July 23, 2009 Rain Event (expressed in MPN/100 mL).

Figure 10 shows the Ecoli results at all stations for the July 23rd wet weather sampling. As the creek flows north through the watershed, a general decrease in water quality occurs. A notable increase in Ecoli concentrations occurred between Stations 5 and 3 on the eastern branch of the creek. The upstream Station 5 had an Ecoli value of 6240 MPN/100mL. Compare this number to downstream Station 3 where Ecoli was 24,810 MPN/100mL. This suggested a source of sanitary waste between the two stations and in fact, this was confirmed by verbal communication with Town of Webster officials. The highest Ecoli value sampled was 198,630 mpn/100mL at Station 8, on a tributary that flows into the eastern branch between Stations 3 and 5. The same pattern can be seen were a notable increase in Ecoli concentration was also found between stations 2 and 6. Both locations will be investigated further for sources of sanitary waste.

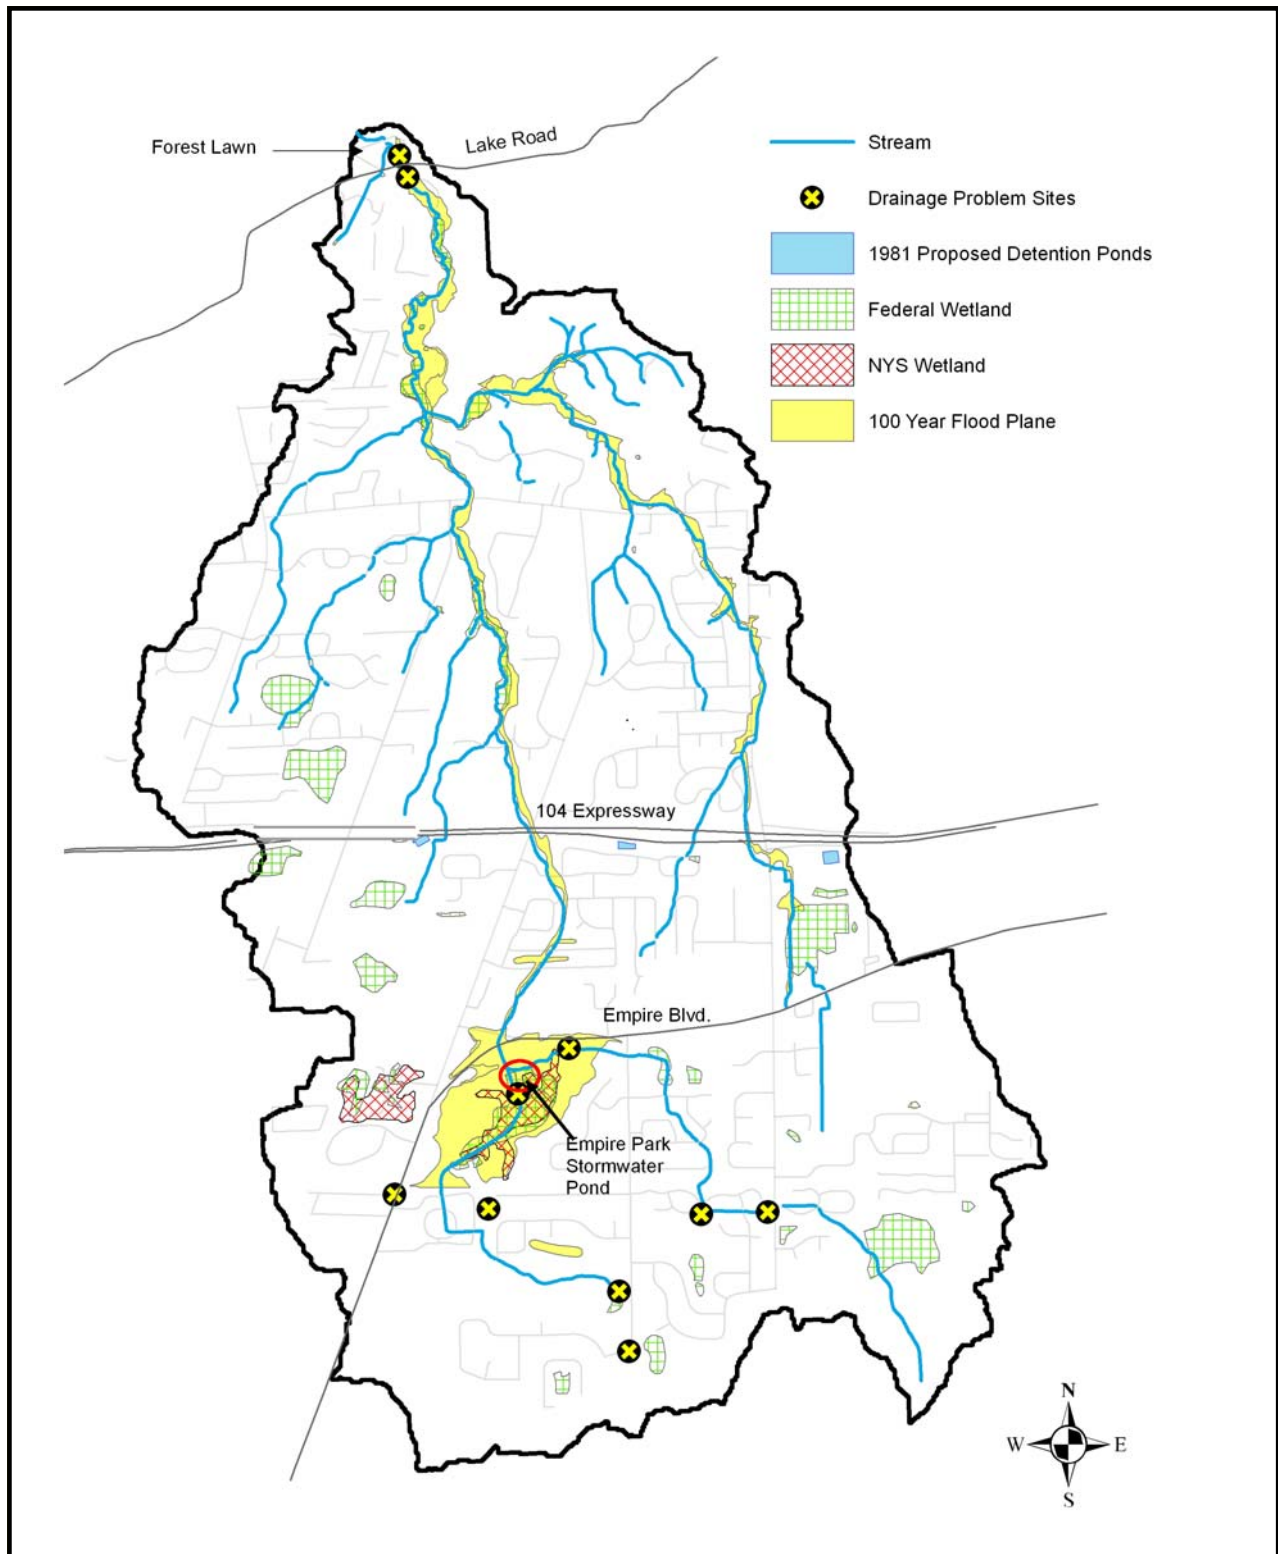
Figure 11 Shipbuilders Creek Drainage and Hydrologic Feature Areas

To illustrate the interconnectedness of these forces on the stream, Figure 11 shows identified drainage problem locations along with proposed stormwater detention ponds identified from former drainage studies, floodplains, wetlands, and stream bank erosion sites.

Penfield's drainage study of SC (MRB Group 2001), notes several locations where road cross culverts' capacity can be exceeded during large storm events which are depicted in Figure 11 as "drainage problem sites". However, few incidences of culvert overtopping have occurred due to the relatively flat topography that allows temporary storage over low-lying woods, lawns and farmland. While standing water has caused citizen complaints, interviews with town engineers note the addition of several detention ponds and modifications of existing pond discharge structures has improved the conditions here. More improvements through detention of small storm events are proposed for this upper portion of the watershed in Section 4 of this SWAAP.

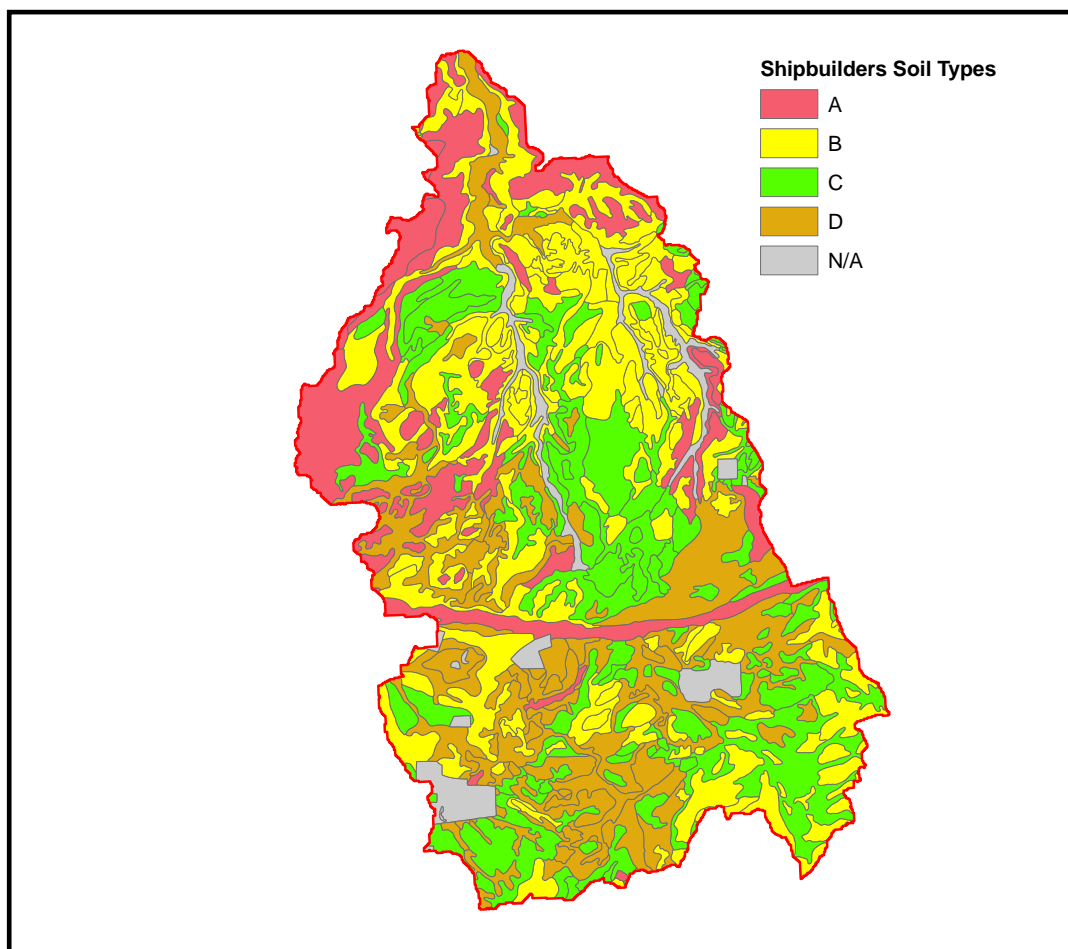
Figure 12. Shipbuilders Creek Hydrologic Soil Types

SC watershed has generally well drained soils that are defined hydrologically as "A" and "B" (where most rainwater soaks in), north of this ridge. Soils here are lacustrine deposits (from prehistoric lakes) of silt and very fine sand and, coarser glacial laid deposits. South of the ridge, the watershed soils are smaller particle sizes of clays and fine textured subsoil that are somewhat poorly drained. These soils infiltrate rainwater much slower and are defined as "C" and "D" soils (Figure 12). South of the ridge, the Creek slopes are flat to moderate and increase along some segments to the north nearing the Lake.

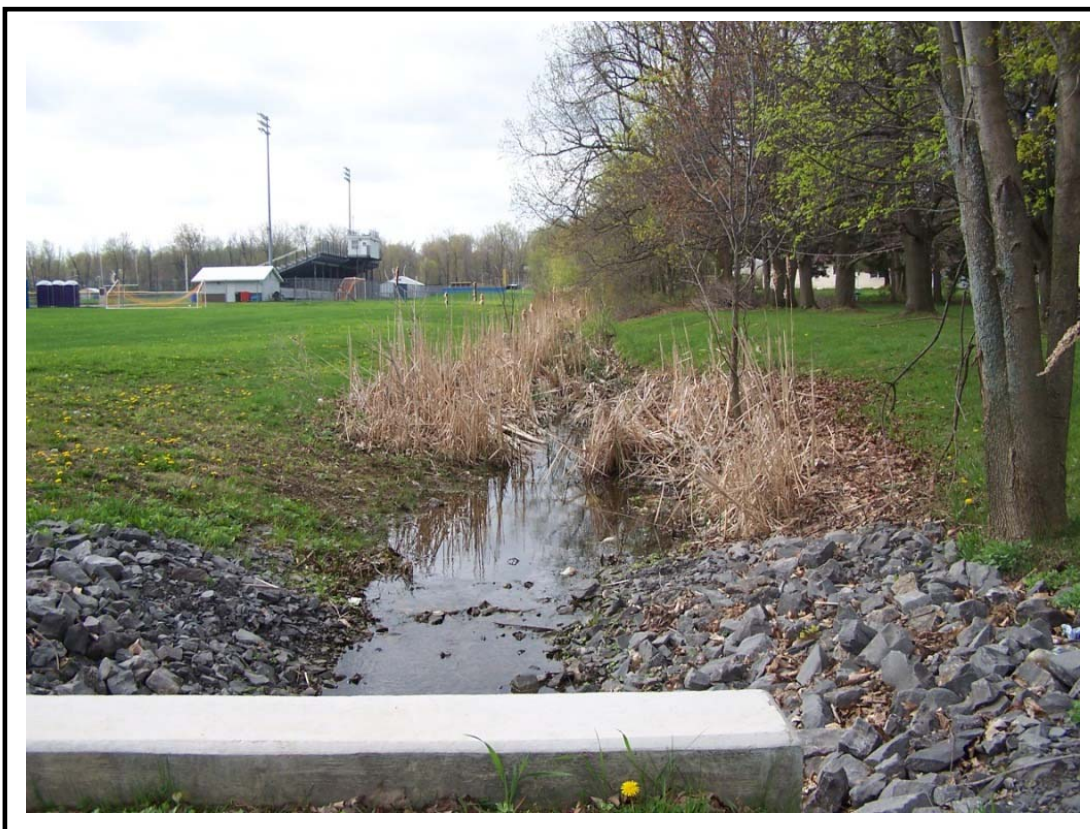
Figure 13. Impacted Buffer at Webster Schroeder High School with High Restoration Potential

Each assessed reach was given a score for reforestation potential ranging from 1-5. A score of 5 indicated that the impacted area was on public land where the riparian area does not appear to be used for any specific purpose with plenty of area available for planting. A score of 1 indicated limited restoration potential with the impacted area on private land where road, building encroachment or other features significantly limit available area for planting. There were 25 impacted reaches identified with 16 having scores of 3-5 (greatest potential for restoration). Figure 13 shows an impacted buffer in subwatershed C.

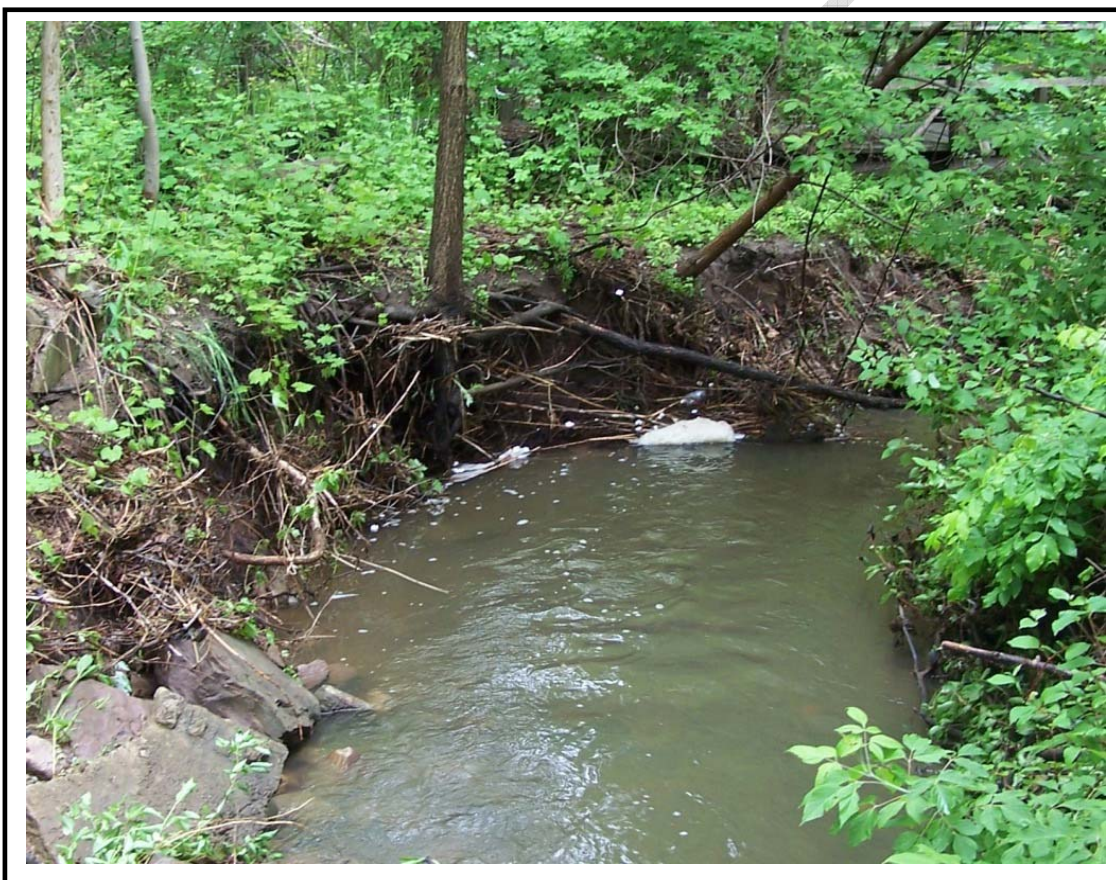
Figure 14. Active Stream Bank Erosion in Subwatershed C

Erosion severity was measured on a scale from 1-5 with a score of 5 indicating active downcutting, tall banks on both sides of the stream, eroding at a fast rate with erosion contributing a significant amount of sediment to the stream, or an obvious threat to property or infrastructure. Only 23 of the 42 erosion sites were ranked as suitable for restoration due to available access to the sites. Of the 23 suitable for restoration, 19 had a severity score of 3 or higher making them priority candidates for restoration/stabilization. Figure 14 shows an example of active stream bank erosion in subwatershed C.

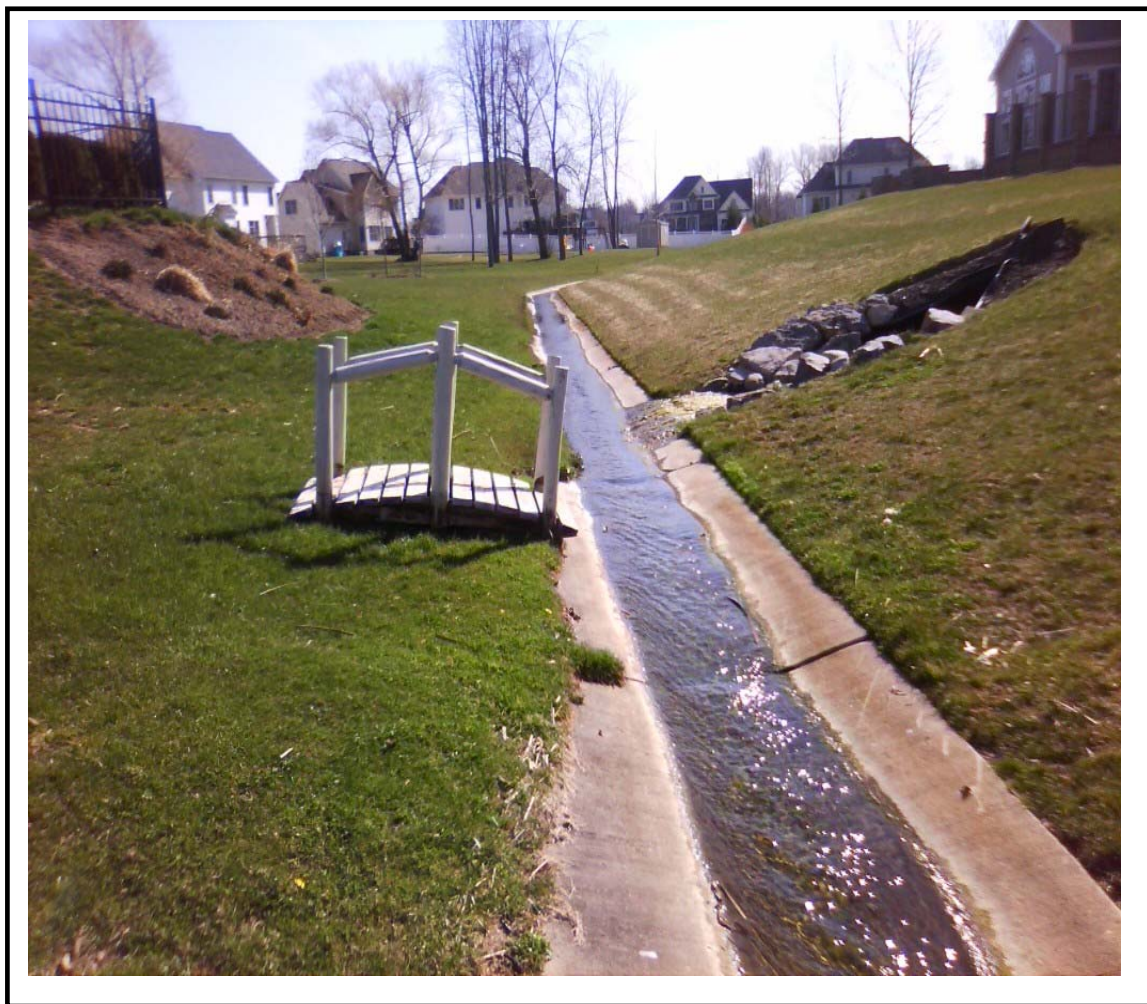
Figure 15: Channelized Stream Segment in Subwatershed E with Severity Score of 5

score of 5. Thirteen reaches were identified with channel modification with 8 of those having severity rankings of 3 or higher. All 14 are candidates for restoration.

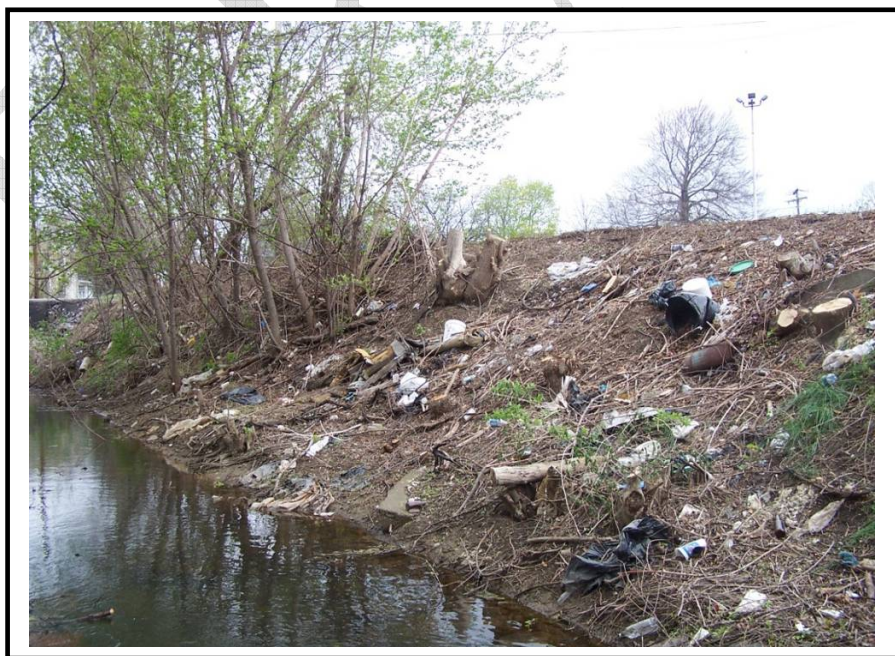
Figure 16. Trash and Debris in Subwatershed D

Six locations were identified as trash and debris hotspots. Materials found ranged from yard waste, pet waste, paper, plastic and automotive products. All locations have high potential for restoration by volunteer clean-ups, education, or removal by municipal staff. Figure 16 shows a trash hotspot in a commercial area of subwatershed D.

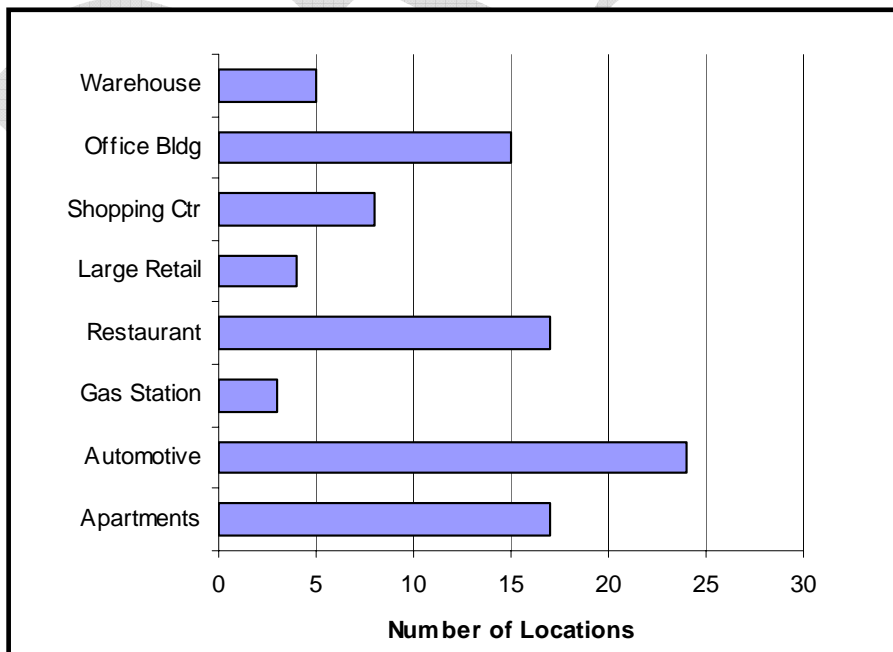
Figure 19: Shipbuilders Creek Watershed Hotspot Types

Commercial hotspots typically experience a great deal of vehicle inputs, generate waste of wash water, handle fuel or repair vehicles, or store products outside. Each type of commercial hotspot can generate its own blend of pollutants which can include nutrients, hydrocarbons, metals, trash or pesticides (CWP, 2005). Figure 19 gives a further breakdown of hotspot types in the SC watershed based on the specific property class description. Figure 20 illustrates a used cooking grease storage bin that has spilled on the ground located less than 20 feet from the stream.

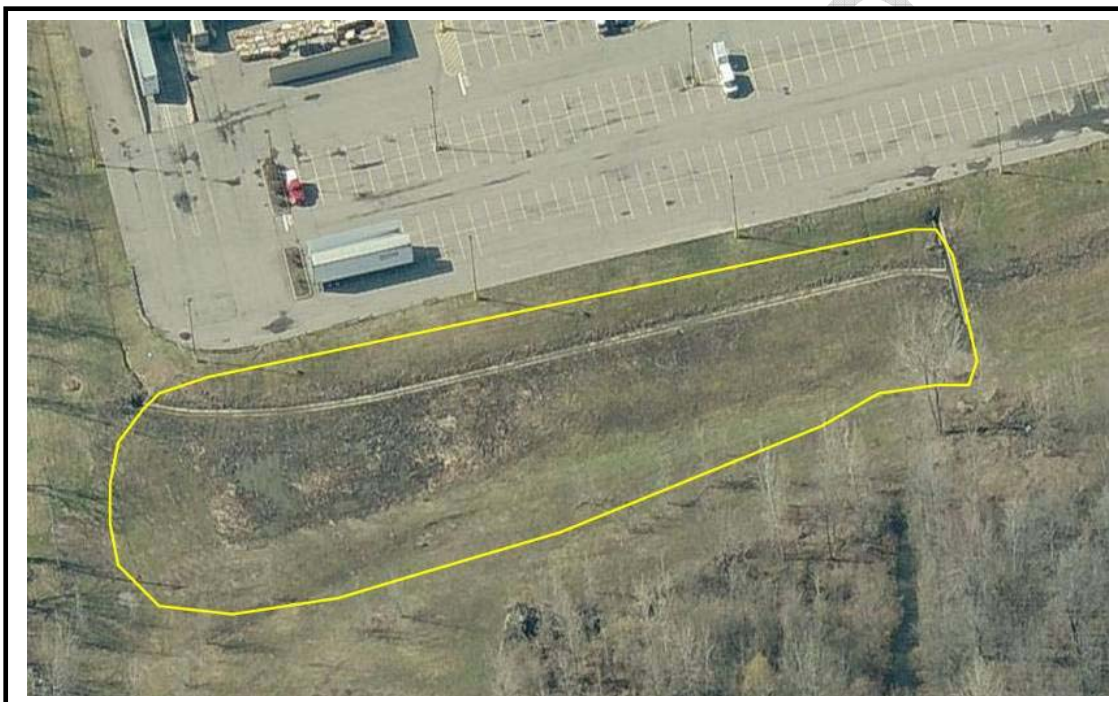
Figure 22: Proposed upgrades of conventional flood control pond in Baytown (Walmart) Plaza – Empire Blvd.

For further information on retrofitting conventional flood control ponds, see Appendix I.

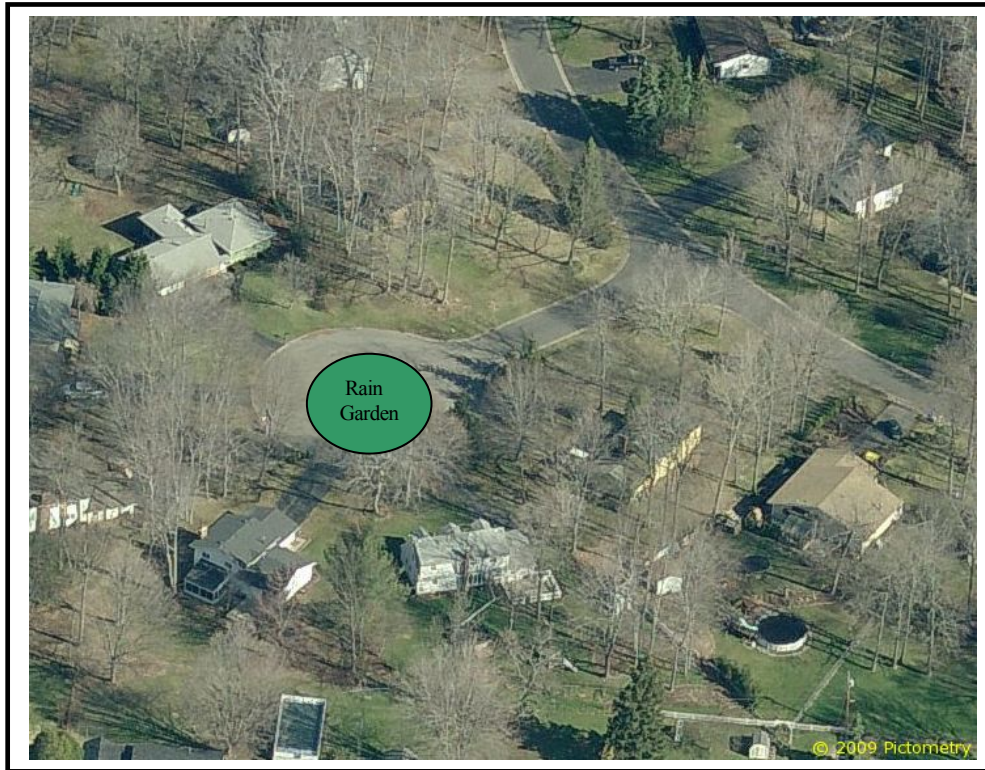
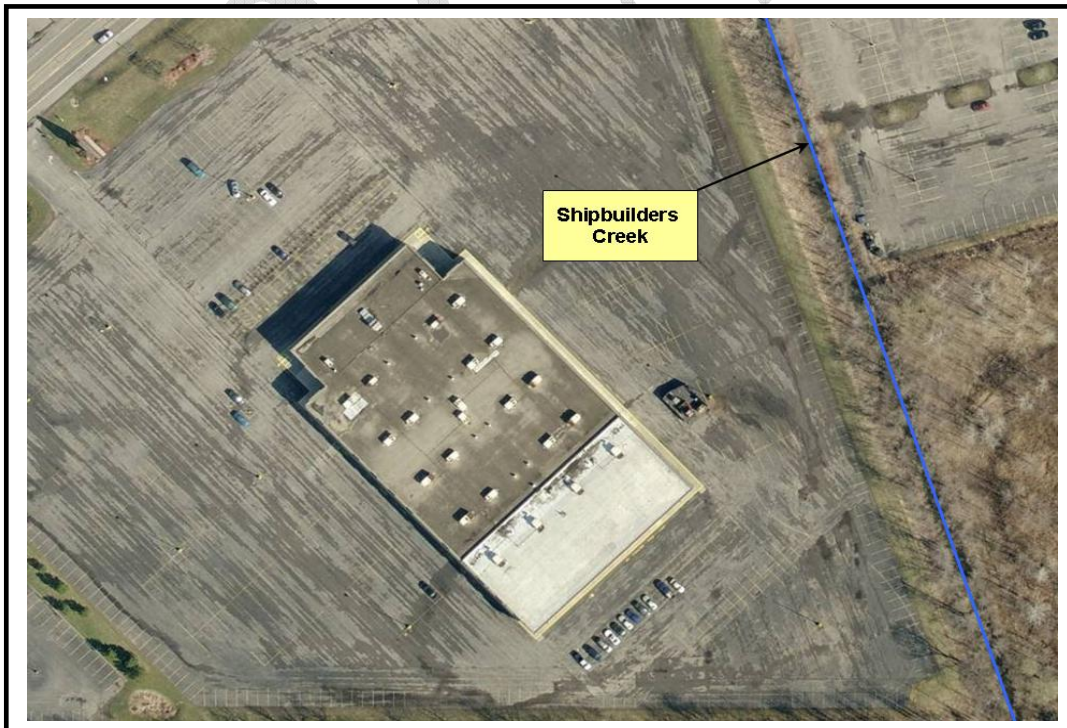
Figure 23: Proposed Cul-de-sac Rain Garden (Ironwood Cir/Sequoia Dr.)

Figures 23 – 25 are examples of potential green infrastructure practices that could be installed in the Shipbuilders Creek watershed. For further details and examples of these practices, see Appendix I.

Figure 24: Proposed Vegetated Bioretention Swale at Lowes Theatre

Figure 25: Proposed Impervious Cover Reduction at Lowes Theatre

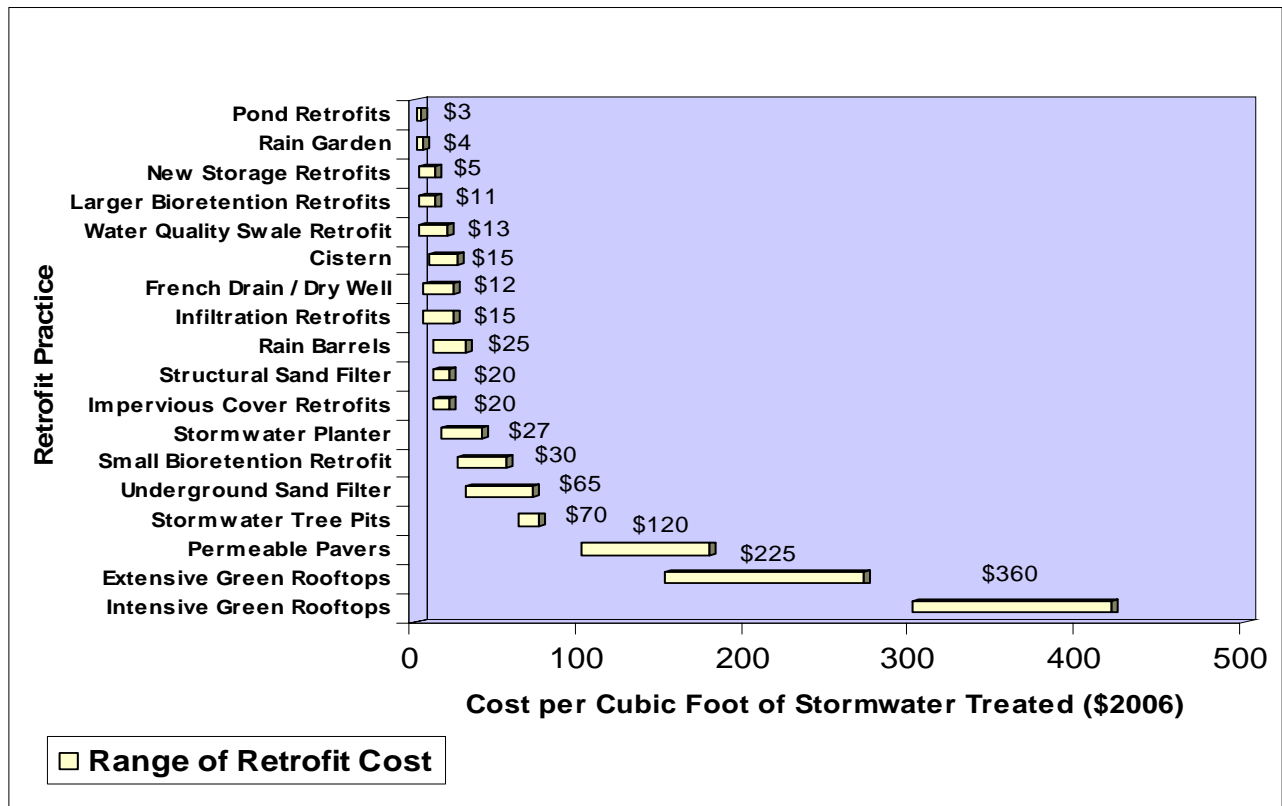
Figure 26. Range of Stormwater Retrofit Costs (Center for Watershed Protection)

1. Highly cost effective projects were those ranging from \$1 to \$11 and were given three points.
2. Median cost effective projects were those ranging from \$12 to \$25 and were given two points.
3. Low cost effective projects were those ranging from \$26 and \$100 and were given one point.
4. All other project types were not ranked – excluding for example green roofs.
