Shipbuilders Creek Stormwater Assessment and Action Plan

Monroe County
Department of Environmental Services
444 E. Henrietta Rd.
Rochester, NY. 14623

Shipbuilders Creek Stormwater Assessment and Action Plan is a
Pilot plan of the Monroe County Stormwater Action Plan

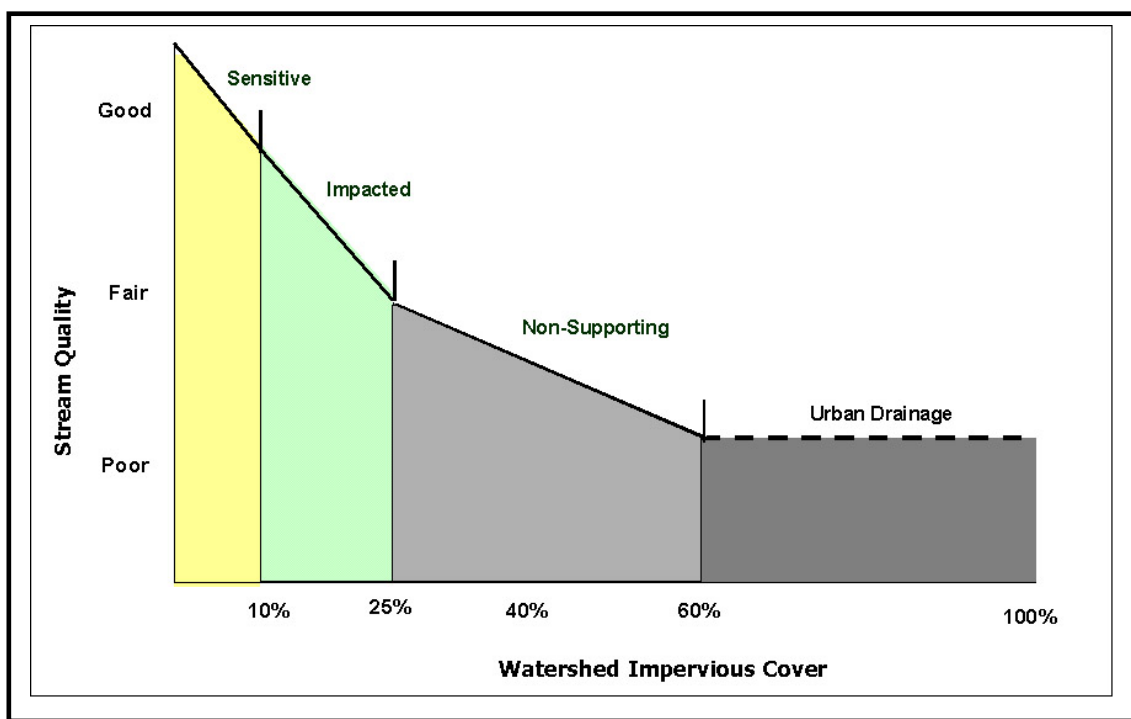
Taking all the research together, it is possible to construct a simple urban stream classification scheme based on impervious cover and stream quality. This simple classification system contains three stream categories, based on the percentage of impervious cover. Figure B1 illustrates this simple, yet powerful model that predicts the existing and future quality of streams based on the measurable change in impervious cover.

The model classifies streams into one of three categories: sensitive, impacted, and non-supporting. Each stream category can be expected to have unique characteristics as follows:

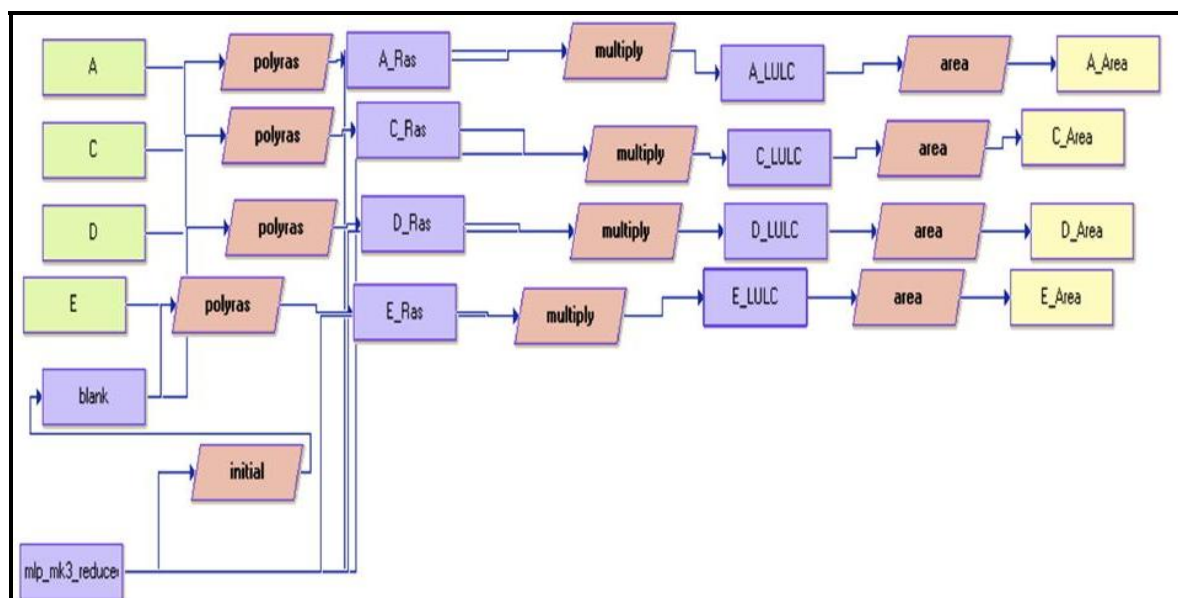
Figure C 4 The IDRISI Model for Extracting the Sub-watersheds

To make the different coverages for the Shipbuilders Creek Watershed I used a Boolean extraction method in IDRISI Andes. This method entailed extracting each sub-water polygon and converting it to a raster. From there the raster was multiplied leaving only the sub watershed. Then the area was calculated for each remaining area. The model below is the actual IDRISI model for the extraction. The model is similar to writing a script but you can see graphically what is going on and it allows you to inspect the steps before running.

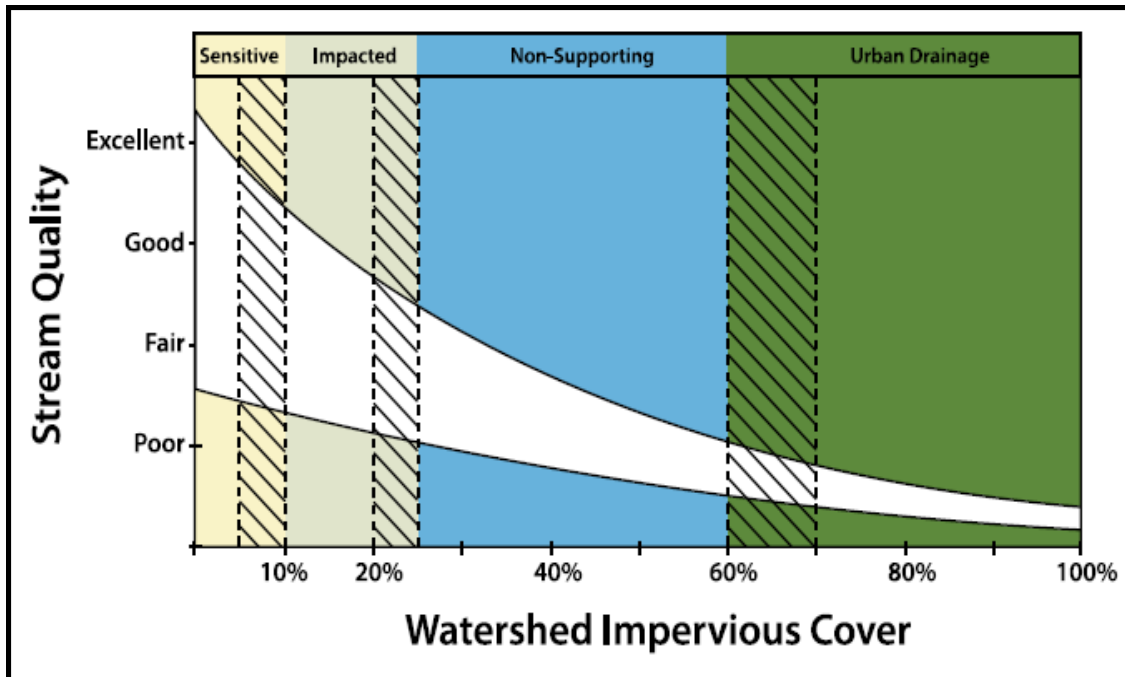
Figure G 1

The relationship between subwatershed impervious cover (IC) and stream quality indicators can be predicted by the ICM, which is based on hundreds of research studies on first to fourth order urban streams (CWP, 2003). It is important to keep in mind that the Impervious Cover Model (ICM) is a guide and not a guarantee: ICM stream indicator predictions are general, and will not apply to every stream within the ICM classification. Urban streams are notoriously variable, and factors such as gradient, stream order, stream type, age of subwatershed development, and past management practices can and will make some streams depart from these predictions. In general, subwatershed IC causes a continuous but variable decline in most stream indicators in a stream category. Therefore, the severity of impacts tends to be greater at the high end of the IC range within each stream category.
