Buckland Creek Stormwater Assessment and Action Plan

Buckland Creek Stormwater Assessment and Action Plan is a pilot plan of the Monroe County
Stormwater Master Plan

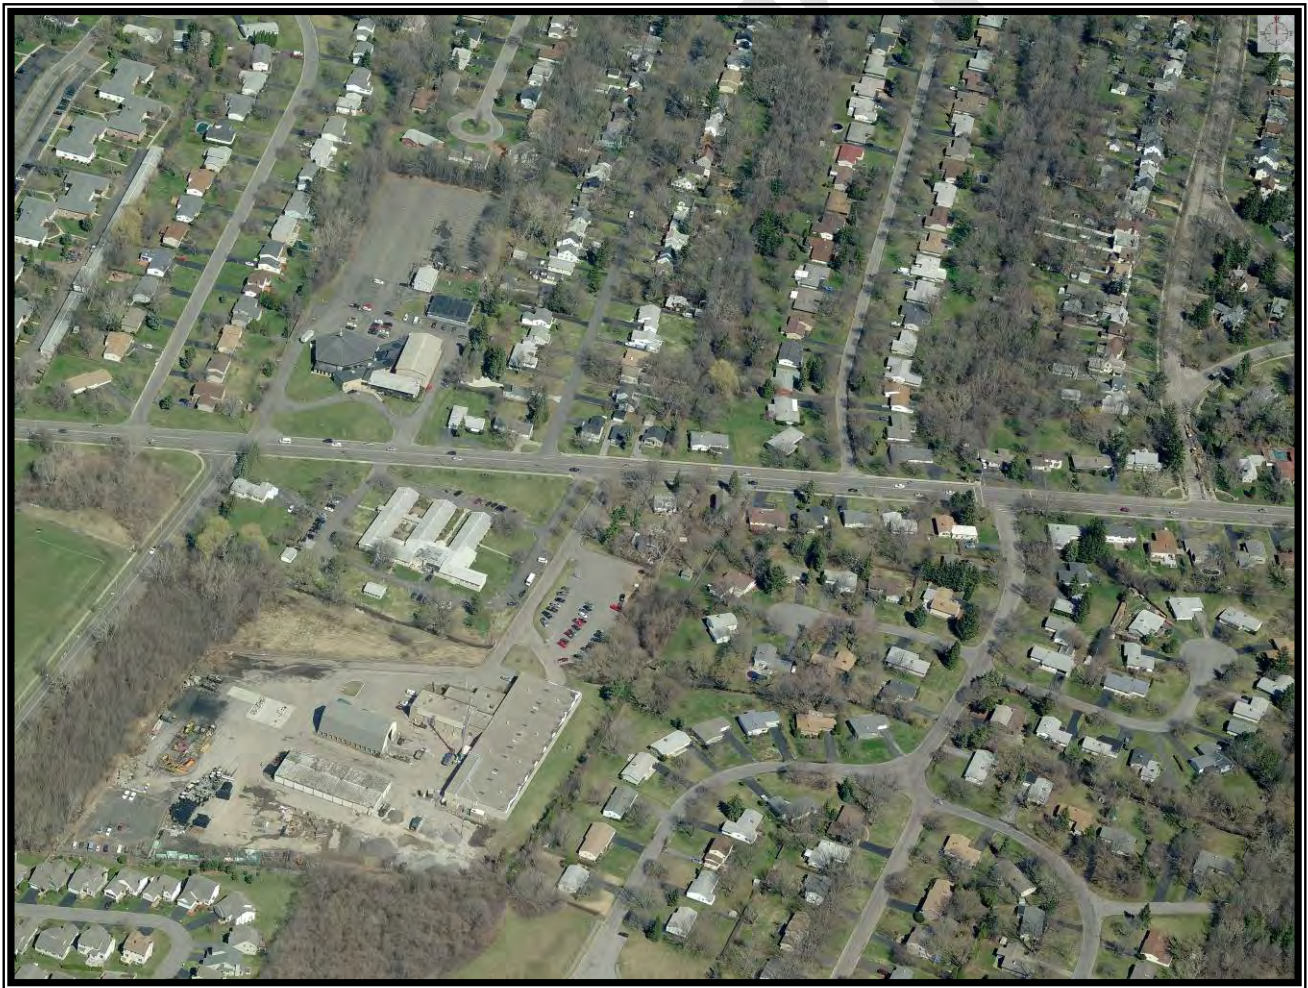
Figure 1. Highly developed nature of the Buckland Creek Watershed

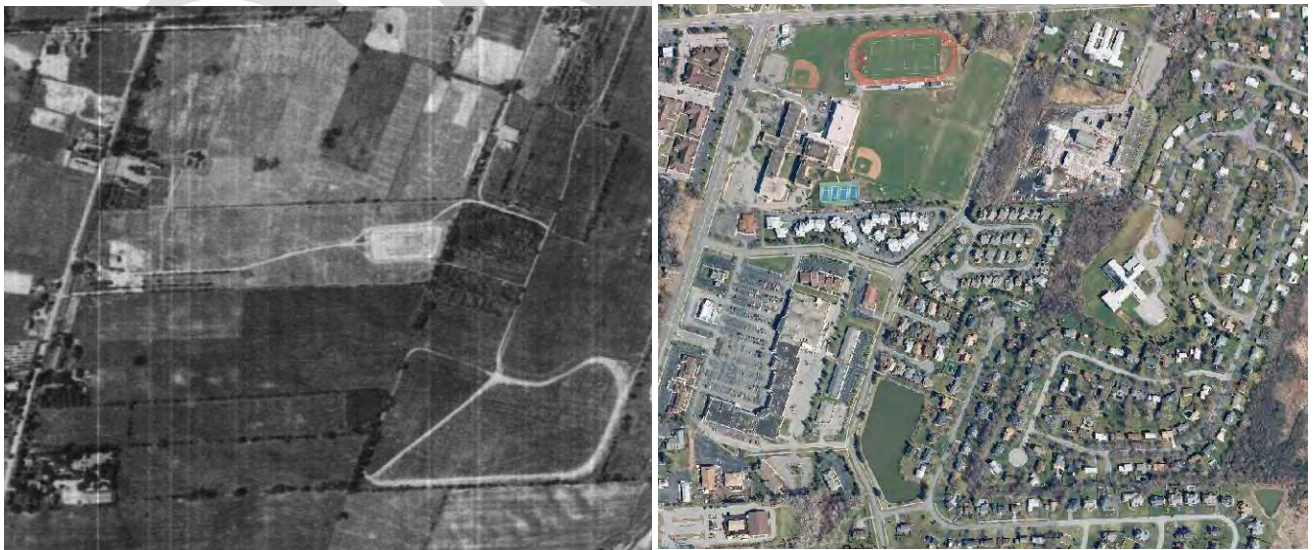
Figure 3. Comparison of land use in Buckland Creek Watershed - 1930 (left) and 2009 (right). Photos are of the Elmwood and South Clinton Avenue area (Town of Brighton).

A comparison of land use through aerial photos from 1930 and 2009 illustrates the increase in land development (see Figure 3). New homes were built as well as schools and commercial areas, replacing agriculture along the southeastern edge of the City of Rochester.

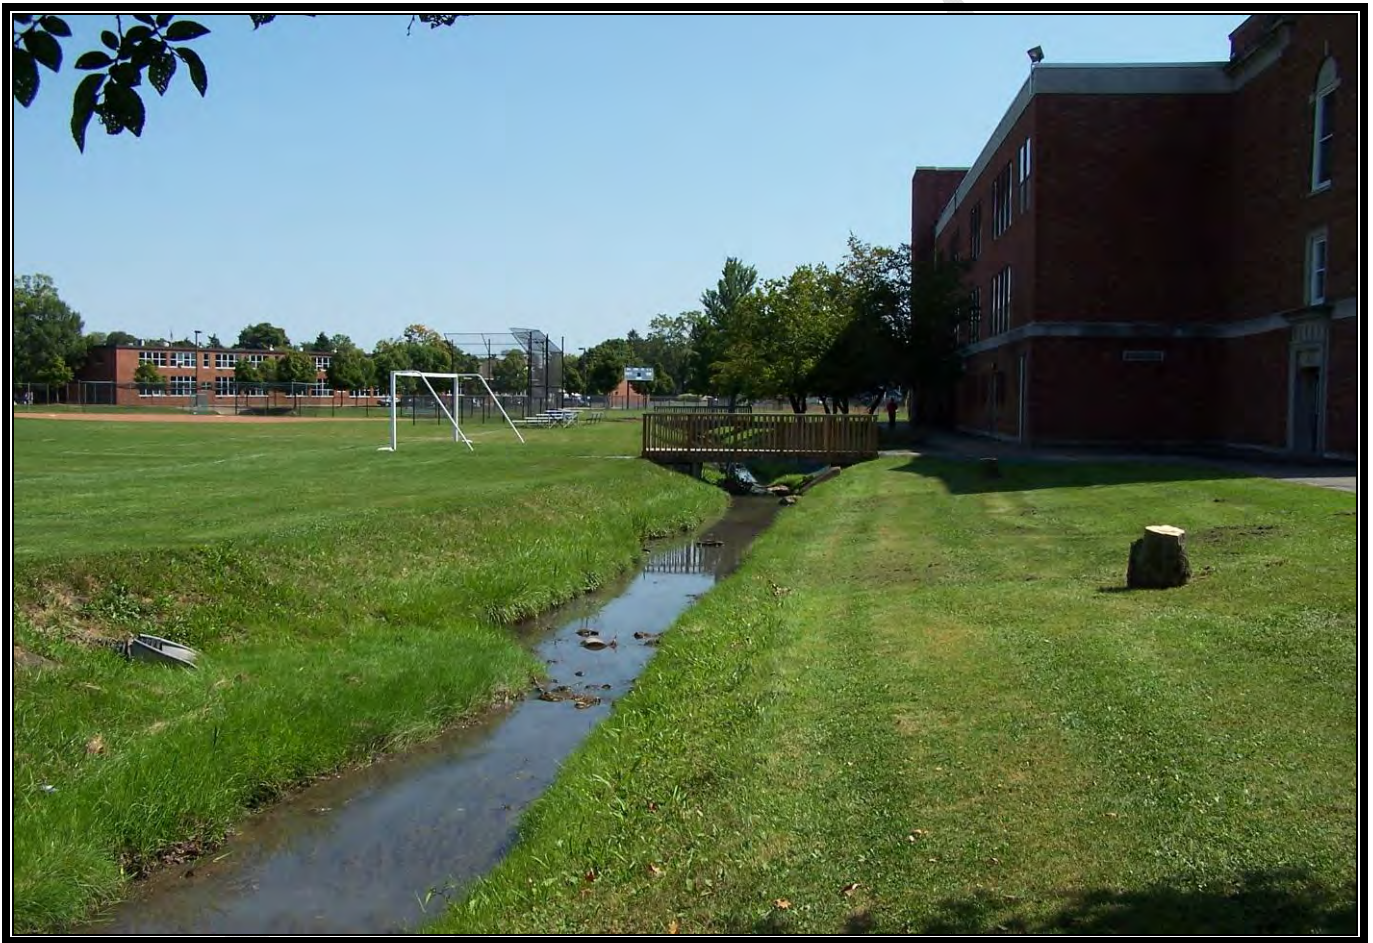
Figure 13. Channelization of Buckland Creek looking east from Winton Road

Channelization has, in some cases, both widened the stream and required the banks to be artificially armored. From a water quality perspective, a wide stream channel causes shallow, slow flow heating water in the summer which depletes oxygen since warm water holds less dissolved oxygen. Aquatic fauna breathe dissolved oxygen so measuring its concentration is one indication of a stream's aquatic health. Fish, insects, zooplankton, phytoplankton, and other aquatic species all have a preferred temperature range. If temperatures get too far above or below this preferred range, the number of individuals of the species decreases until finally there are none. Most aquatic organisms begin to feel stress at stream temperatures above 70° Fahrenheit. Figures 11 and 12 show dissolved oxygen and temperature data respectively provided by Brighton High School students sampling data. Samples were taken at the Brighton Twelve Corners School Campus (see Figure 13). This location has numerous problems. The stream reach has been channelized, armored and has no riparian corridor throughout the Campus making the stretch unsuitable habitat for benthic macroinvertebrates. In another example, the habitat was suitable for macroinvertebrates, but the population was tolerant of poor water quality, showing that the location may have been subjected to pollutants recently. This data should be supplemented with more summer months (outside of the school year when no data is available at the time of this writing).

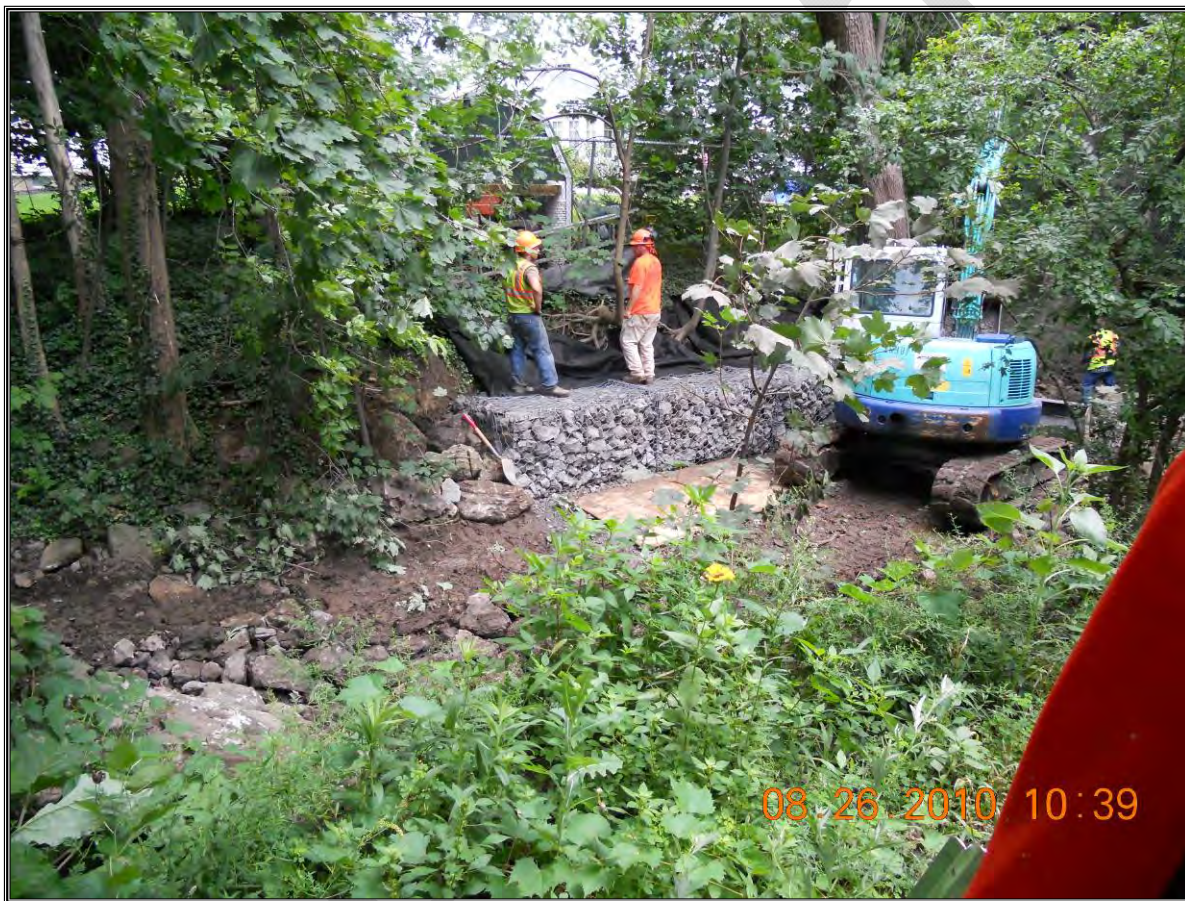
Figure 14. Stream Bank Erosion site being stabilized with rock-filled gabion baskets

Extensive bank erosion and channel headcuts are expected in urban subwatersheds. Trimble (1997) estimated that more than half the sediment loads from highly urban watersheds were derived from eroded stream banks. The low-gradient of the stream has reduced these typical effects however, erosion problems are present and mainly consist of stream widening (as opposed to headcutting- prevalent on streams with steeper slopes). The erosion severity was measured on a scale from 1-5 with a score of 5 indicating eroded banks on both sides of the stream, eroding at a fast rate with erosion contributing a significant amount of sediment to the stream, and an obvious threat to property or infrastructure. Figure 14 shows an example of active stream bank erosion in Brighton where a town crew is installing about 30 feet of gabion baskets to prevent damage to a nearby home foundation.

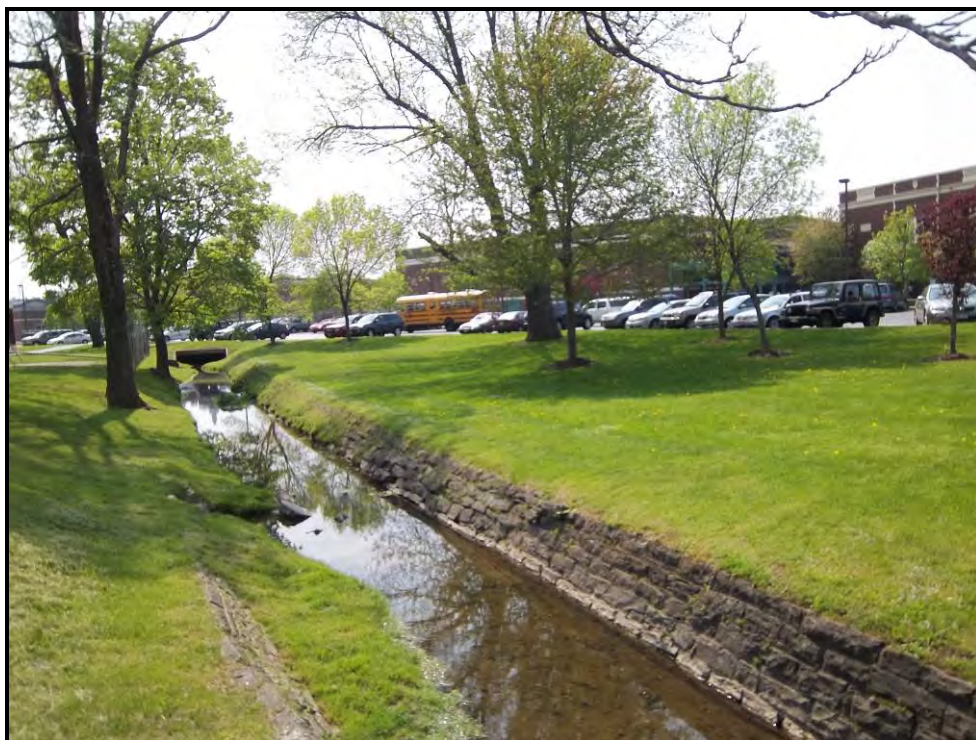
Figure 15: Channelized Stream Segment with Severity score of 5

As with erosion and buffers, channel modification was measured for severity and restoration potential. The highest level of severity indicates a long section (>500 ft) with very shallow channel water and no natural sediments present in the channel. Without question, the most severe case of channel modification in Buckland Creek is the segment that is piped under Elmwood Avenue after it flows through St Johns Meadows and runs eastward crossing under Clinton Avenue. Figure 15 is an example of a stream reach on Buckland Creek with a severity score of 5. Thirteen reaches were identified with channel modification with 8 of those having severity rankings of 3 or higher. All 14 are candidates for restoration.

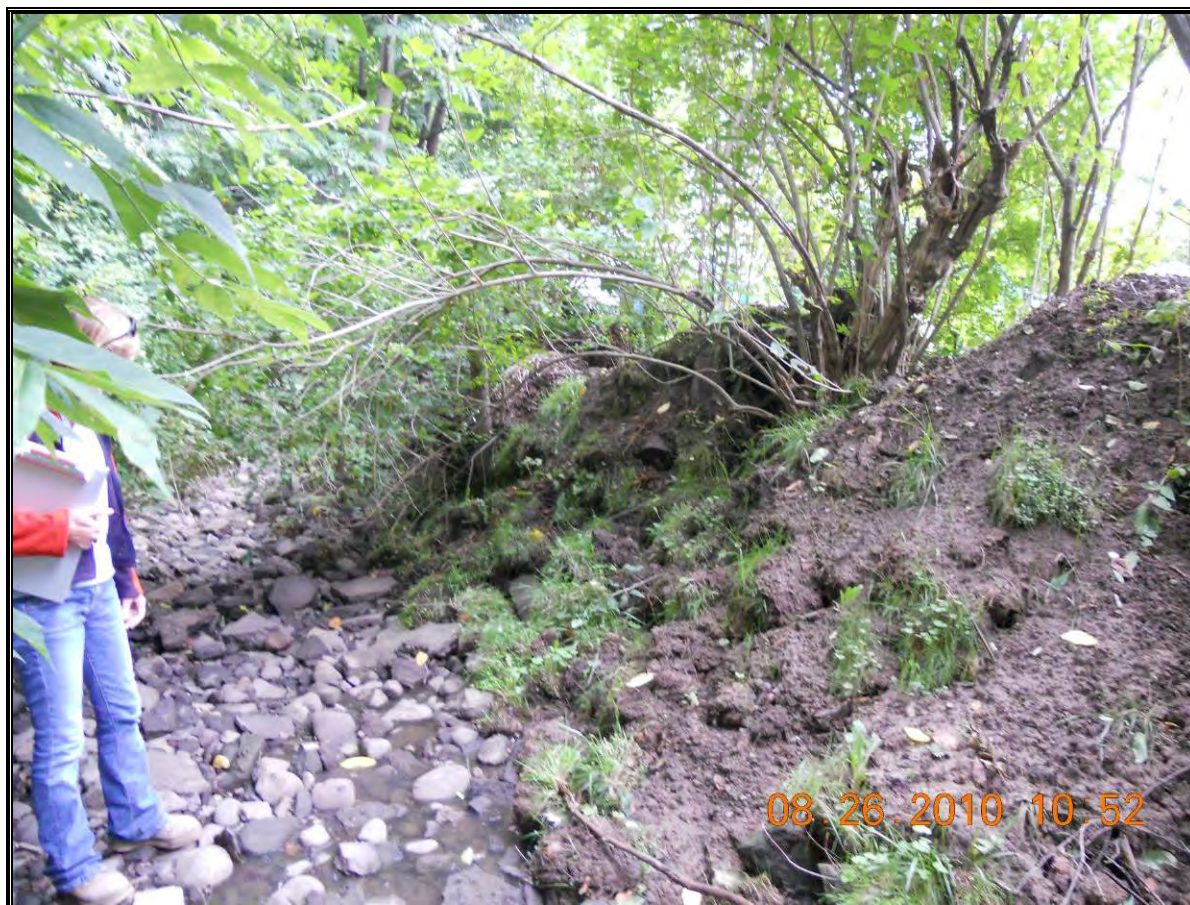
Figure 16. Trash and Debris – sod and topsoil wasted along the stream's bank and bed in Brighton.

Three locations were identified as trash and debris spots all from yard waste where the stream flows through residential neighborhoods. The fact that highly-urbanized Buckland Creek does not suffer from excessive trash likely speaks to an educated citizenry and active municipality. A proposed action of this SWAAP is to increase the residents' awareness that yard waste is indeed a pollutant that adds pollutants to the stream, namely nutrients and decreases dissolved oxygen through the biological break down of organic substances by microorganisms. Figure 16 shows yard waste and topsoil dumped in creek bed in a residential area of Brighton.

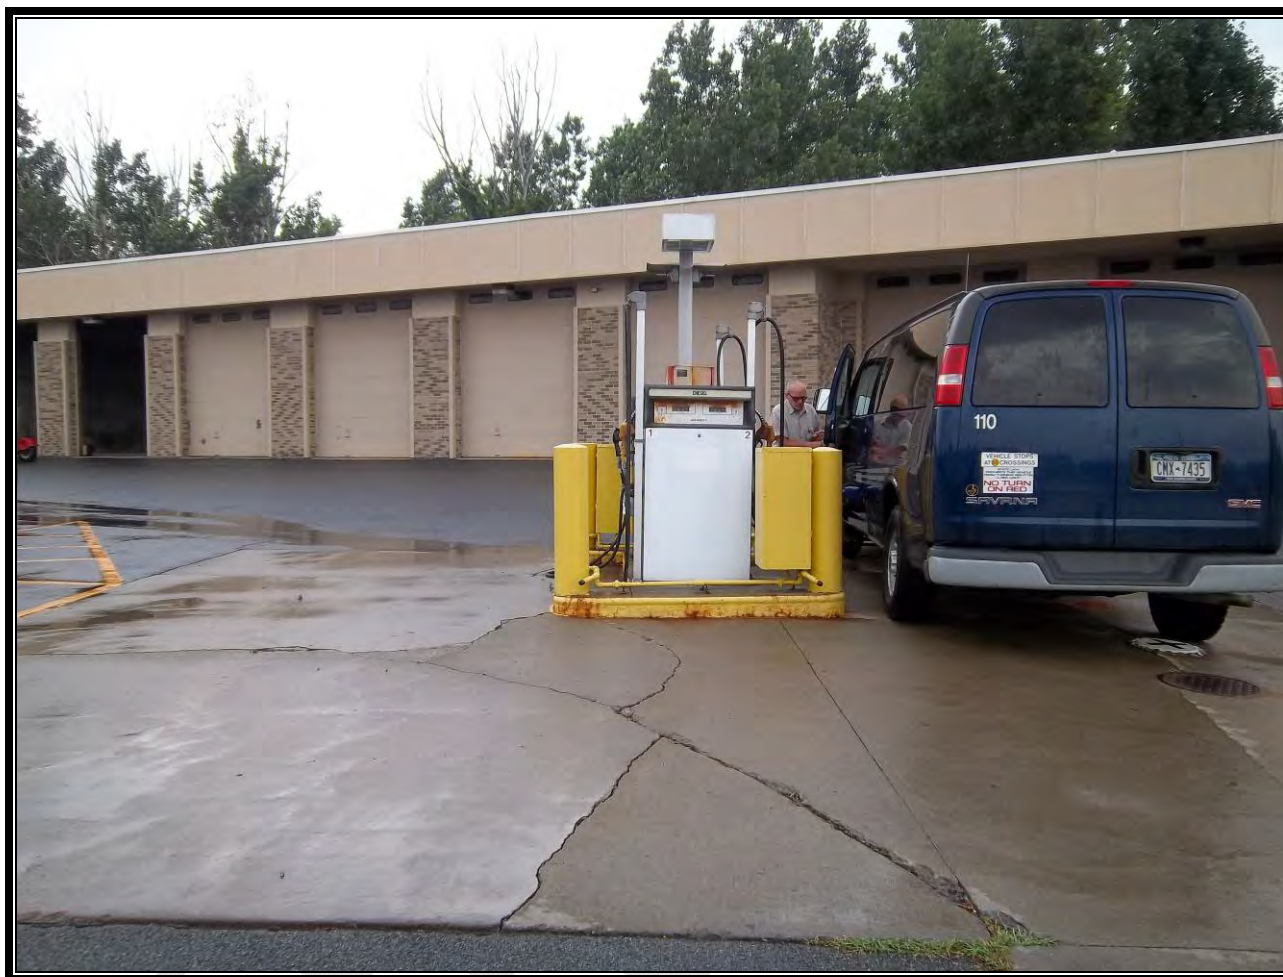
Figure 17. An example of a potential watershed Hotspot in Buckland Creek – an uncovered fueling station

uncovered fueling station and vehicle repair shop can generate hydrocarbon pollutants that travel to nearby Buckland Creek.

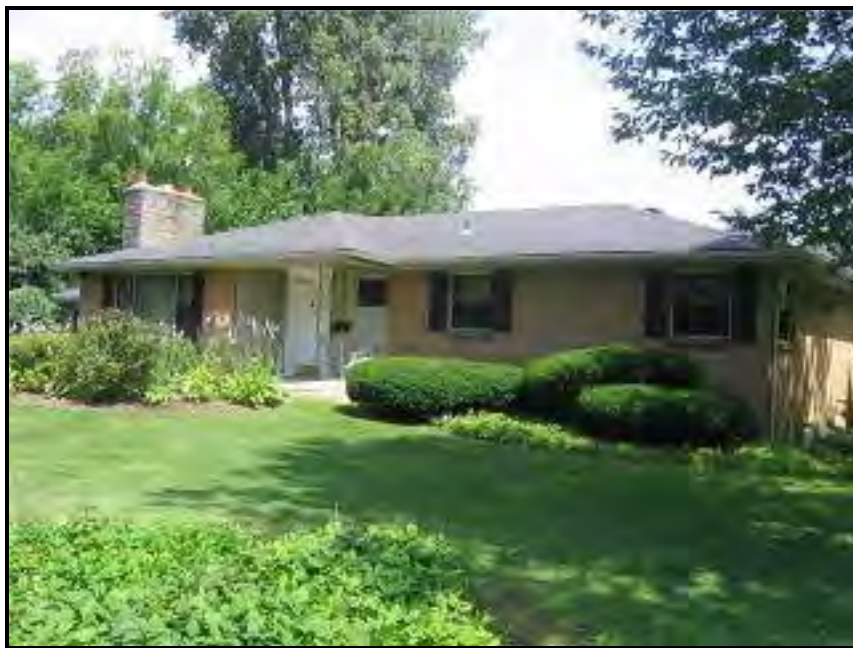
Figure 18. A residential neighborhood identified for its highly manicured lawns

One location that provides an example of how the neighborhood assessment was used to determine land use impacts to Buckland Creek is the Elmwood Heights neighborhood in Brighton built in 1950s. The neighborhood has well manicured lawns, indicative of large inputs of lawn care chemicals (see Figure 18).

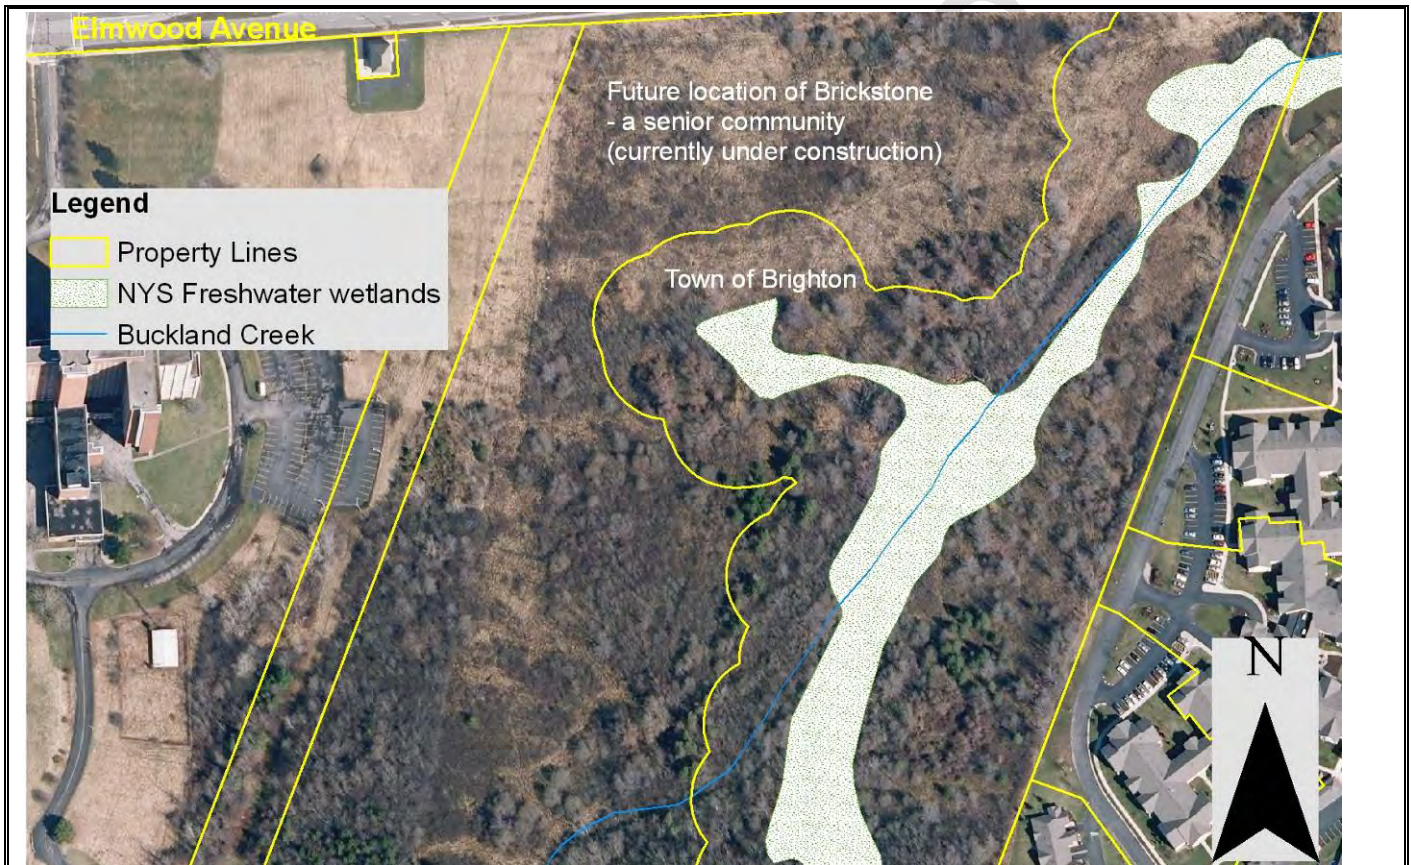
Figure 19. Parcel currently under construction located in the headwaters of Buckland Creek

Woodlands are the most beneficial land use for stream health, especially those adjacent to streams. Woodlands act like a sponge, soaking up typically all but five percent of all the annual stormwater they receive. As stormwater becomes groundwater, soils slowly ration water, over time, to the stream - helping to minimize dry stream beds thereby promoting perennial aquatic habitat. To protect Buckland Creek, future development will need to incorporate infiltrating stormwater management practices and protect the remaining wooded stream corridors.

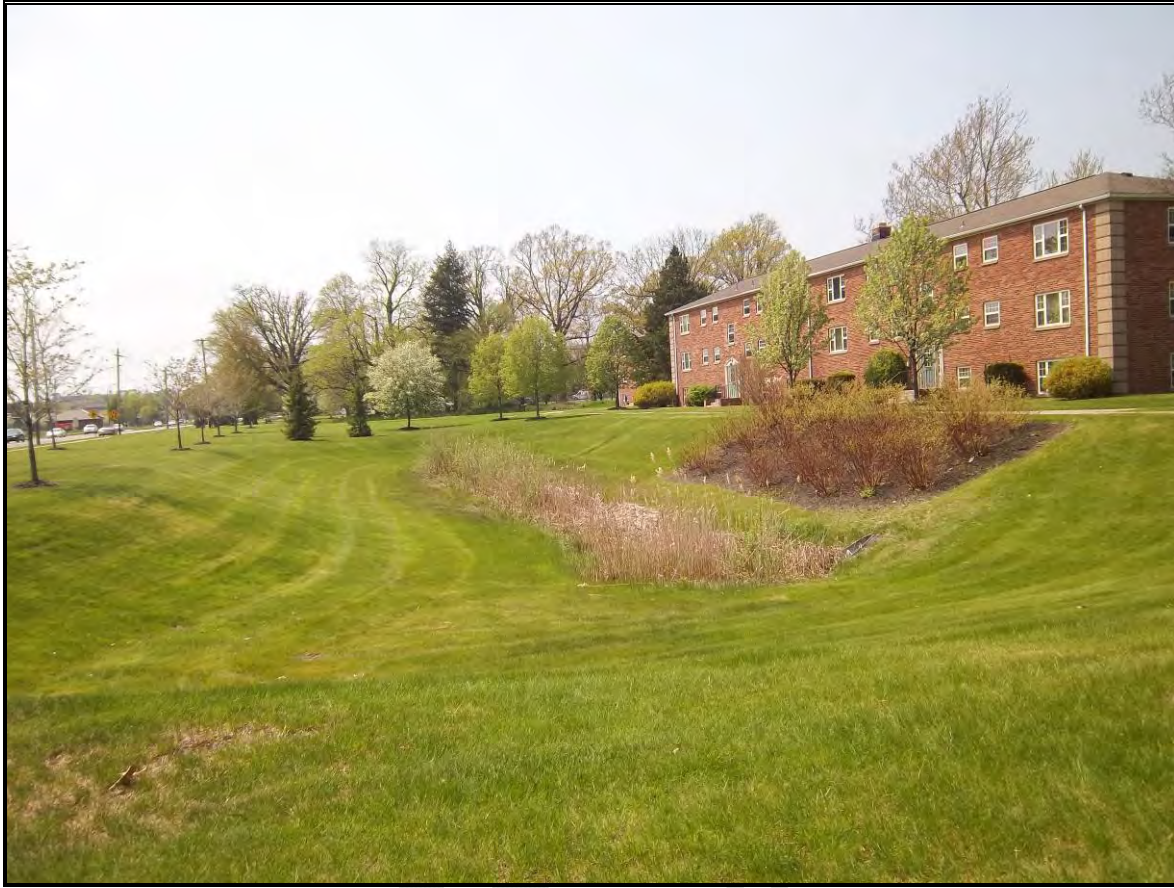
Figure 20. Potential Retrofit of a Conventional Flood Control Pond on Elmwood Avenue in Brighton

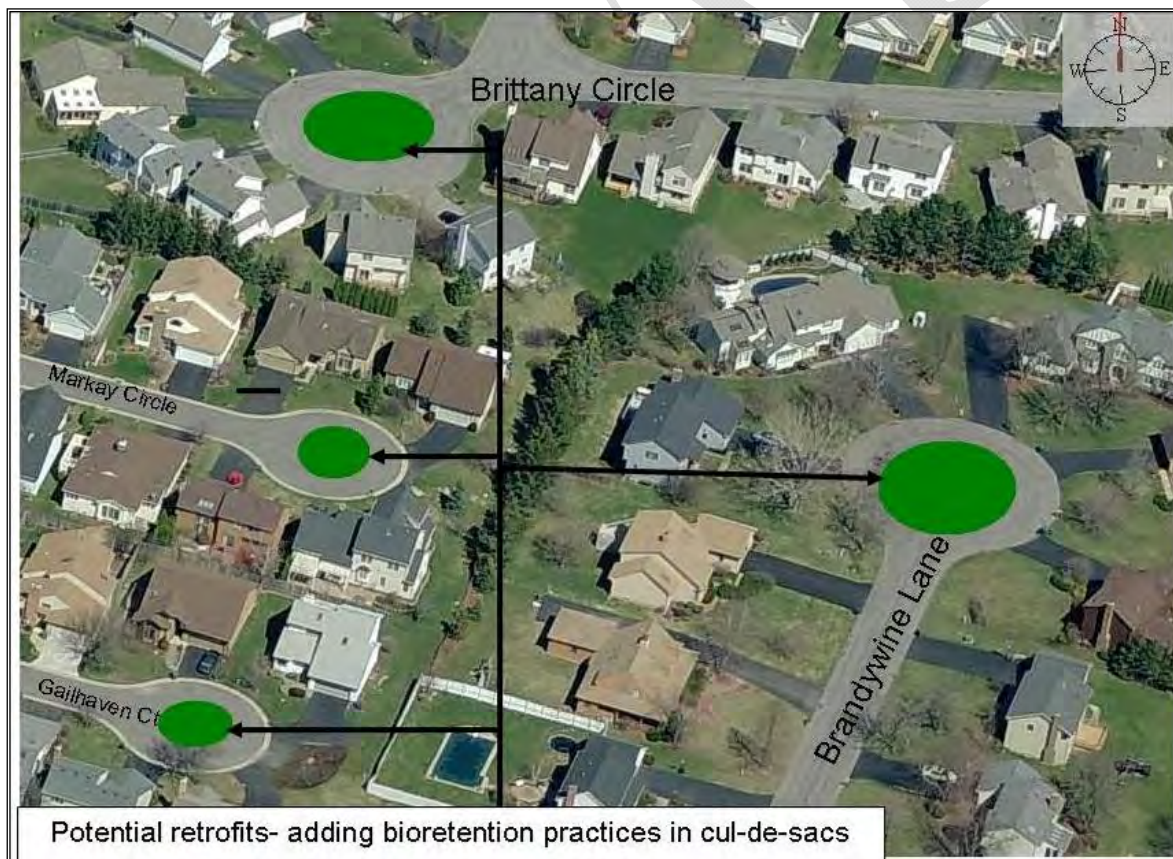
Figure 22: Proposed Cul-de-sac Bioretention in Brighton

A basic bioretention detail is shown in Figure 21 and potential retrofit projects in the watershed are shown in Figures 22.

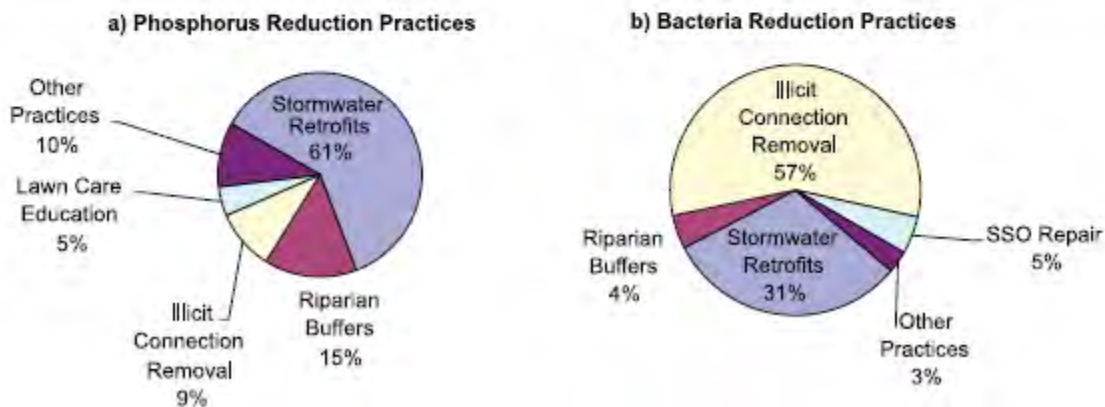
Figure 4. Estimated pollutant removal attributable to various management practices for phosphorus (a) and for bacteria (b).

Total Phosphorus (kg/year)			Fecal Coliform (billion/year)		
	Load Before	Load After	Reduction (%)	Load Before	Load After	Reduction (%)
Urban Land	2,433	2,054	16%	919,641	742,213	19%
Active Construction	14	8	42%	-	-	-
SSOs	29	27	8%	291,960	270,063	8%
Channel Erosion	472	463	2%	-	-	-
Rural Land	187	187	0%	22,924	22,924	0%
Livestock	22	22	0%	1,600	1,600	0%
Open Water	3	3	0%	-	-	-
Illicit Connections	44	0	100%	256,238	-	100%
Septic Systems	62	48	22%	32,906	25,886	21%
Total Storm Load	3,090	2,695	13%	1,090,145	901,769	17%
Total Non-Storm Load	176	118	33%	435,124	160,917	63%
Total Load to Surface Waters	3,266	2,812	14%	1,525,269	1,062,686	30%
