Green Infrastructure Rapid Assessment Plan Glen Haven Creek

**The Stormwater Coalition of Monroe County
and Monroe County Department of Environmental Services**

New York State Environmental Protection Fund

June 2013

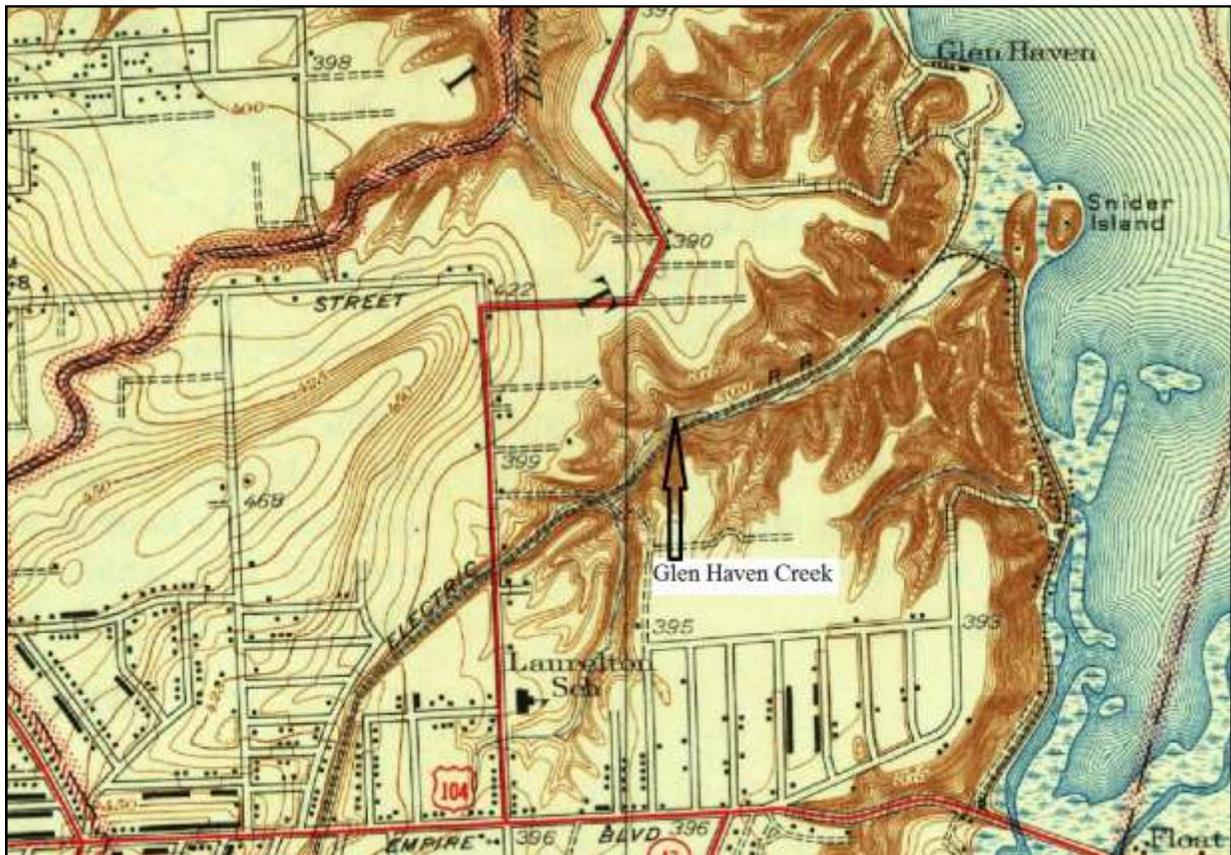
Figure 1: 1935 USGS map showing rail line to Glen Haven

This tributary has no name on record. For this report, it was given the name Glen Haven Creek because it discharges at a point bar where the famous Glen Haven Hotel once stood on the shore of Irondequoit Bay (Figure 1). The Creek originates in the northeast portion of the city of Rochester NY, flows northeasterly through the town of Irondequoit, down a long embankment of mature hardwood to Irondequoit Bay (Figure 2). Approximately half of its length is protected in Irondequoit Bay Park West—a 147 acre county park. The actual watershed size of 885 acres is considerably smaller than would naturally drain to this watershed since a portion drains to the Rochester Combined Sewer System (see “Combined Sewer System” section 1.4.1 below). The watershed’s predominate land use is residential with some commercial area along Empire Blvd (Figure 3). There is 50 percent impervious cover and most of its length piped. Table 1 lists other relative watershed statistics. piped.

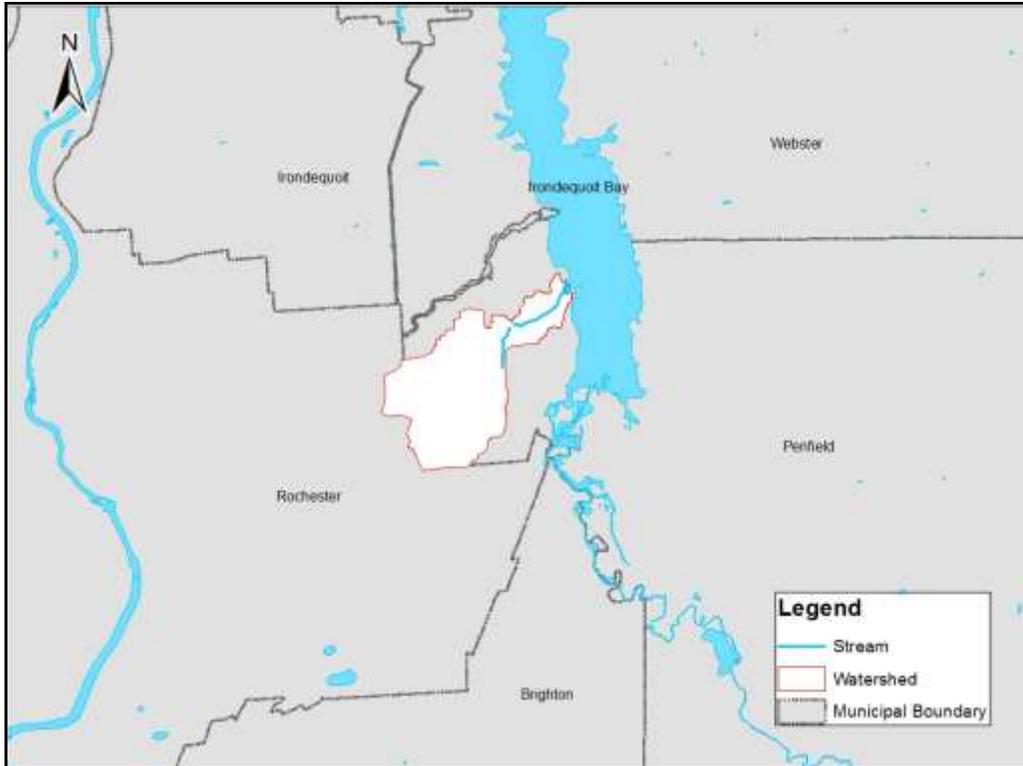
Figure 2: Glen Haven Creek Watershed.

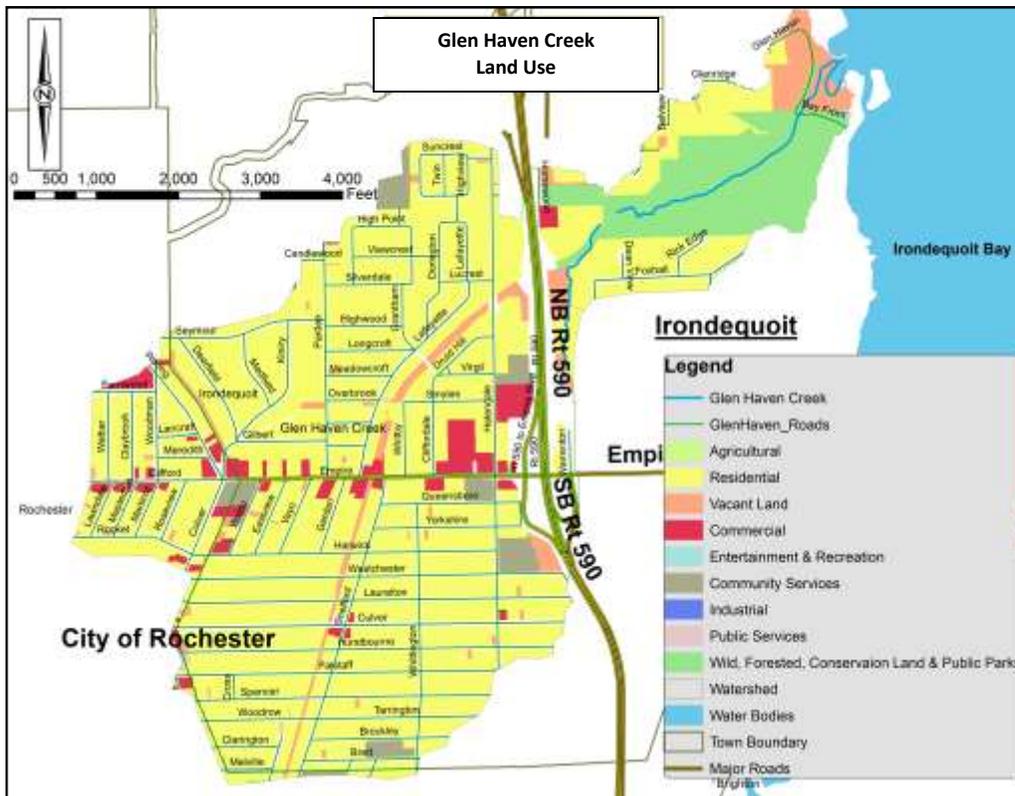
Figure 3: Land use within Glen Haven Creek Watershed.

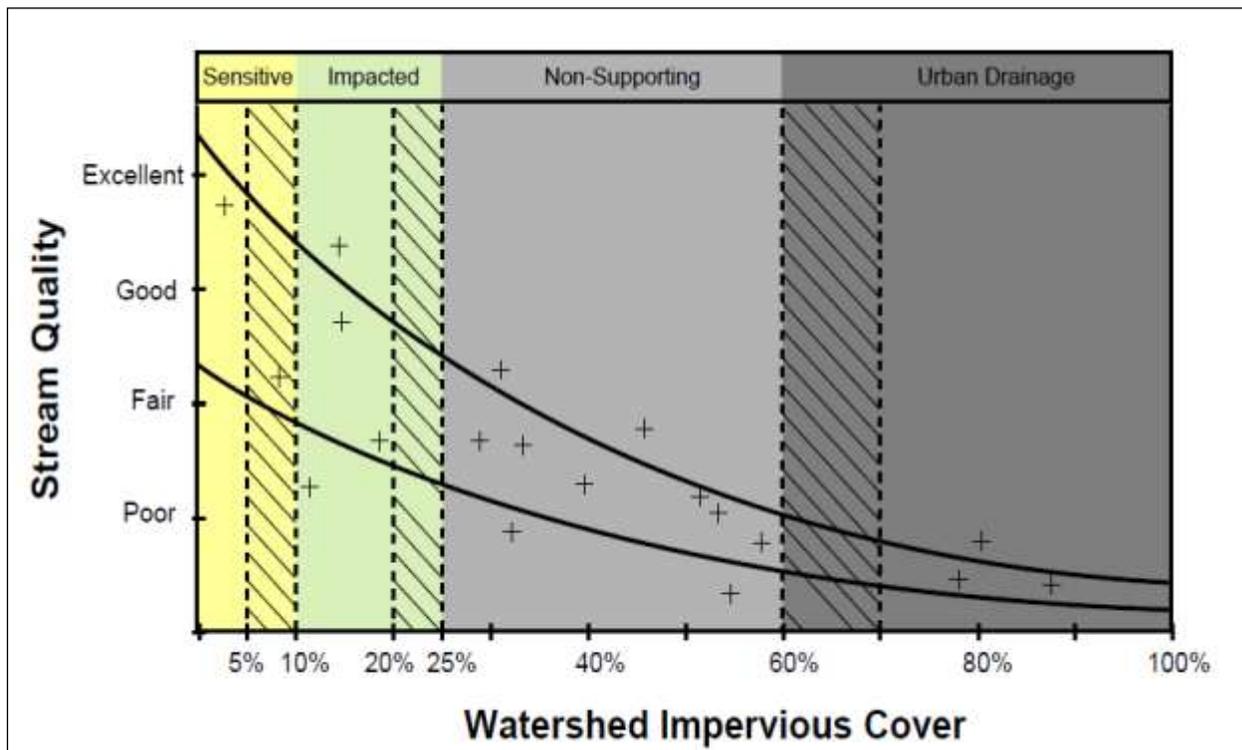
Figure 4. Impervious Cover Model (based on current zoning, future impervious cover over the

1.4.2 Impervious Cover Analysis The Center for Watershed Protection created the “Impervious Cover Model” (ICM) to predict a typical stream’s health using the relationship between subwatershed impervious cover and stream quality indicators and has been confirmed by nearly 60 peer-reviewed stream research studies (Figure 4) . The ICM shows that stream quality decline becomes evident when the watershed impervious cover exceeds ten percent. Glen Haven has an average of 50 percent impervious cover placing stream quality somewhere between poor and fair and non supporting for aquatic life. Based on current zoning, future impervious cover (over the next 20 years) will increase by 1 percent.

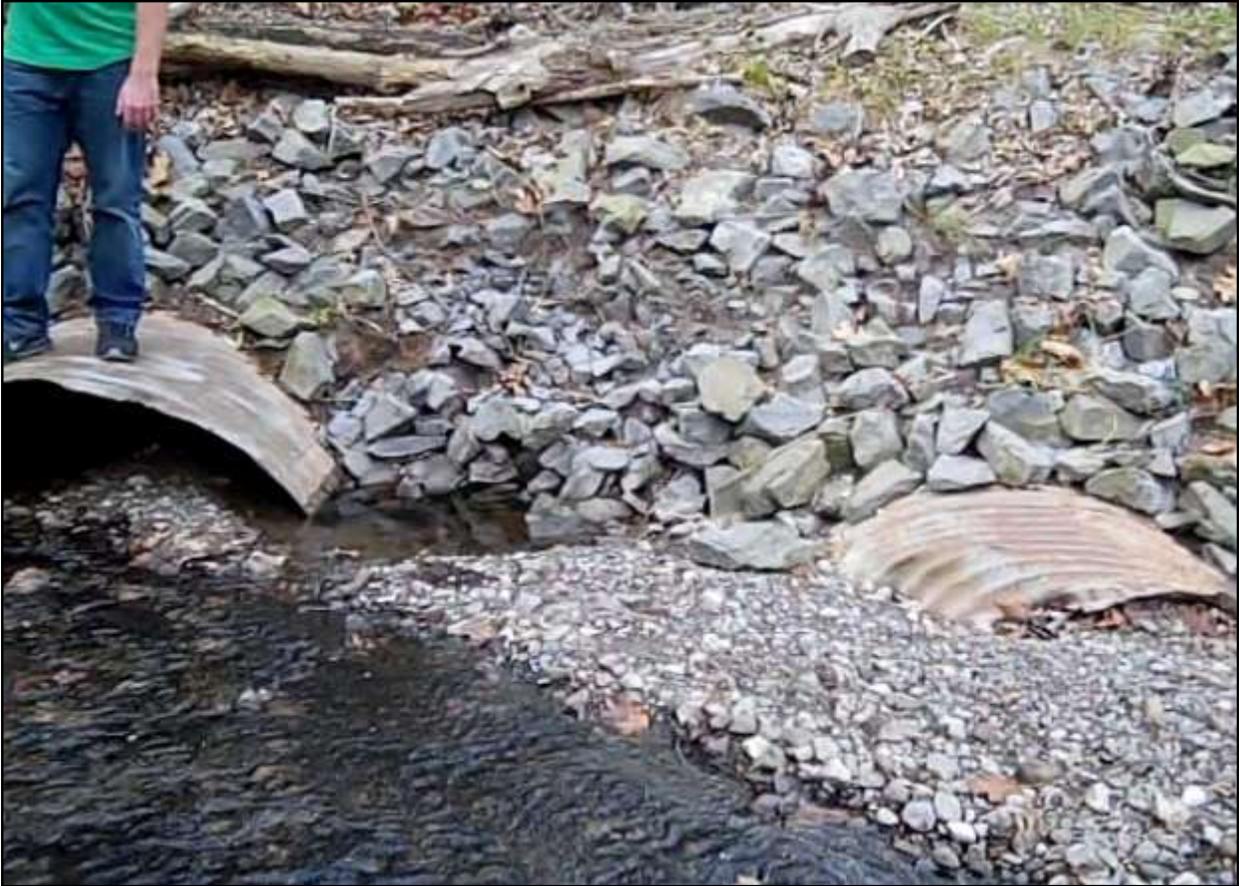
Figure 5. Upstream erosion of glacially laid gravels regular deposit at these twin culvert pipes on South Glen Road, Irondequoit, NY

1.4.4 Streambank Erosion The Creek has numerous locations of eroding streambanks and has been piped through most of the developed portions of the watershed. Several significant eroding sections exist downstream of NYS Route 590. Annually, large storms cause the Creek to overtop South Glen Road due to large gravel depositions from the eroding streambanks upstream (Figure 5). High velocities are apparent from boulders displaced in the creek bed (Figure 6).

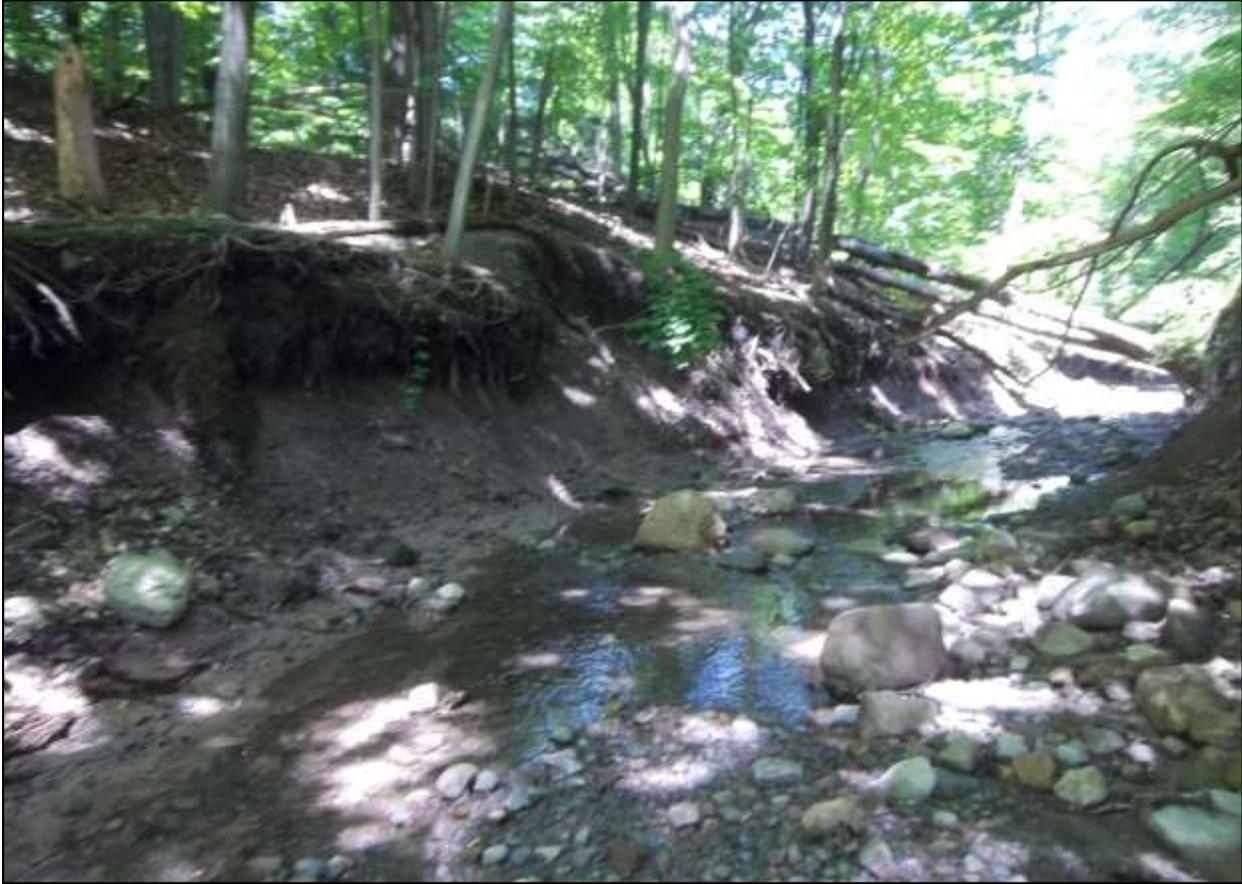
Figure 6. Severe streambank erosion on Glen Haven Creek, exists through much of the section in Irondequoit Bay Park West.

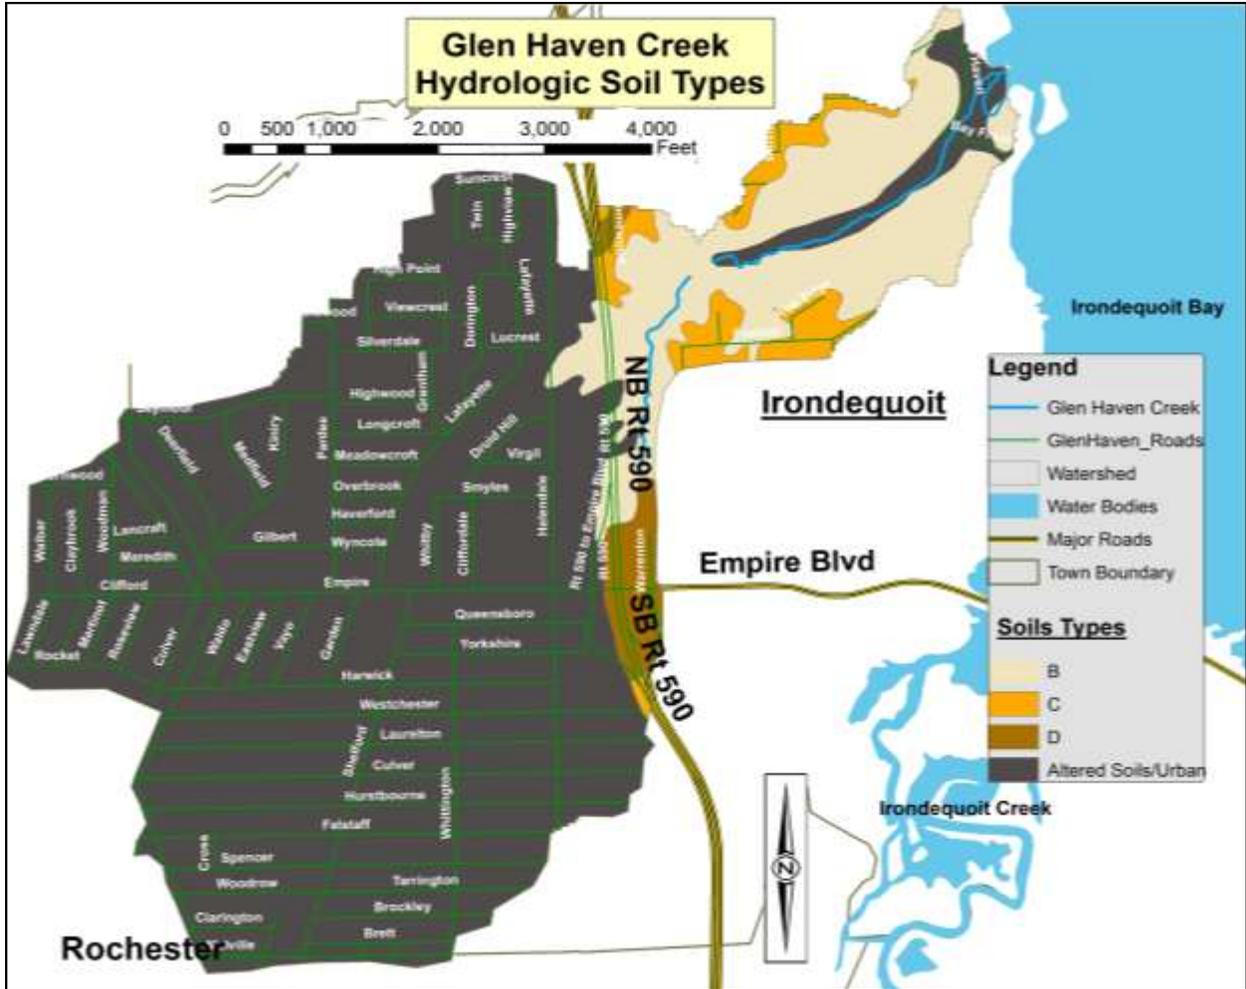
Figure 6. Hydric Soils Map of Glen Haven Creek Watershed

1.4.5. Soils A simplistic yet useful way to define how much stormwater runs off the pervious land surface is to determine soils' infiltration capabilities, their ability to absorb stormwater. Infiltration practices installed in the upper parts of a watershed can prevent and reduce flooding, drainage problems, and streambank erosion as well as greatly improve water quality in streams. Soil scientist have categorized soils into four categories, A through D. "A" and B soils are well drained and absorb much of the stormwater that drains on or over them. C and D soils are more poorly drained. However, the soils in some parts of this watershed are not categorized, denoting areas that have been so altered by land development that grouping a specific soil type is not feasible. The amount of each soil type in Glen Haven Creek is: A soils 0%; B soils 15%; C soils 3%; D soils 2%, altered/urban 80% (Figure 6).

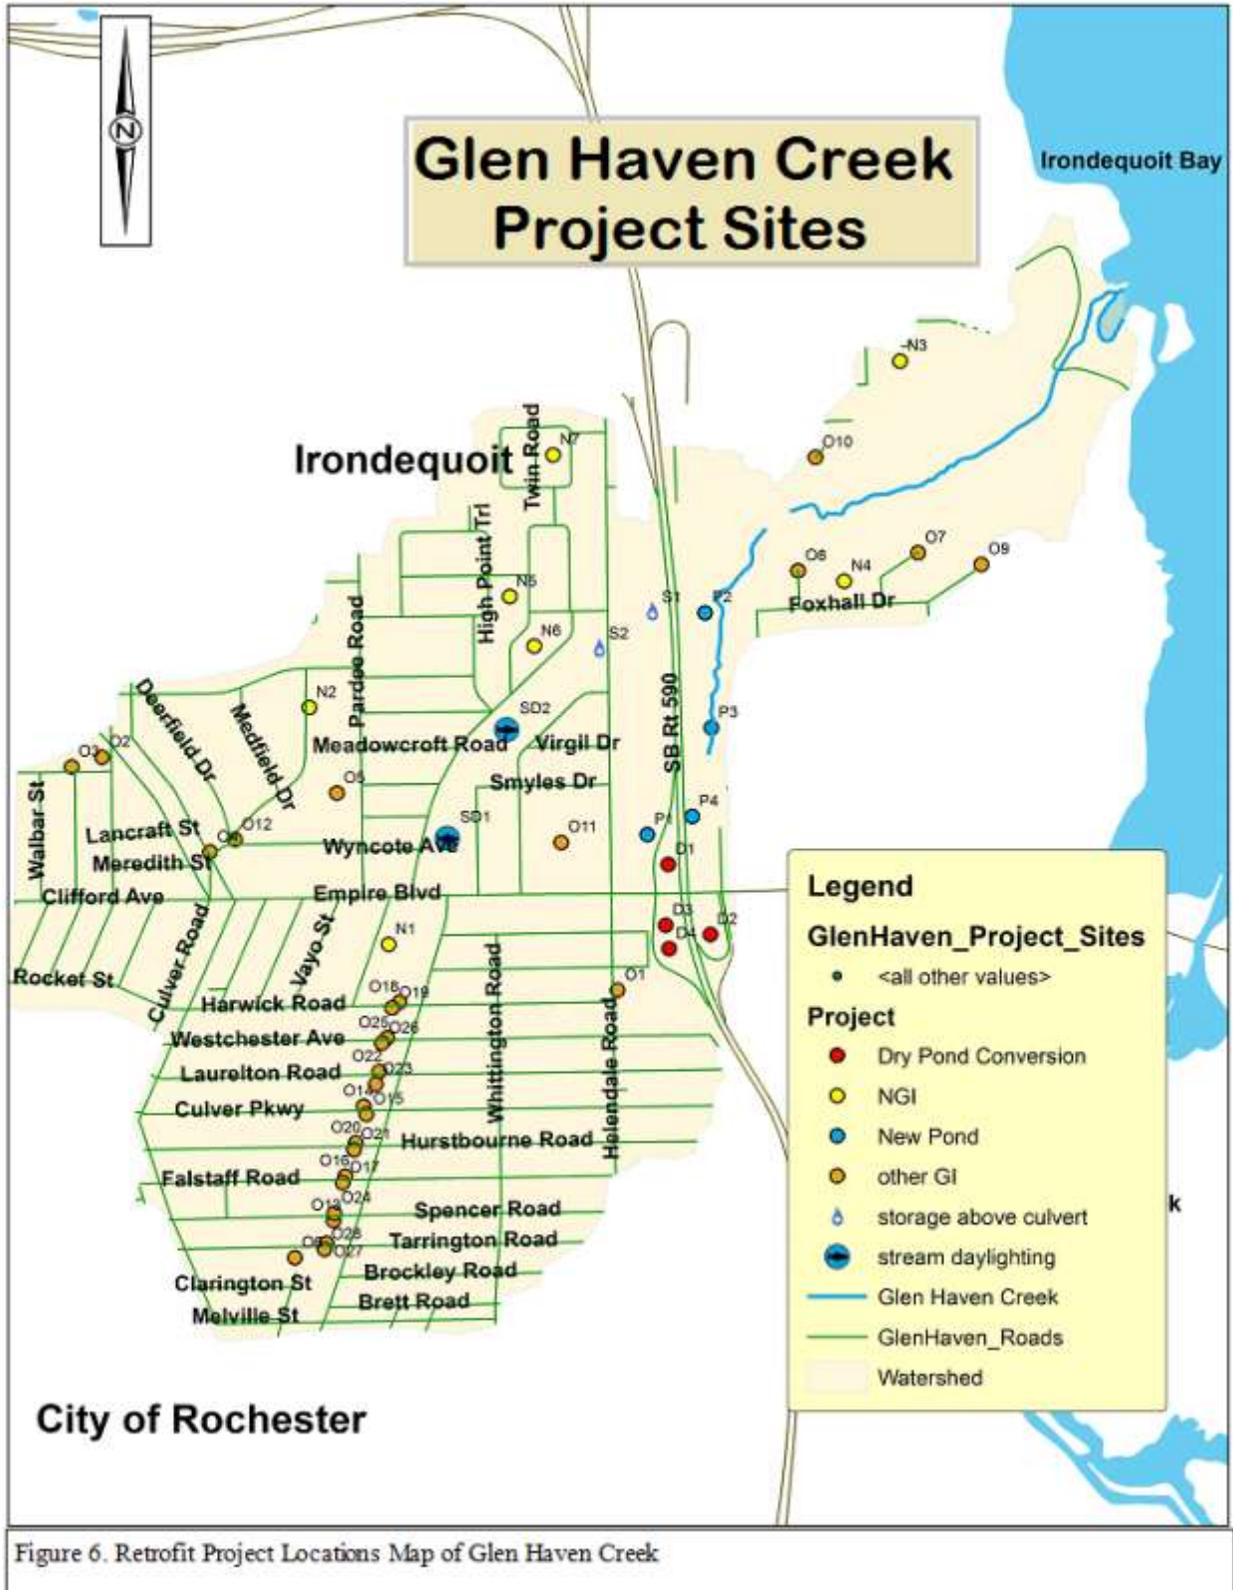
Figure 6. Retrofit Project Locations Map of Glen Haven Creek

Figure 6 shows project locations and project number within the watershed. Table 2 lists project addresses and how they scored. Diagrams of the top scoring projects follow the table.

In addition, Figure 6 shows another group of retrofits along the Rochester Gas and Electric easement/greenway south of Empire Boulevard. Retrofit opportunities include capturing road runoff in landscaped bioretention basins before allowing it to enter storm sewers where the seven residential roads cross the 45 foot wide easement with overhead utility poles (Figure 7).

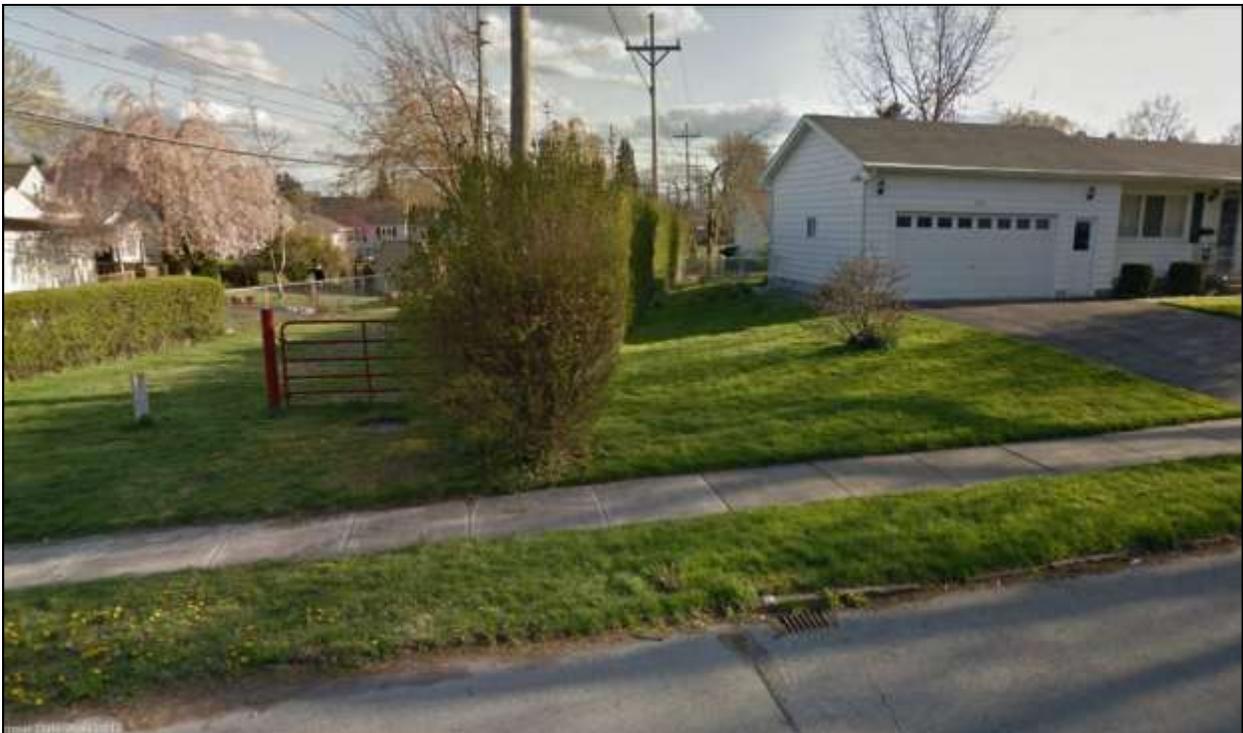
Figure 7. Bioretention could be installed in the road right-of-way adjacent to RG&E’s 45 foot wide easement (note the red gate access)
