# **Slater Creek**

## **Stormwater Assessment**

### **and Action Plan**

**Monroe County Department of Environmental Services**

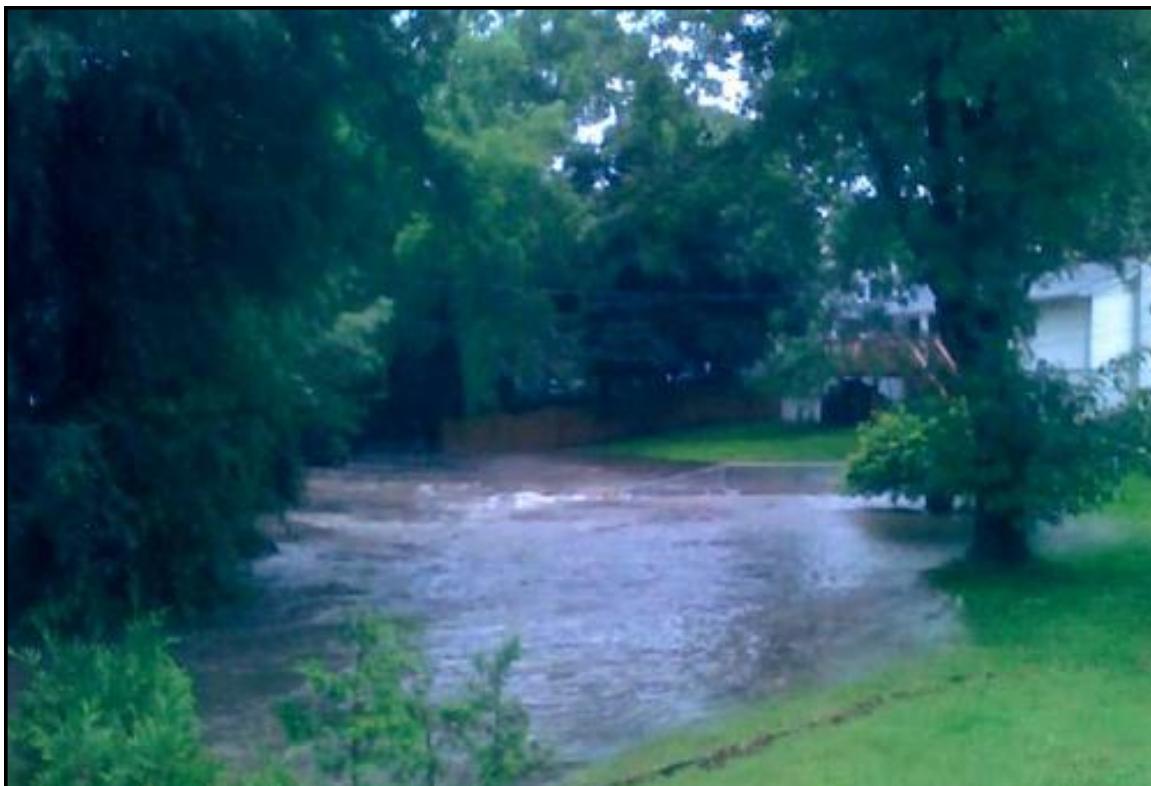
Figure 9 Fleming Creek Near Ripplewood Drive, 2008 flooding

In 2011 the Town of Greece studied the drainage issues at the confluence of Veness Creek and Fleming Creek (Erdman Anthony 2011). The area was prone to frequent flash flooding, resulting in nuisance and frequent yard repair to residents living along the stream corridor as shown in Figure 9. The goal of the study was to identify problems in the stream corridor and to decrease the frequency of flooding. Preliminary recommendations were to perform maintenance, remove obstructions, minimize debris potential, improve access, increase channel capacity, and improve performance of culverts. Although there are no specific water quality improvement measures proposed in the study, there will be some benefit to water quality from stream bank repair and flow attenuation measures.

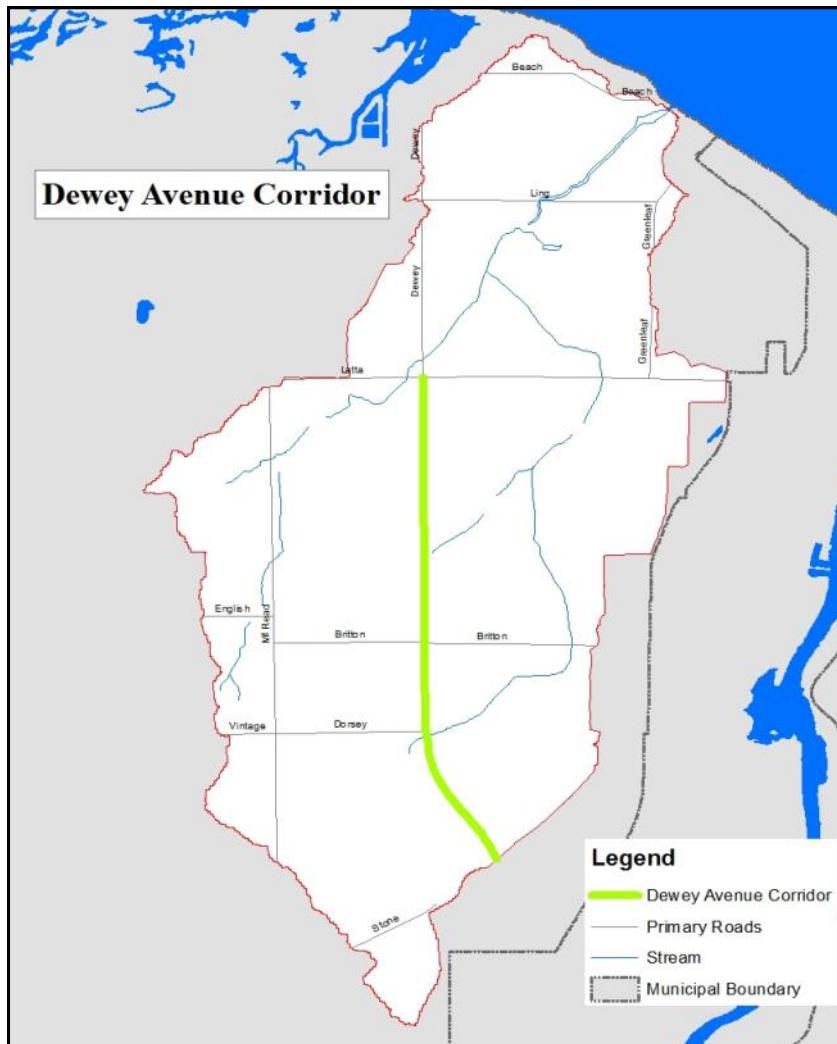
Figure 10 Dewey Avenue Corridor in Slater Creek Watershed

In 2007 the Town of Greece conducted a study of the what is called the “Dewey Avenue Corridor”. Dewey Avenue is a primary roadway that runs through the heart of Slater Creek watershed as shown in Figure 10. In general, the Dewey Avenue area consists of businesses and residential neighborhoods that are within about one half mile of the street, and contains some of the oldest commercial and residential development in the Town. (Figure 11 A and B) Study goals were the following:

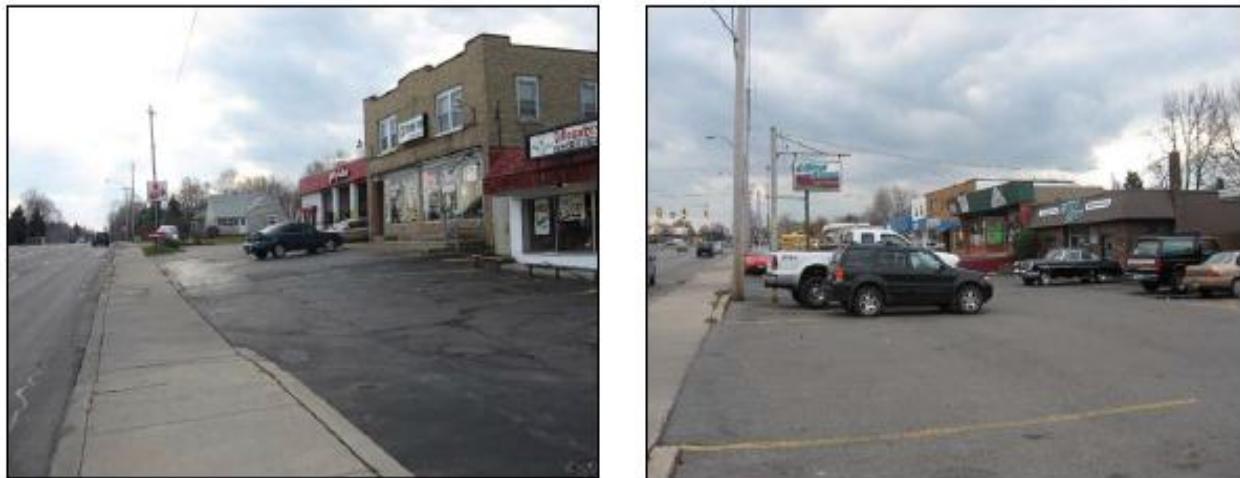
Figures 11 A and B Examples of Older Development in the Dewey Avenue Corridor

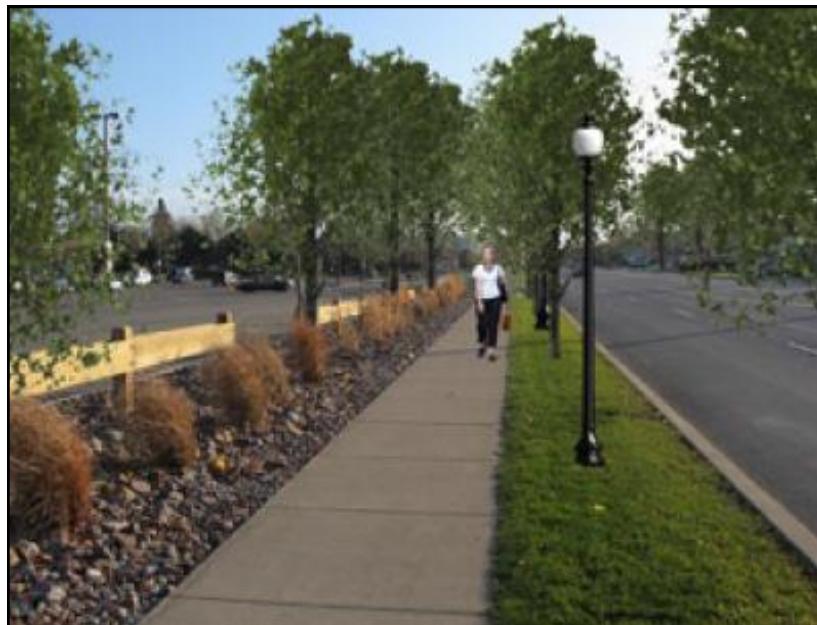
Figure 12 Dewey Ave Corridor Proposed Streetscape Enhancements

While the study and recommendations were not directed at stormwater, there will certainly be a net benefit to stormwater as the plan gets implemented. The proposed impervious cover reduction and open space enhancement will serve to reduce stormwater runoff and improve water quality. Figure 12 shows an example of proposed streetscape enhancements near Britton Road. Figure 13 demonstrates how redevelopment within a watershed can include improvements to water quality. The figure shows Northgate Plaza, a large multi acre parcel built well before current stormwater standards. The second photo shows the redevelopment of the plaza in 2012 that includes green infrastructure such as bioretention and swales as well as impervious cover reduction. As redevelopment occurs along Dewey Avenue we will see more of these kinds of features and the resultant benefit to water quality in Slater Creek.

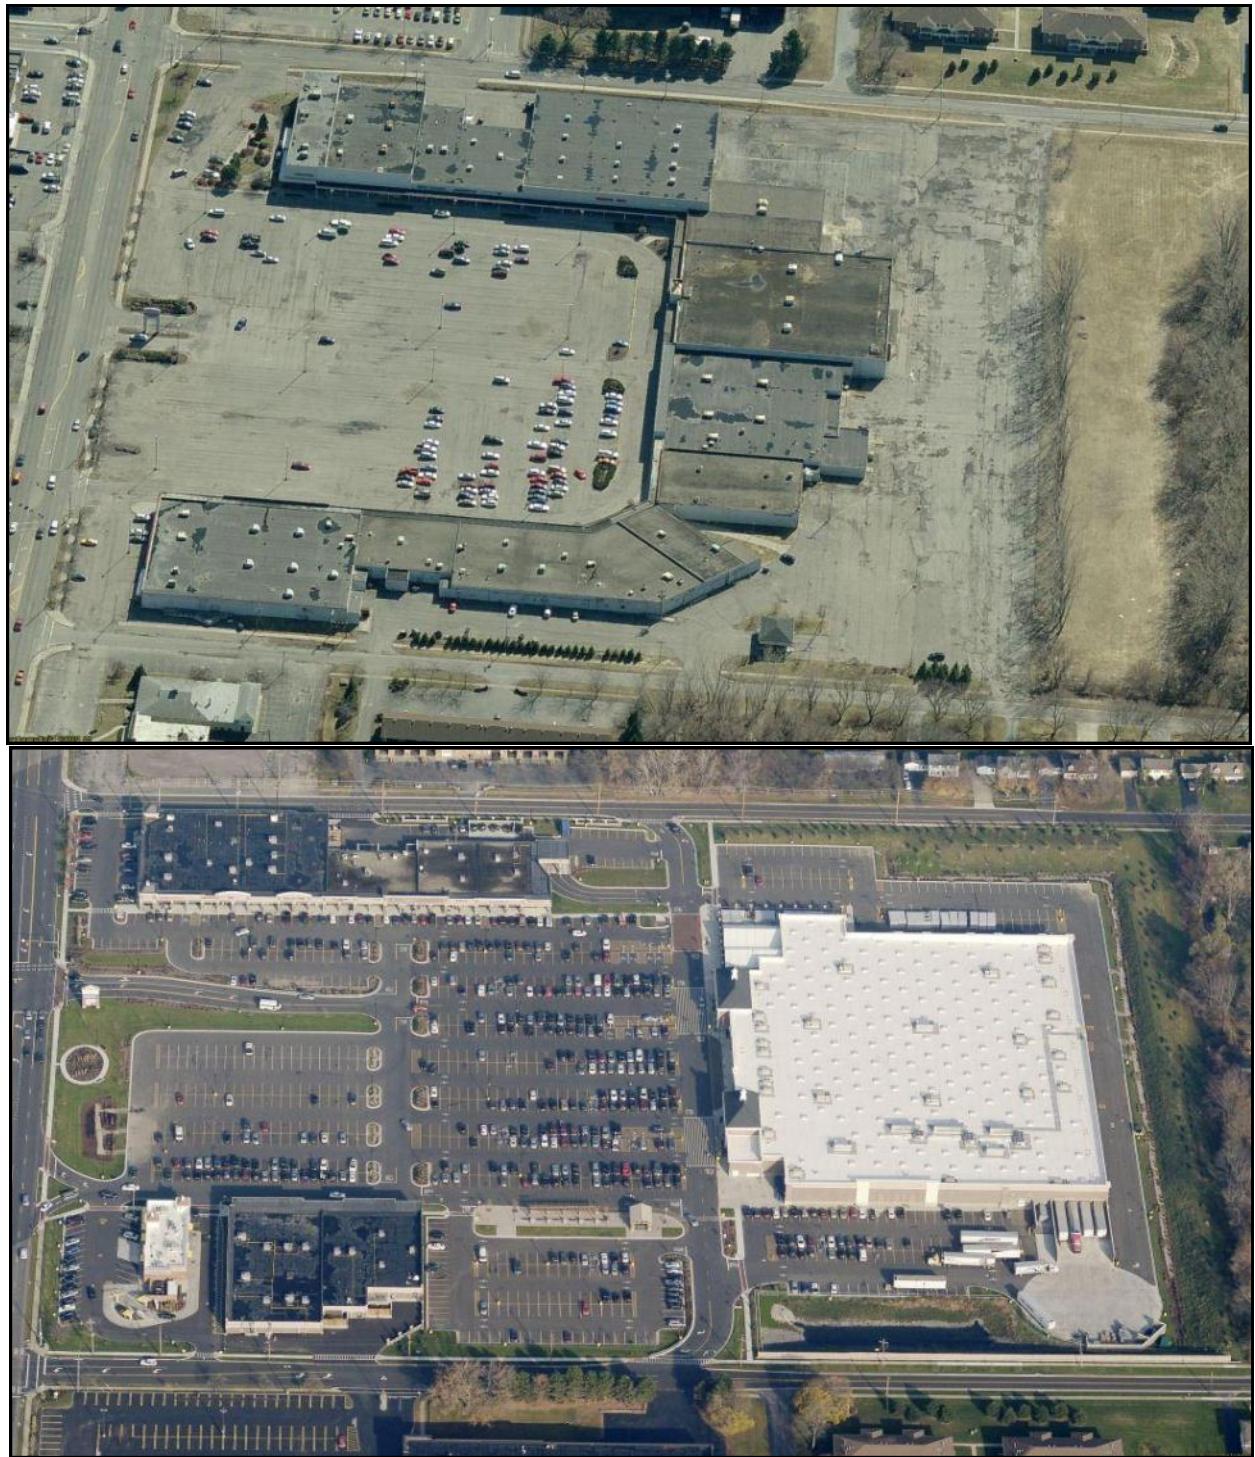
Figure 13 Northgate Plaza in 2009 (above) and 2012 (below) Showing impervious area reduction and increased green space
