ADDENDUM NO. 1

ABRAHAM LINCOLN PARK IMPROVEMENTS - PHASE 2

Capital Improvement Project No. 1462.01

This report summarizes our Geotechnical Evaluation for the referenced project. The project consists of a new Lodge/Shelter to replace the existing 'Quonset Hut' along the waterfront. New parking lots will be added and the access road will be repaved. The access road is to be paved with its width limited to about a single lane. The parking lots will consist of some type of permeable pavement or a gravel surface. The new structure will be two stories and include meeting space, etc. Part of the first floor and the entire second floor will be available for use 'year round'; the majority of the first floor will be used as boat storage for summertime activities. Column loads are expected to generally be between 50 kips and 100 kips. Finished floor is expected to be near elevation 254. This blends fairly well with the existing grades.

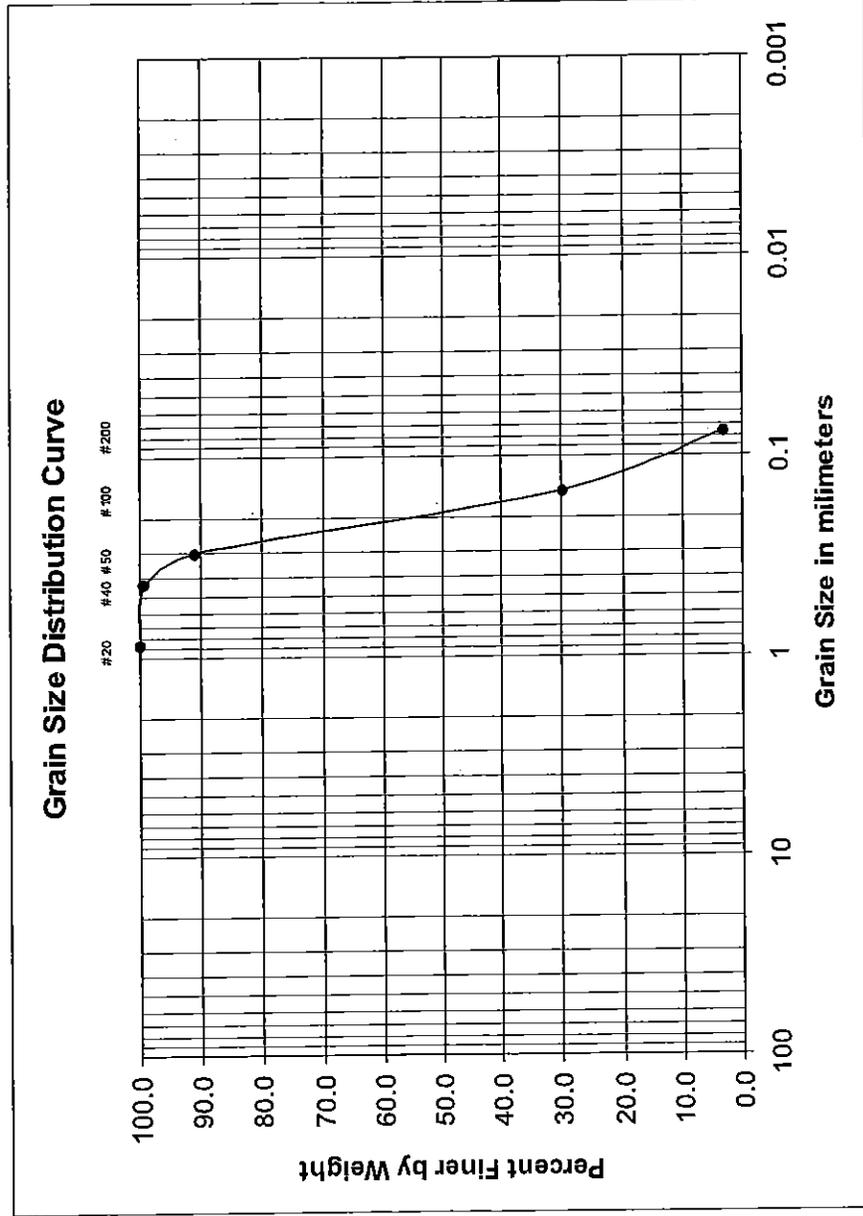
CLIENT:	Foundation Design, P.C.	REPORT No.:	36757S-56-1210
PROJECT:	Lincoln Park Lodge (F.D. Job #3487.0)	SAMPLE No.:	RL9611
SAMPLE LOCATION:	B10-4; S-3; 4' to 6'	DATE DELIVERED:	12/27/10
SOIL CLASSIFICATION:	Brown mf SAND, trace SILT		
		PAGE:	1 of 3

We also subcontracted with CME Associates, Inc. to perform laboratory analysis of soil samples we selected. The testing program consisted of three sieve analyses, four moisture content tests, and four organic content tests. The test results are discussed below. The CME Associates, Inc. laboratory report is also attached.

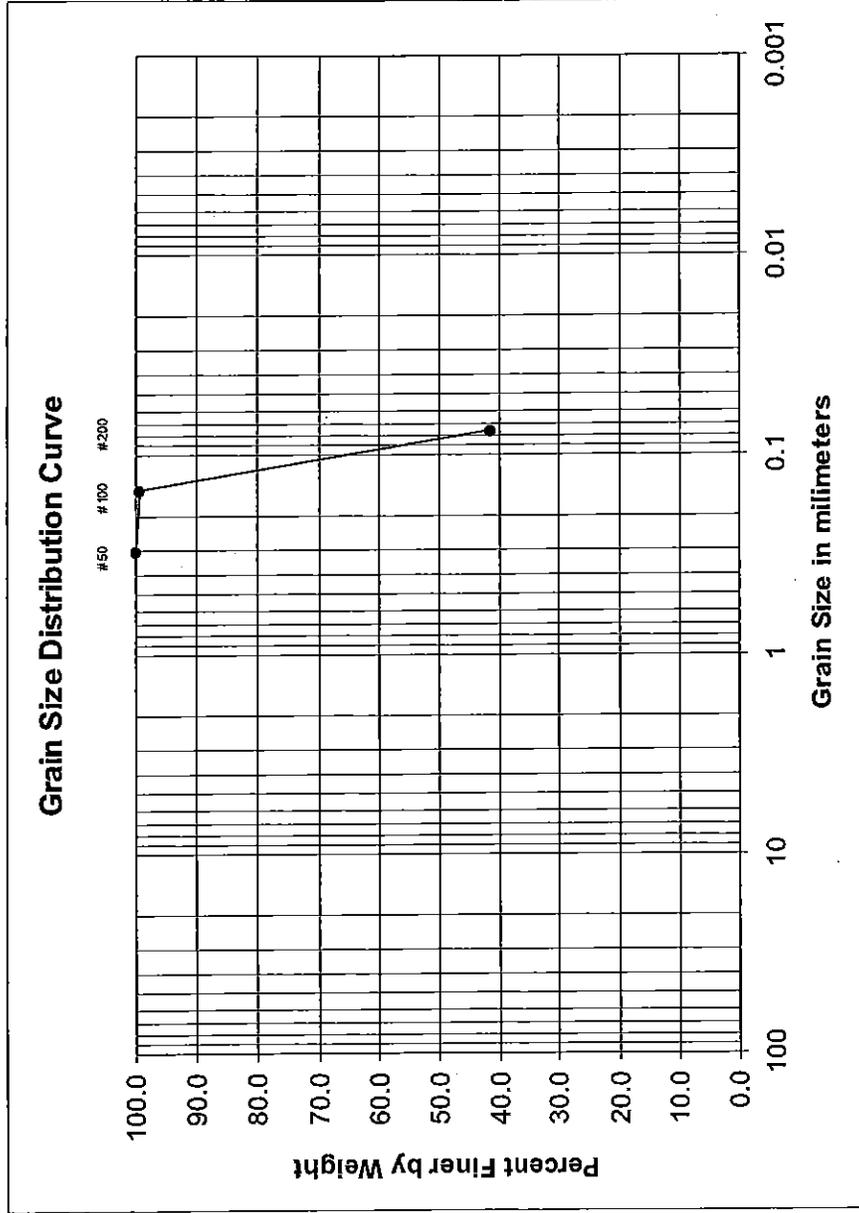
CLIENT:	Foundation Design, P.C.	REPORT No.:	36757S-56-1210
PROJECT:	Lincoln Park Lodge (F.D. Job #3487.0)	SAMPLE No.:	RL9611
SAMPLE LOCATION:	B10-5; S-9; 19' to 21'	DATE DELIVERED:	12/27/10
SOIL CLASSIFICATION:	Brown f SAND, and SILT		
		PAGE:	2 of 3

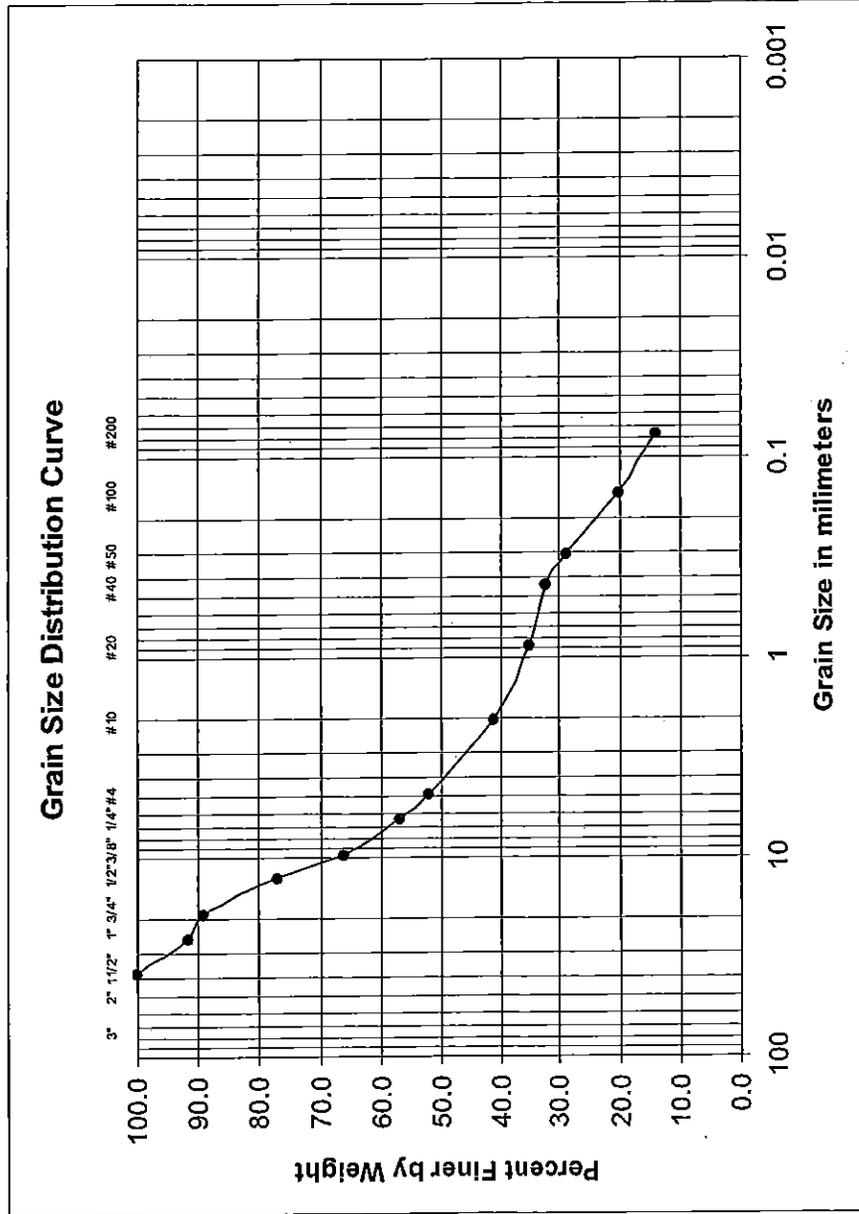
CLIENT:	Foundation Design, P.C.	REPORT No.:	36757S-56-1210
PROJECT:	Lincoln Park Lodge (F.D. Job #3487.0)	SAMPLE No.:	RL9611
SAMPLE LOCATION:	B10-5; S-10; 24' to 26'	DATE DELIVERED:	12/27/10
SOIL CLASSIFICATION:	Brown cmf GRAVEL, and cmf SAND, little SILT/CLAY		
		PAGE:	3 of 3
