Green Infrastructure Rapid Assessment Plan

East Branch Allen Creek Watershed

**The Stormwater Coalition of Monroe County and
Monroe County Department of Environmental Services**

October, 2013

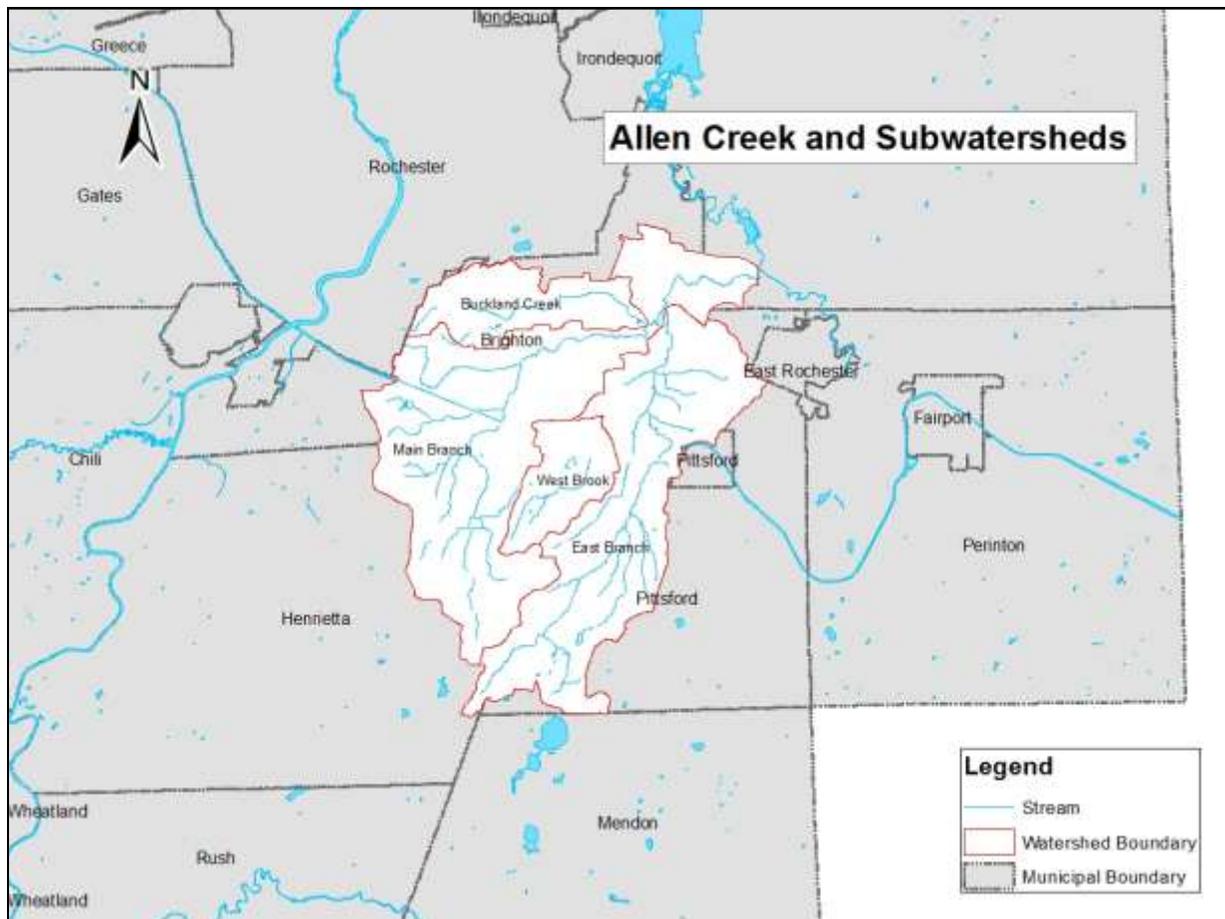
Figure 1: Allen Creek watershed.

Allen Creek consists of two significant and diverse subwatersheds, Main branch and East branch (Figure 1). After merging with the Main branch in the Town of Pittsford, the Creek flows through Brighton and then discharges into Irondequoit Creek in Panorama Valley (Penfield). Because of their size and diversity, the two branches were assessed separately (see also “Green Infrastructure Rapid Assessment Plan Allen Creek Watershed—Main Branch”). A middle branch of the creek, referred to as West Brook, drains into the Erie Canal at lock 32 near Clover Street. Retrofits for that tributary area of approximately 1000 acres were considered in this report.

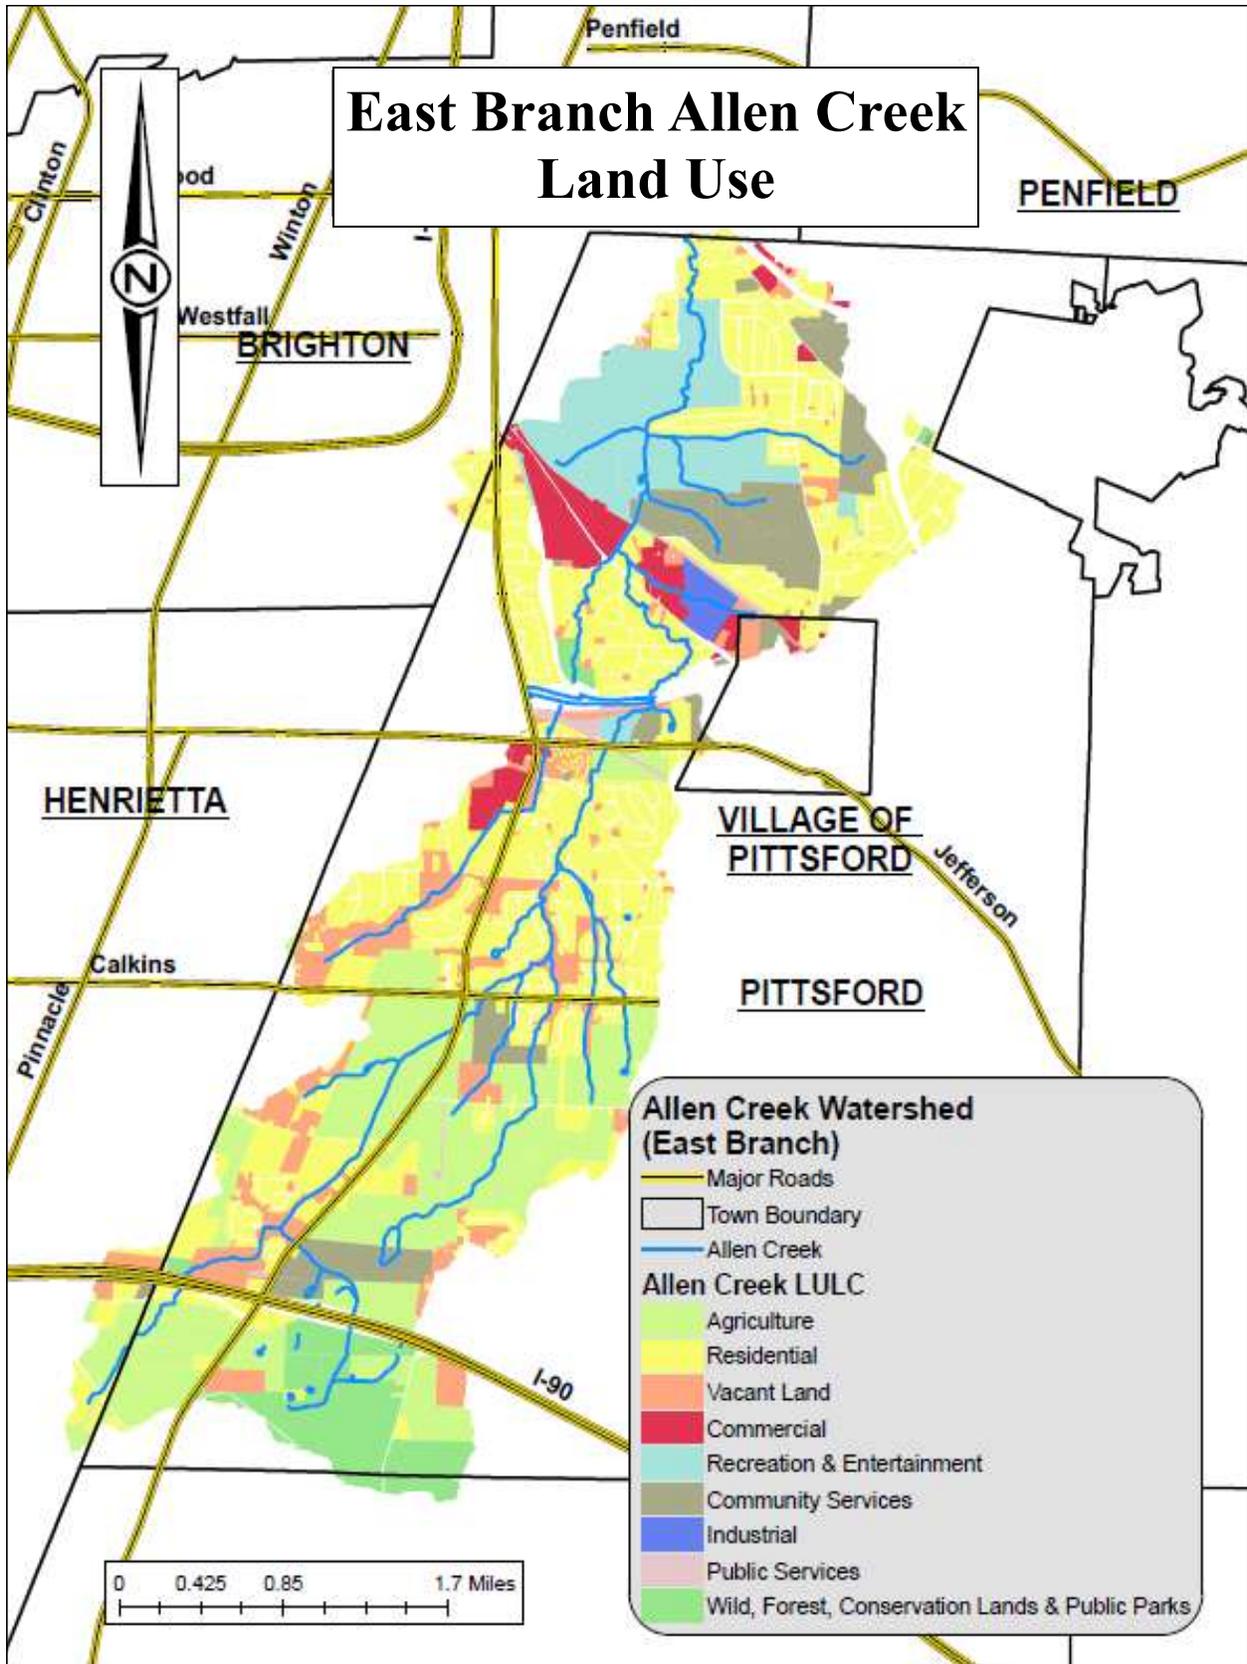
Figure 2: Land use within East Branch Allen Creek watershed.

Virtually the entire 6300 acre East Branch watershed lies in the Town of Pittsford. The main land use throughout the upper watershed is agriculture which transitions to residential in the central and lower portion and a small area of commercial land use along Monroe Avenue in the northeast (Figure 2).

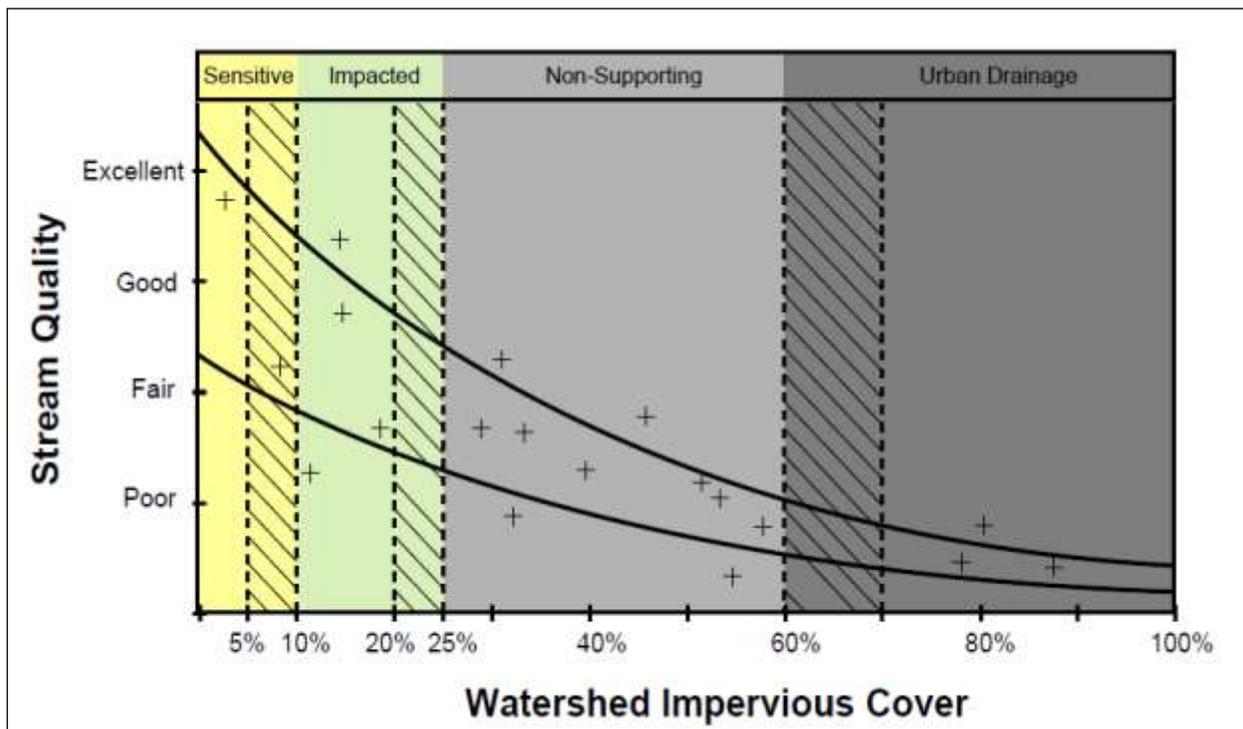
Figure 4: Impervious Cover Model

1.4.2 Impervious Cover Analysis The Center for Watershed Protection created the “Impervious Cover Model” (ICM) to predict a typical stream’s health using the relationship between subwatershed impervious cover and stream quality indicators. This relationship has been confirmed by nearly 60 peer-reviewed stream research studies (Figure 4). The ICM shows stream quality decline becomes evident when the watershed impervious cover exceeds ten percent. The East Branch has an average of 24 percent impervious cover identifying stream quality somewhere between poor and good and impacted (aquatic life).

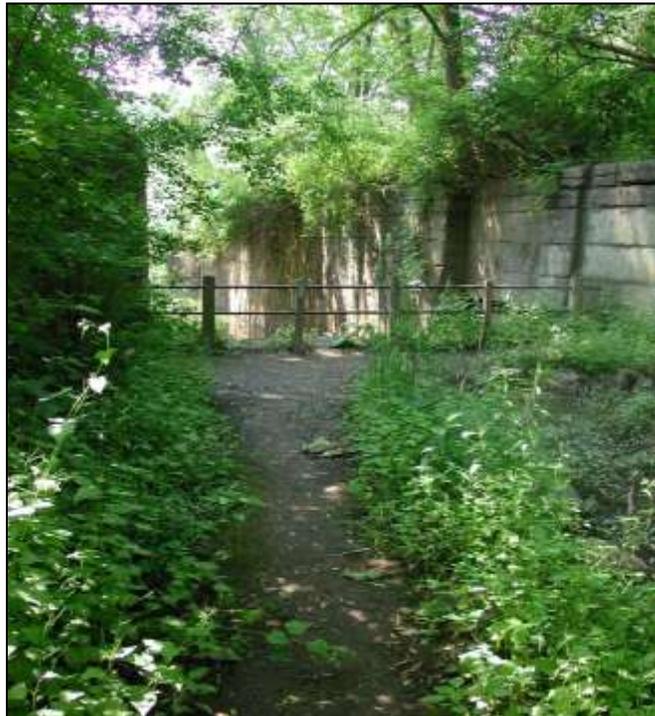
Figure 5: Old Erie Canal Bed—potential available storage.

Also described in the 1982 Report are potential locations for stormwater storage basins – most in the upper portions of the watershed. For example, there is an opportunity to provide stormwater storage in a small drainage area in the northwest corner of the Village of Pittsford. Also, the use of the old (empty) Barge Canal bed should be investigated (Figure 5). Construction of these storage basins may reduce flooding and erosion problems in downstream areas and are included as retrofits.

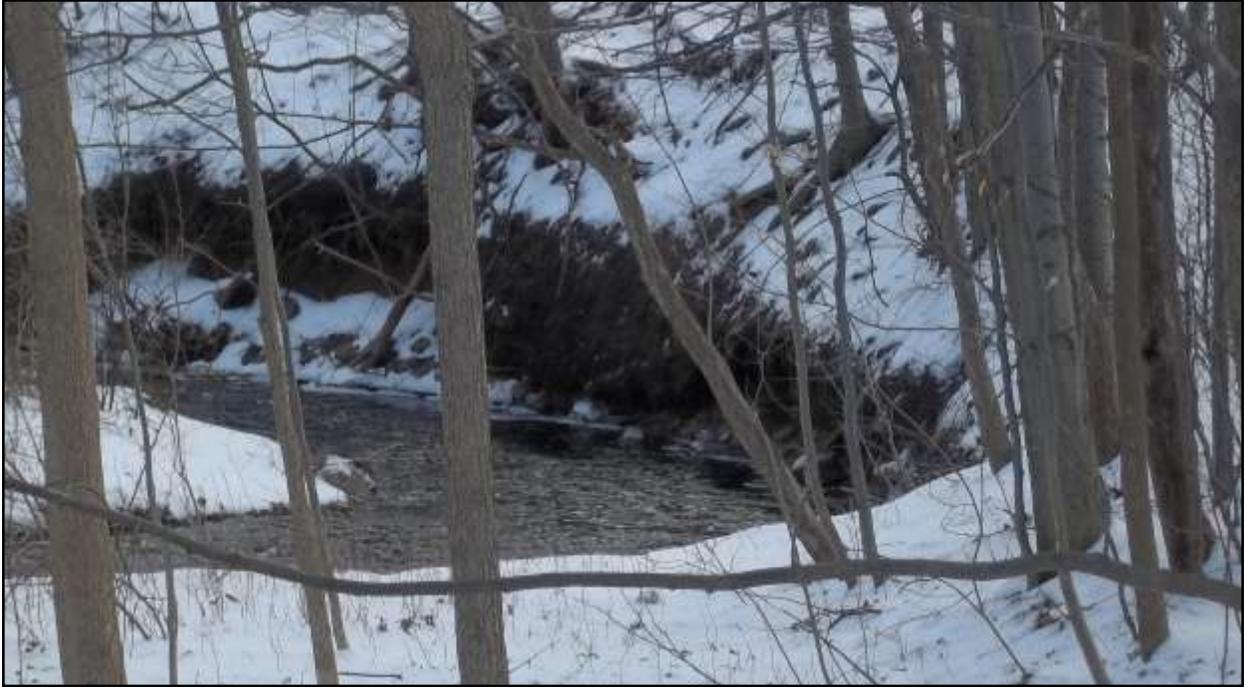
Figure 6: Eroded Streambank downstream of Toby Road in Pittsford on East Branch Allen Creek.

1.4.4 Streambank Erosion There are five reported erosion sites on East Branch Allen Creek from assessments done in 2001 by the Monroe County Soil & Water Conservation District. All sites are located upstream of Jefferson Road. All five sites were visited and show mostly minor eroded stream banks (Figure 6). DPW staff at the Town of Pittsford found no recent reports of erosion complaints elsewhere however, the stream has been heavily armored in the most downstream reach as it meanders through Oak Hill Country Club (Figure 7). This suggests the stream was migrating and likely impacting the course.

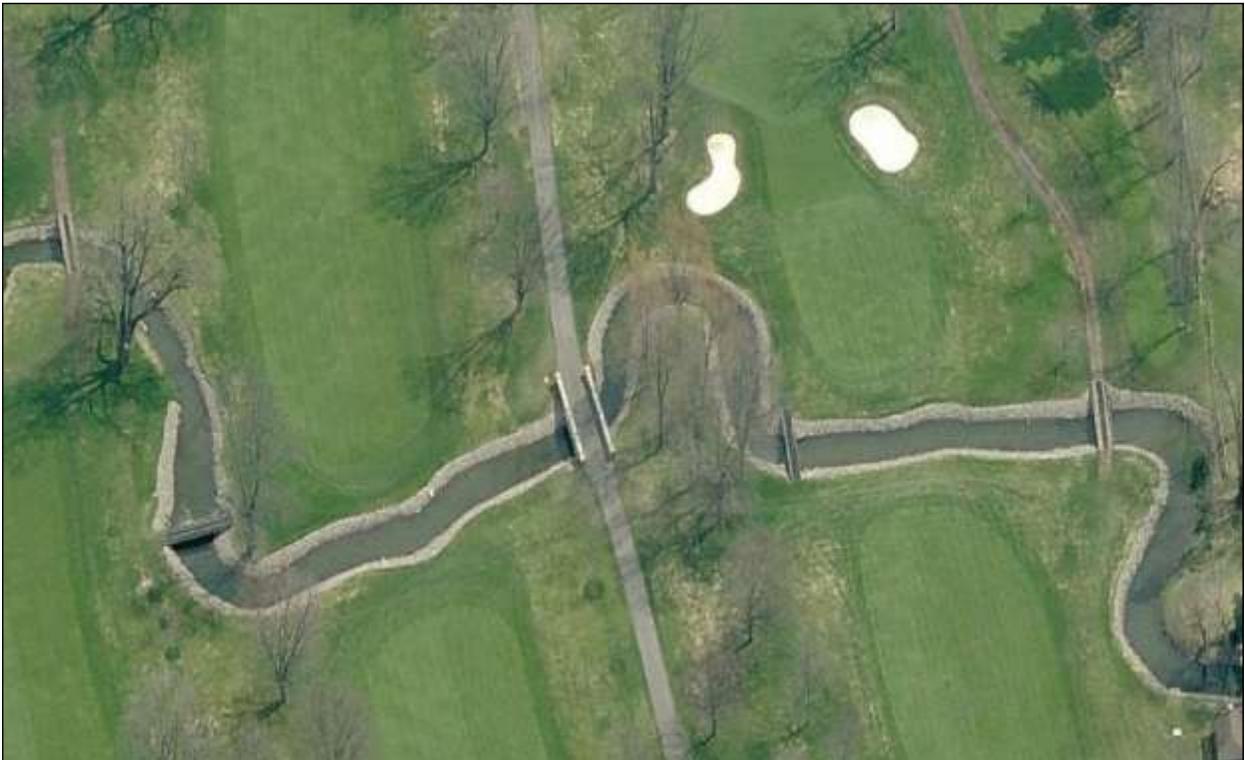
Figure 7: Rock-lined streambanks as it flows through Oak Hill Country Club.

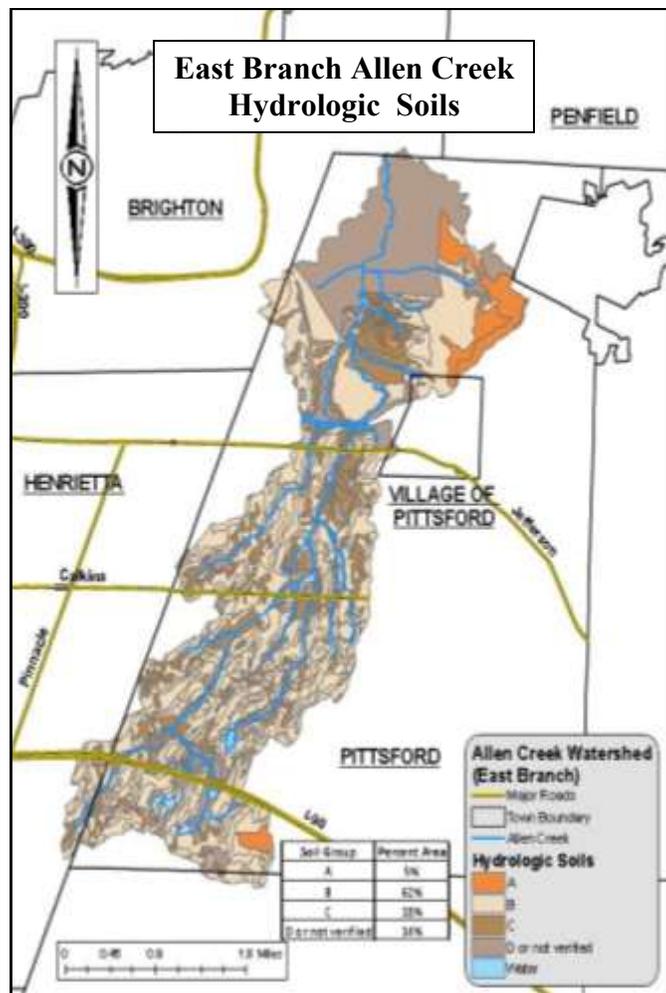
Figure 8. Hydric Soils Map of East Branch Allen Creek

1.4.5 Soils A simplistic yet useful way to define how much stormwater runs off the pervious land surface is to determine soils' infiltration capabilities, their ability to absorb stormwater. Soil scientist have categorized soils into four categories, A through D. A and B soils are well drained and absorb much of the stormwater that drains on or over them. C and D soils are more poorly drained. However, the soils in some parts of this watershed are not categorized, denoting areas that have been so altered by land development thus grouping a specific soil type is not feasible. The amount of each soil type in East Branch Allen Creek is: A soils 5%; B soils 62%; C soils 18%; D soils or not verified 14% (Figure 8).

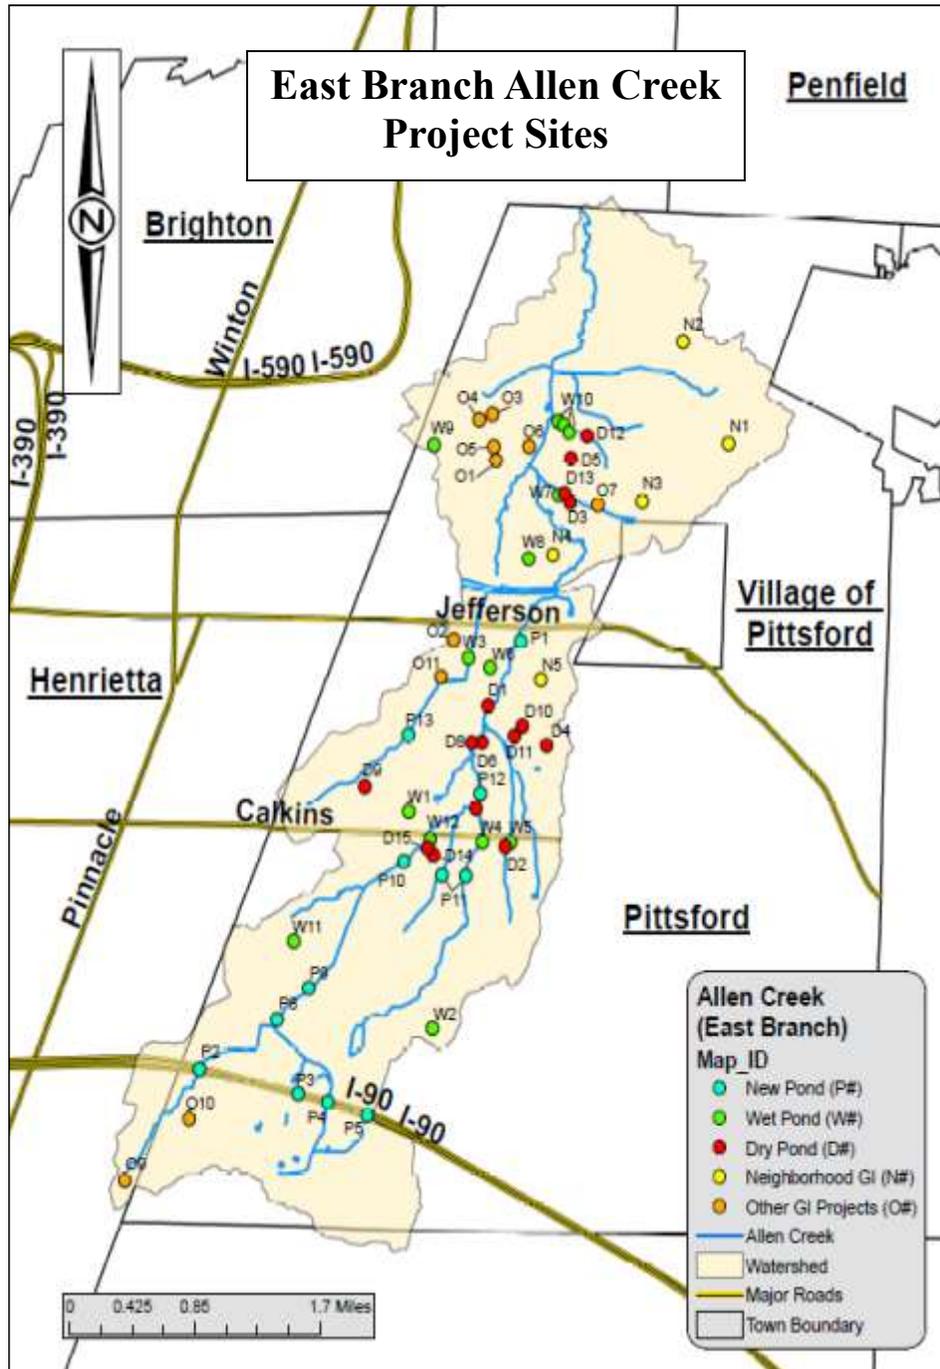
Figure 9: A map of the potential projects sites branch watershed.

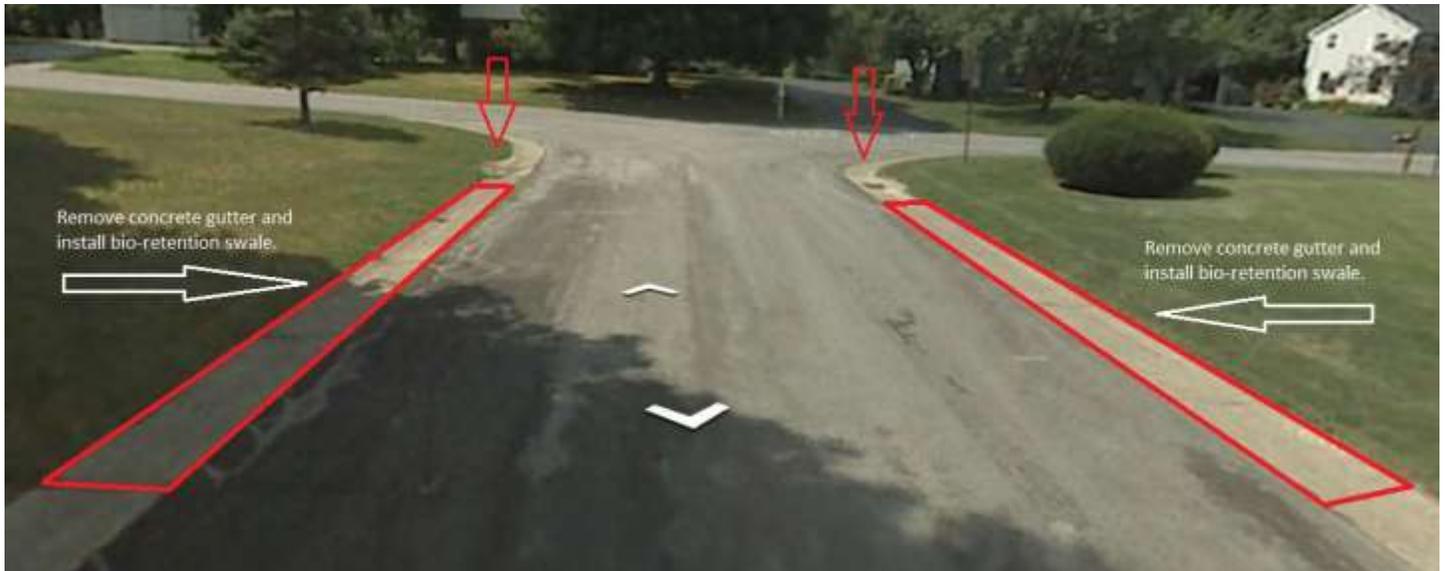
Figure 7: Above is an example typical residential street. Stormwater runoff is channeled into the concrete gutters along the sides of the road and conveyed to the stormwater sewer system through the storm inlets (red arrows). In order to reduce runoff into the stormwater sewer system and increase infiltration, bio-retention swales could be installed. These green infrastructure retrofits would replace the concrete gutter and contain stormwater runoff and allow it to infiltrate back into groundwater.

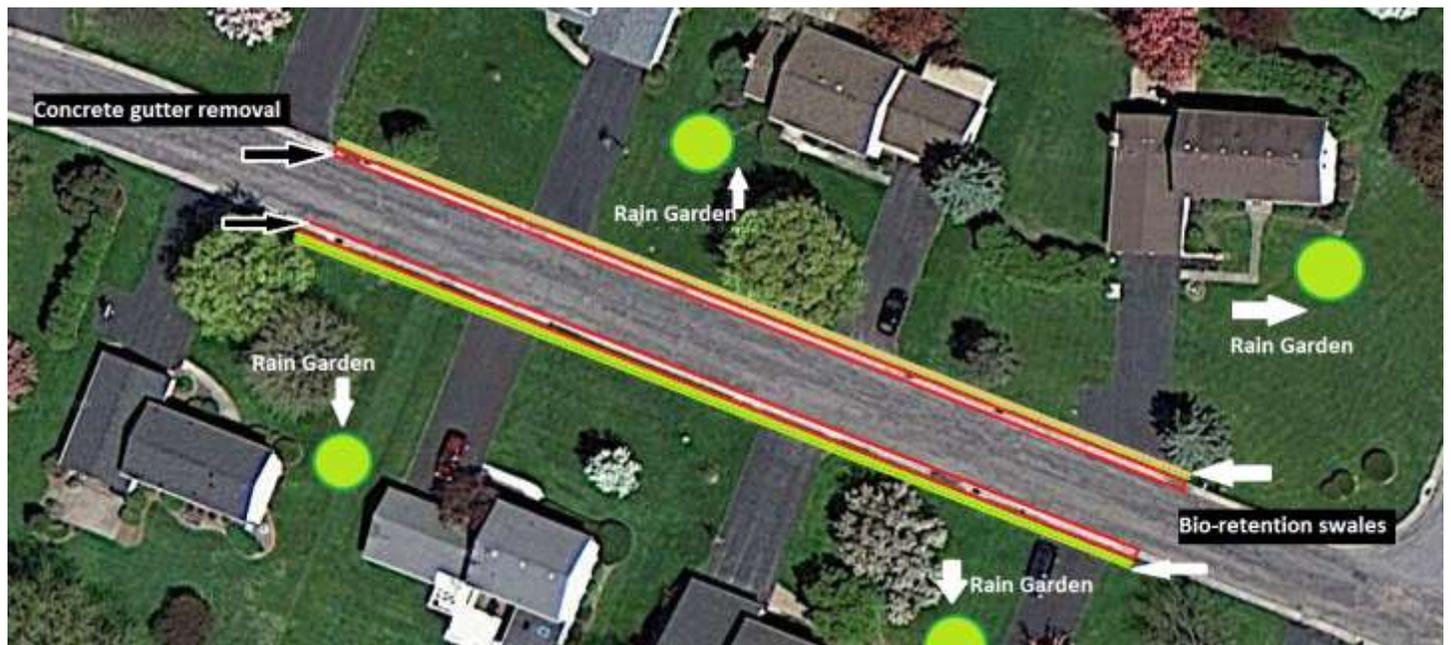
Figure 8: Above is an example of a neighborhood with standard stormwater management practices i.e. concrete gutters along the streets which connect to the stormwater sewer, fair amounts of impervious cover, and roof top connections to the stormwater sewer. Replacing the concrete gutter with bio-retention swales and diverting roof top runoff to rain gardens provide source control and infiltration for stormwater runoff.

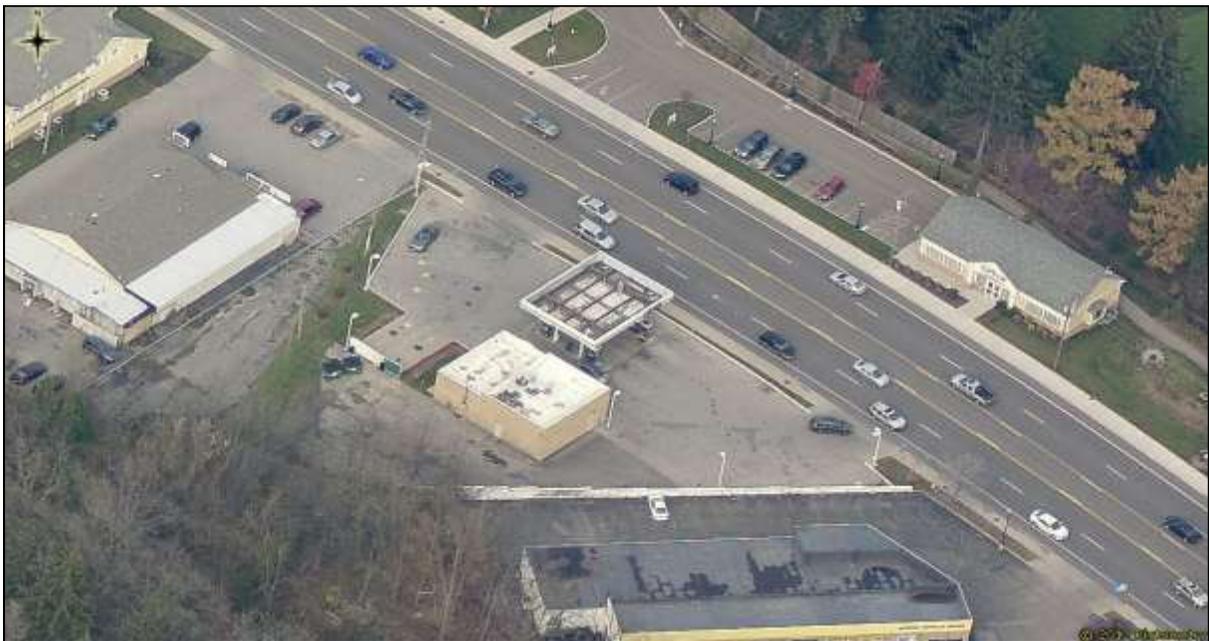
Figure C-1: This gas station is a potential hotspot locations

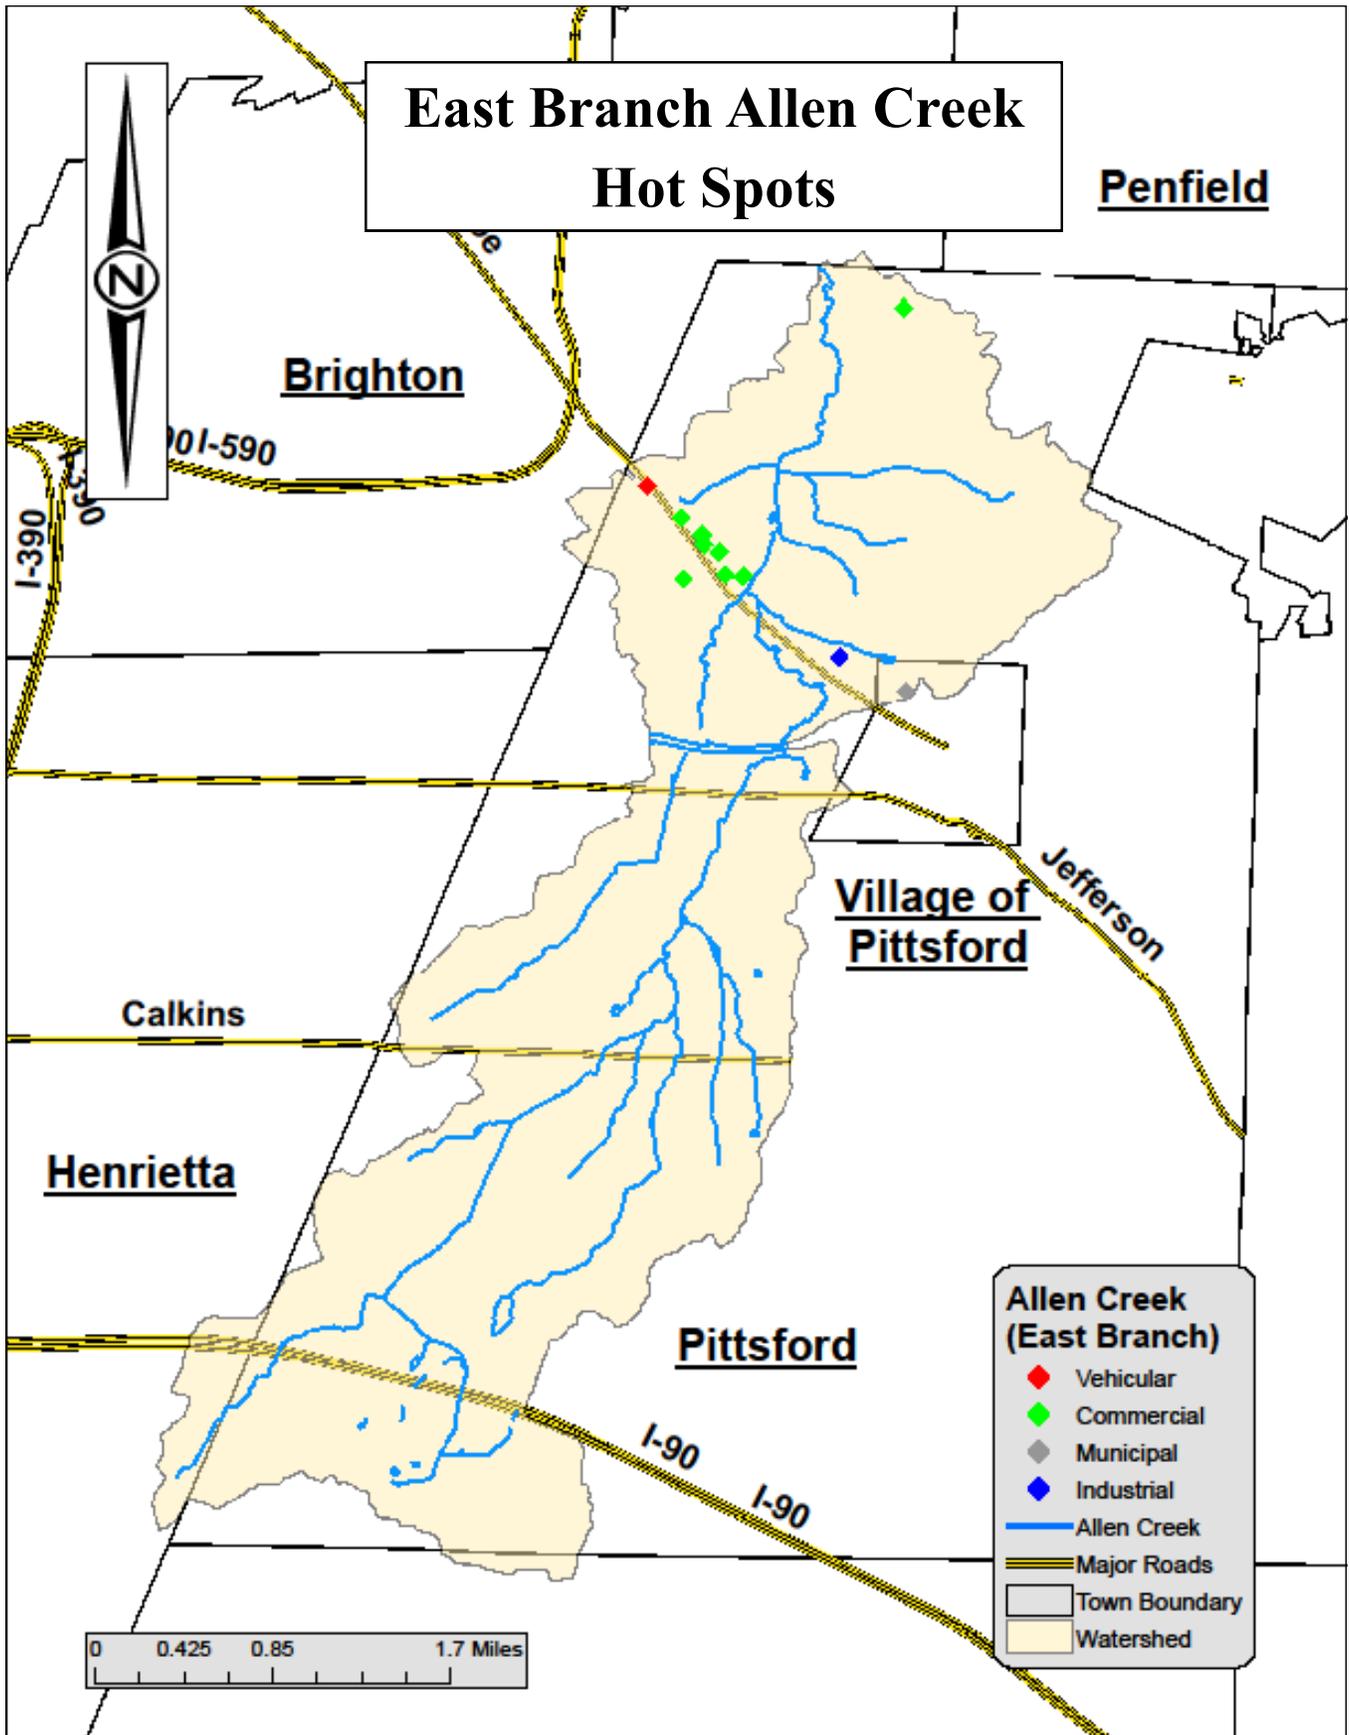
Figure C-2: Locations for potential hotspot within the Allen Creek east branch watershed.

Using the watershed parcel records and the parcel property class description, potential hotspots were identified, mapped and listed (Figure C-1 and Table C-1 respectively). Property uses include trucking, gas stations, auto washing, storage, repair and recyclers, minimarts, and fast food restaurants. Pollution prevention methods will vary greatly depending on the type of facility but could include better handling of automotive fluids at an auto recycling yard or installing a canopy over a gas station’s fueling island. The goal is to have the facility owners implement site specific practices to treat the quality of runoff from all severe stormwater hotspots using existing authority under industrial and/or municipal stormwater permits and ordinances. It is recommended that the sites listed be visited and evaluated by technical staff in order to a) determine if and how stormwater pollutants are being generated and exported from the site and, b) define the specific needed retrofit project.

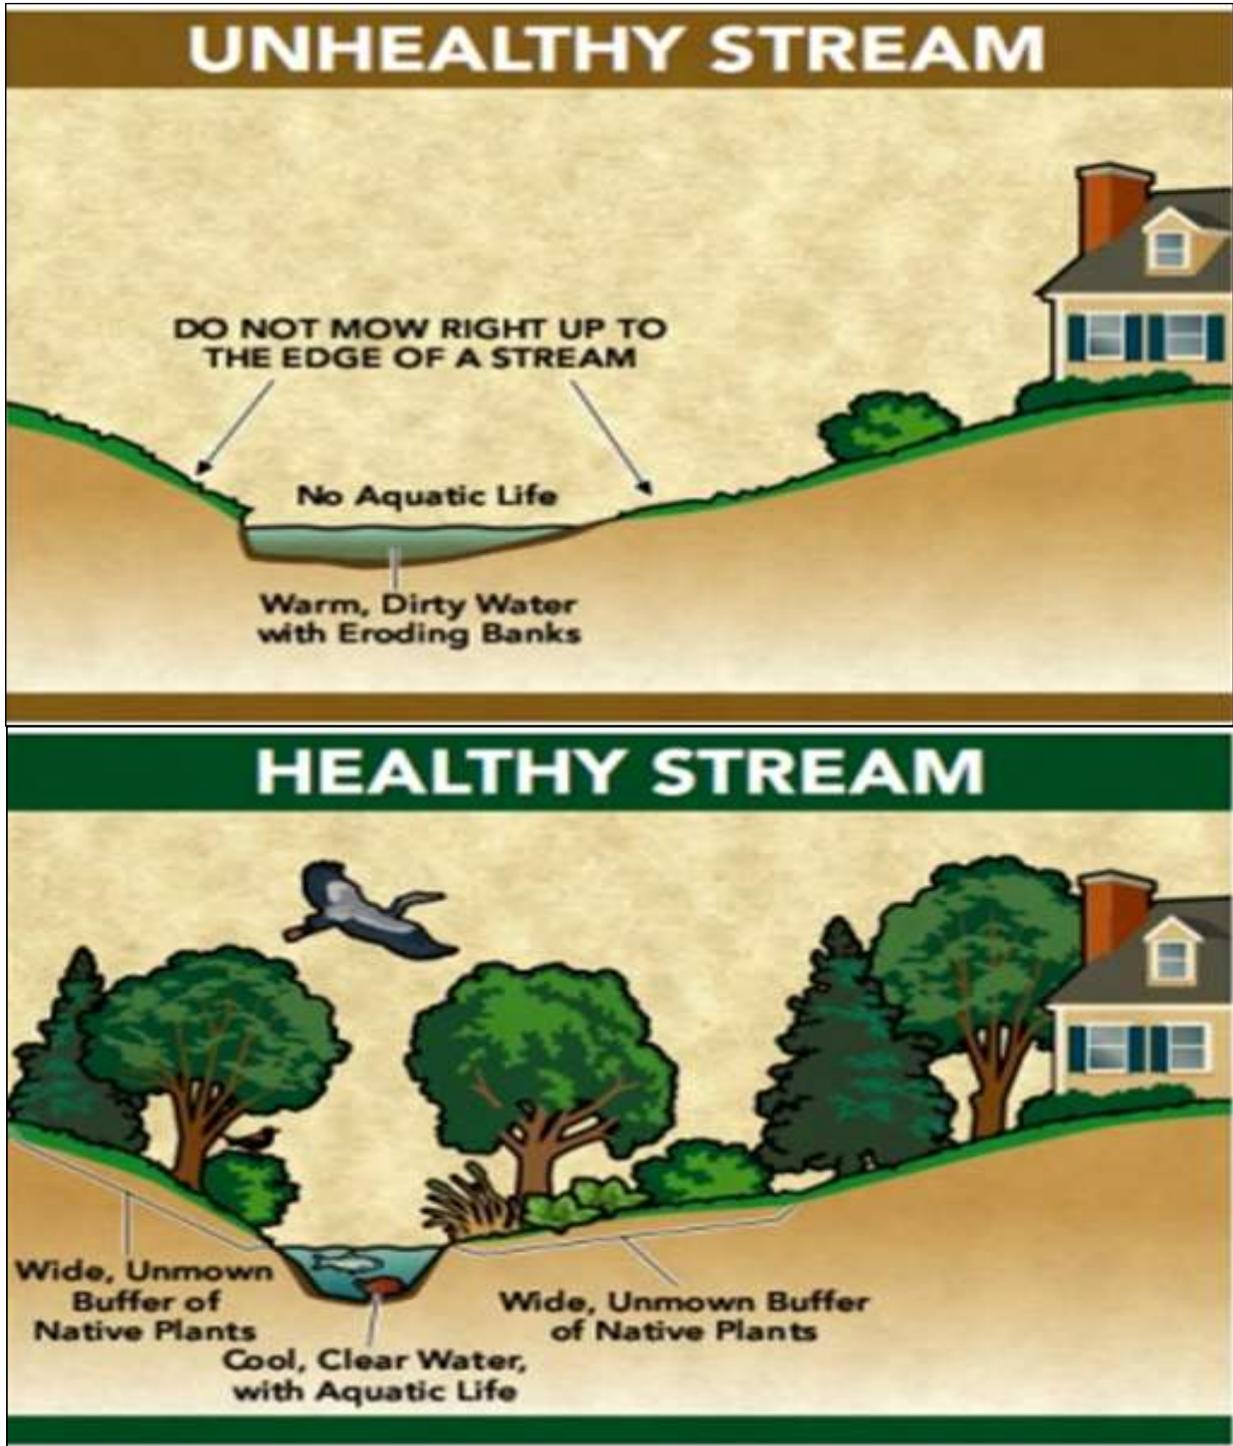
Figure D-1 . Streams need naturalized buffers to protect aquatic habitat and maintain water quality (Source, Philadelphia Water Department).

Stream Repairs include physical modifications to stream channels, banks, and in-stream habitat to repair and improve degraded or unstable conditions. The project objectives are to reduce streambank erosion, recover biological diversity of a naturalized stream, protect threatened infrastructure such as adjacent homes or roads, and to add community resources, aesthetics and recreation opportunities (Figure D-1).
